Cased Pipe Assessment

PHMSA Casing Workshop

Ken Davis- Ameren Services

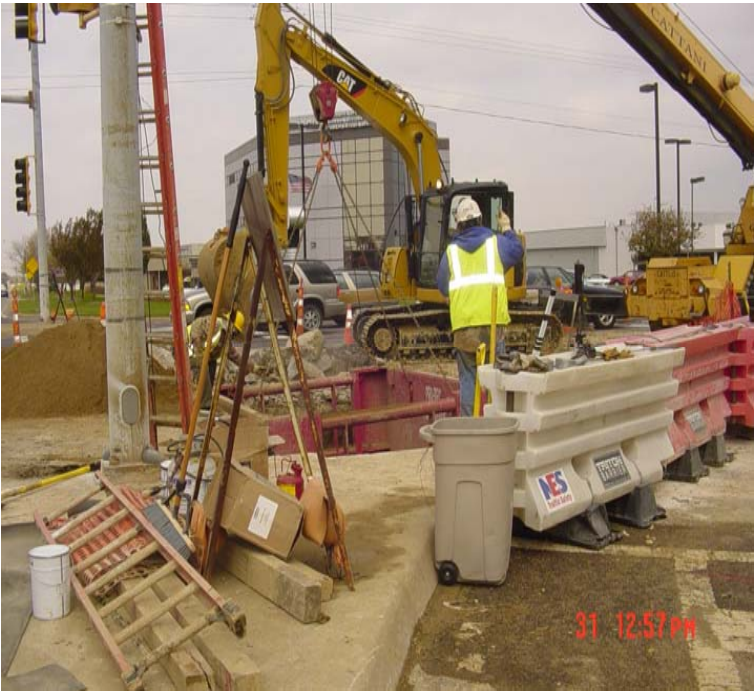
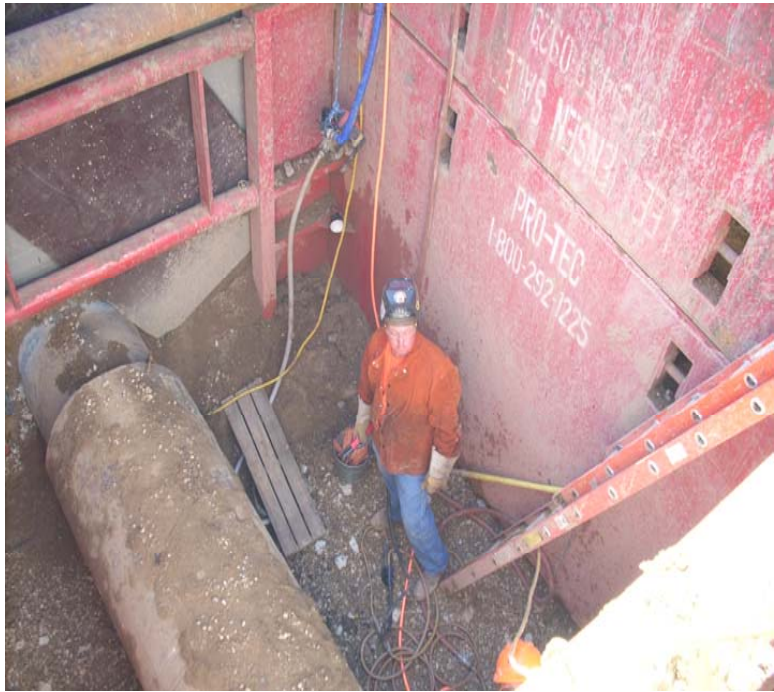
Casing Removal Example

- 30" pipeline in 67' long 36" casing
- No vents
- Under 6 lanes of pavement and a paved median
- Depth- 9' 7" to the top of the pipe and 14' to the bottom of the excavation
- Cost to remove the casing - \$ 360,xxx
(pavement restoration is not yet complete)
