# PHMSA Cased Pipeline Integrity Assessment Workshop

Chicago, IL  
July 15-16, 2008

Scott Meierotto

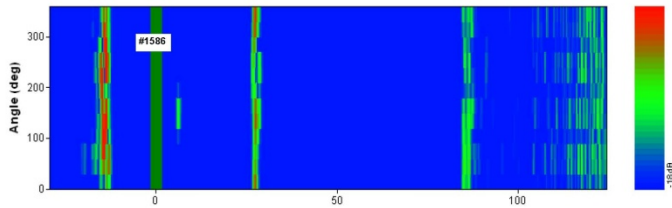
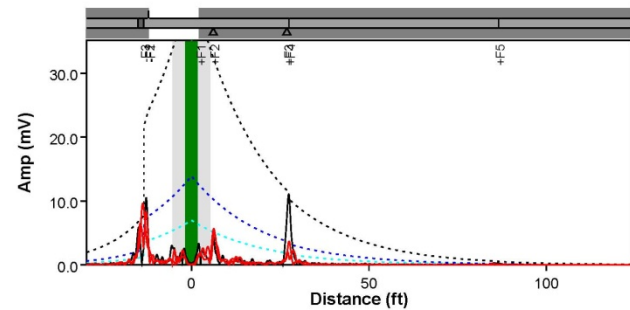
General Notes: (Wall thickness at test location .215" to .220") Grid 168-17/27, North Side of St Charles Rock Rd, Casing Length approx 98'. Test range from North side was 60'. No corrosion was noted above the 3% ECL Line.

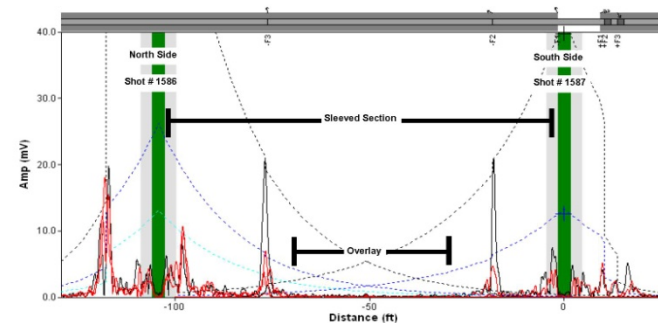
Feature	Location	Size (mV)	ECL	Extent	Class	Notes
+F5	86'6"	0.366	-	70	Weld	
+F4	27'5"	13.4	25	80	Weld	
+F3	27'1"	11.1	-	80	Support	
+F2	6'2"	5.28	-	0	Support	
+F1	2'3"	4.02	-	50	Sleeve	Entrance to the sleeved section.
-F1	-12'0"	5.92	-	45	Vent	
-F2	-12'2"	8.13	-	60	Entrance	
-F3	-13'5"	6.52	-	0	45 deg Bend

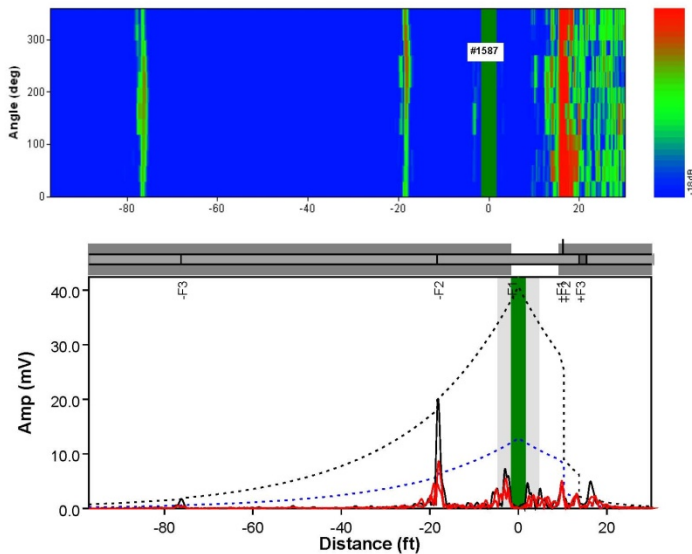
General Notes: (Wall thickness at test location .216" to .219") Grid 168-17/ 27 , South Side of St Charles Rock Rd , Casing Length approx 80' , Test range from South side was 80'. No corrosion was noted above the 3% ECL Line.

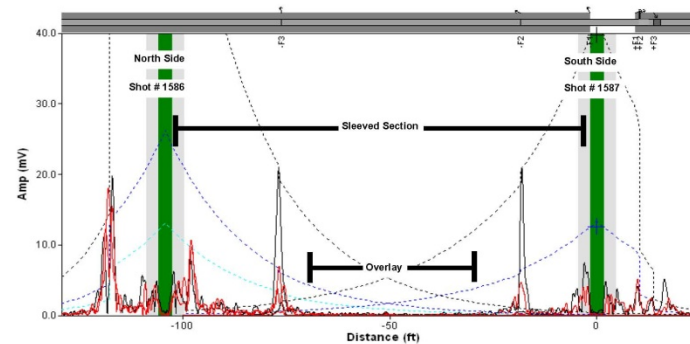
Feature	Location	Size (mV)	ECL	Extent	Class	Notes
+F3	13'8"	2.18	-	35	5 deg Bend	
+F2	10'3"	2.91	-	0	Vent	
+F1	9'3"	3.14	-	0	Earth	
-F1	-1'9"	4.41	-	45	Sleeve	Entrance to the sleeved section.
-F2	-18'4"	19.9	25	80	Weld	
-F3	-76'3"	1.76	-	80	Weld

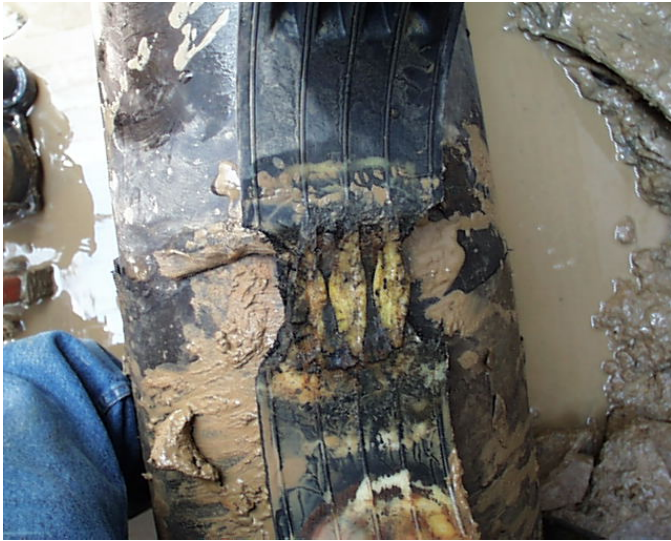
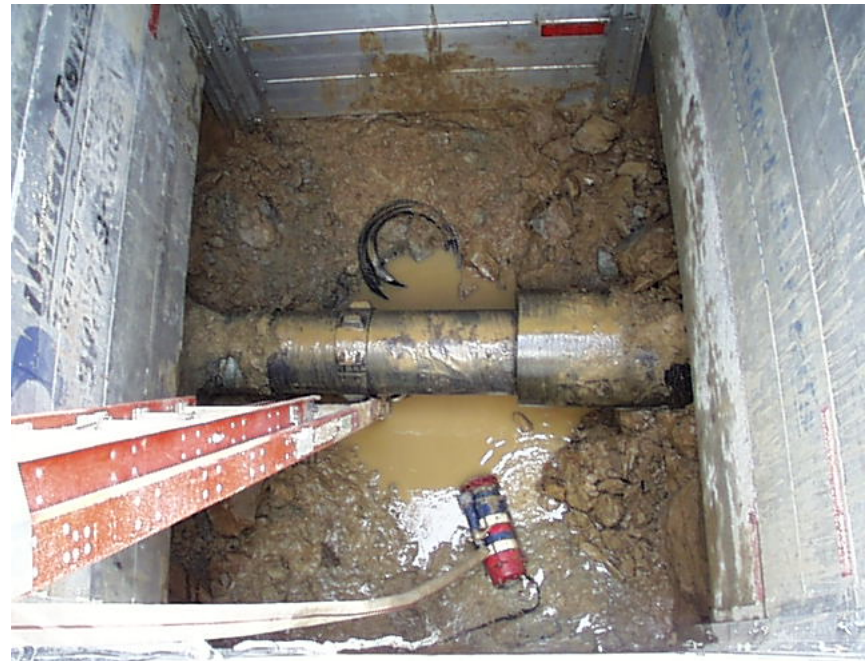
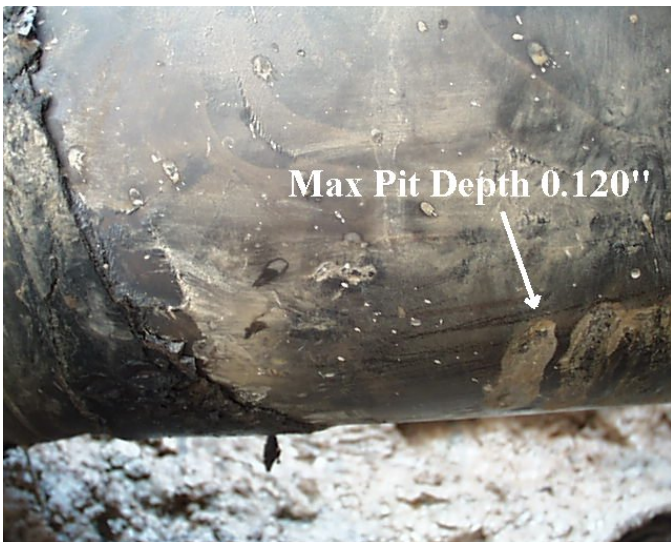
12" Carrier 0.250" wall – 18" Casing 35' Long  
Installed 1964

Under insulator – Passed B31G

Coating damaged by slipping Insulator – Passed B31G

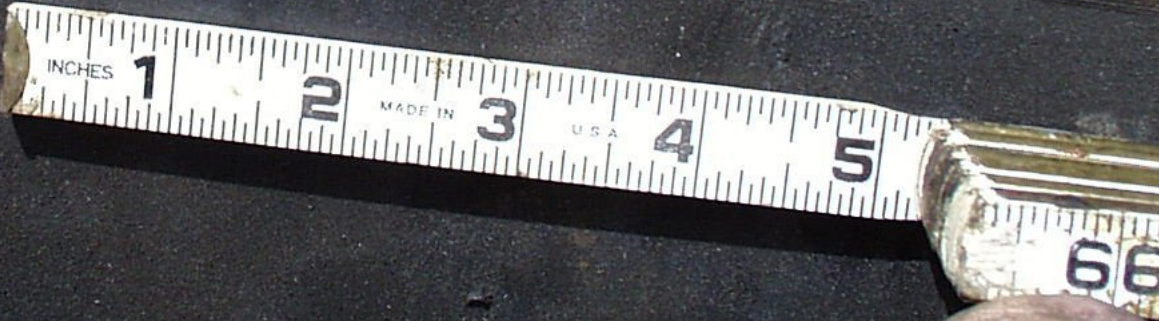
Remaining coating under gouge

Pit .030" Deep

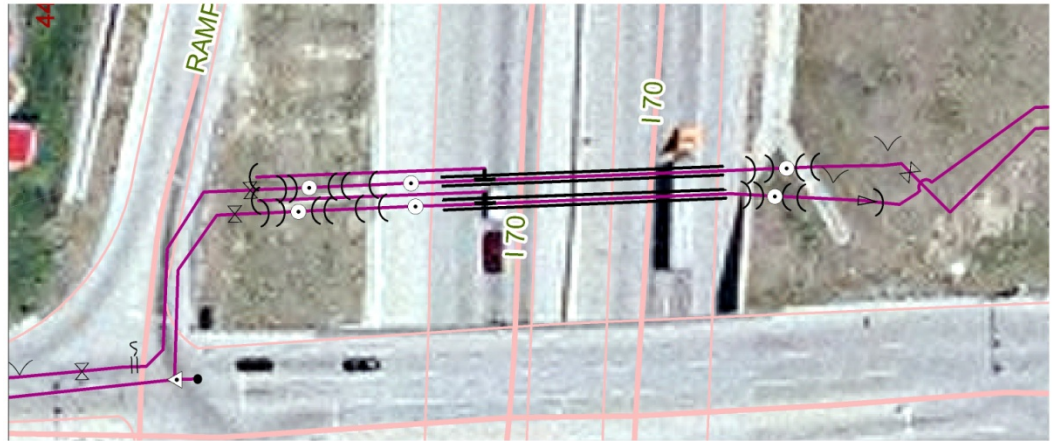
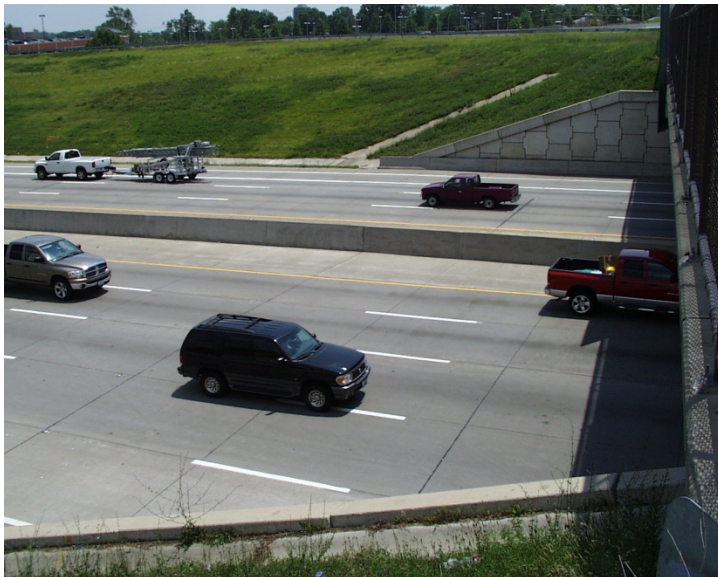
24" Carrier

30" Casing 125' long

Installed 1958

Ends relocated in 2001
