# PLYMOUTH PLANT INCIDENT INVESTIGATION

# Overview

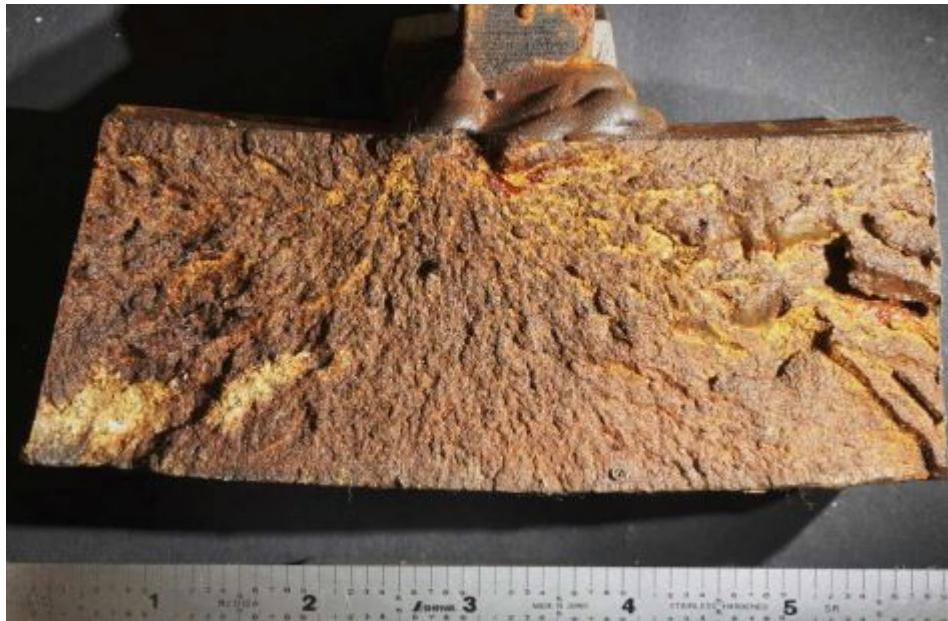
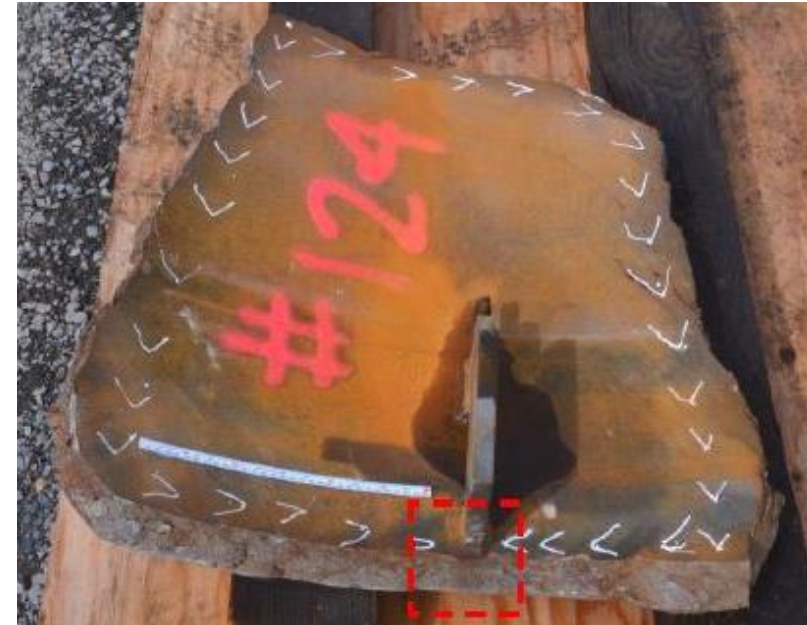
- Chevron markings point towards fracture ‘initiation sites’
- Fragments containing points of interest were shipped to SES facilities in Houston for detailed examination

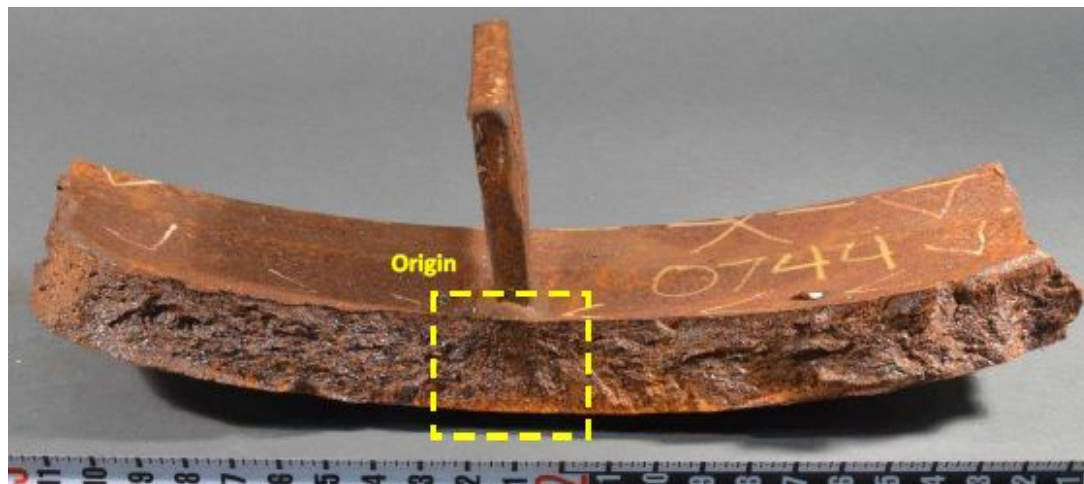
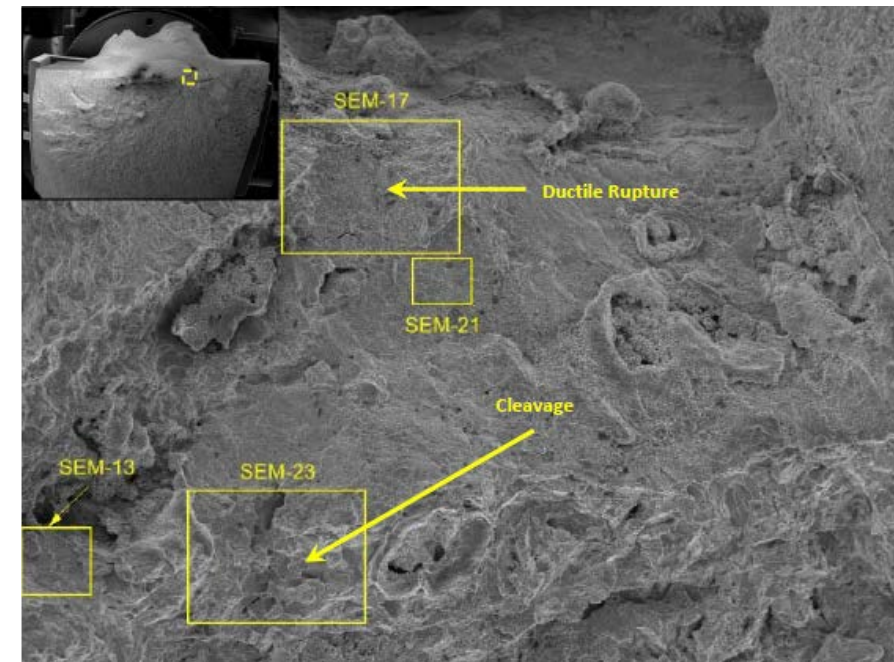
- SES also performed testing to confirm proper materials of construction
  - Found no cause for concern
  - Found no evidence of soot/combustion materials on vessel walls

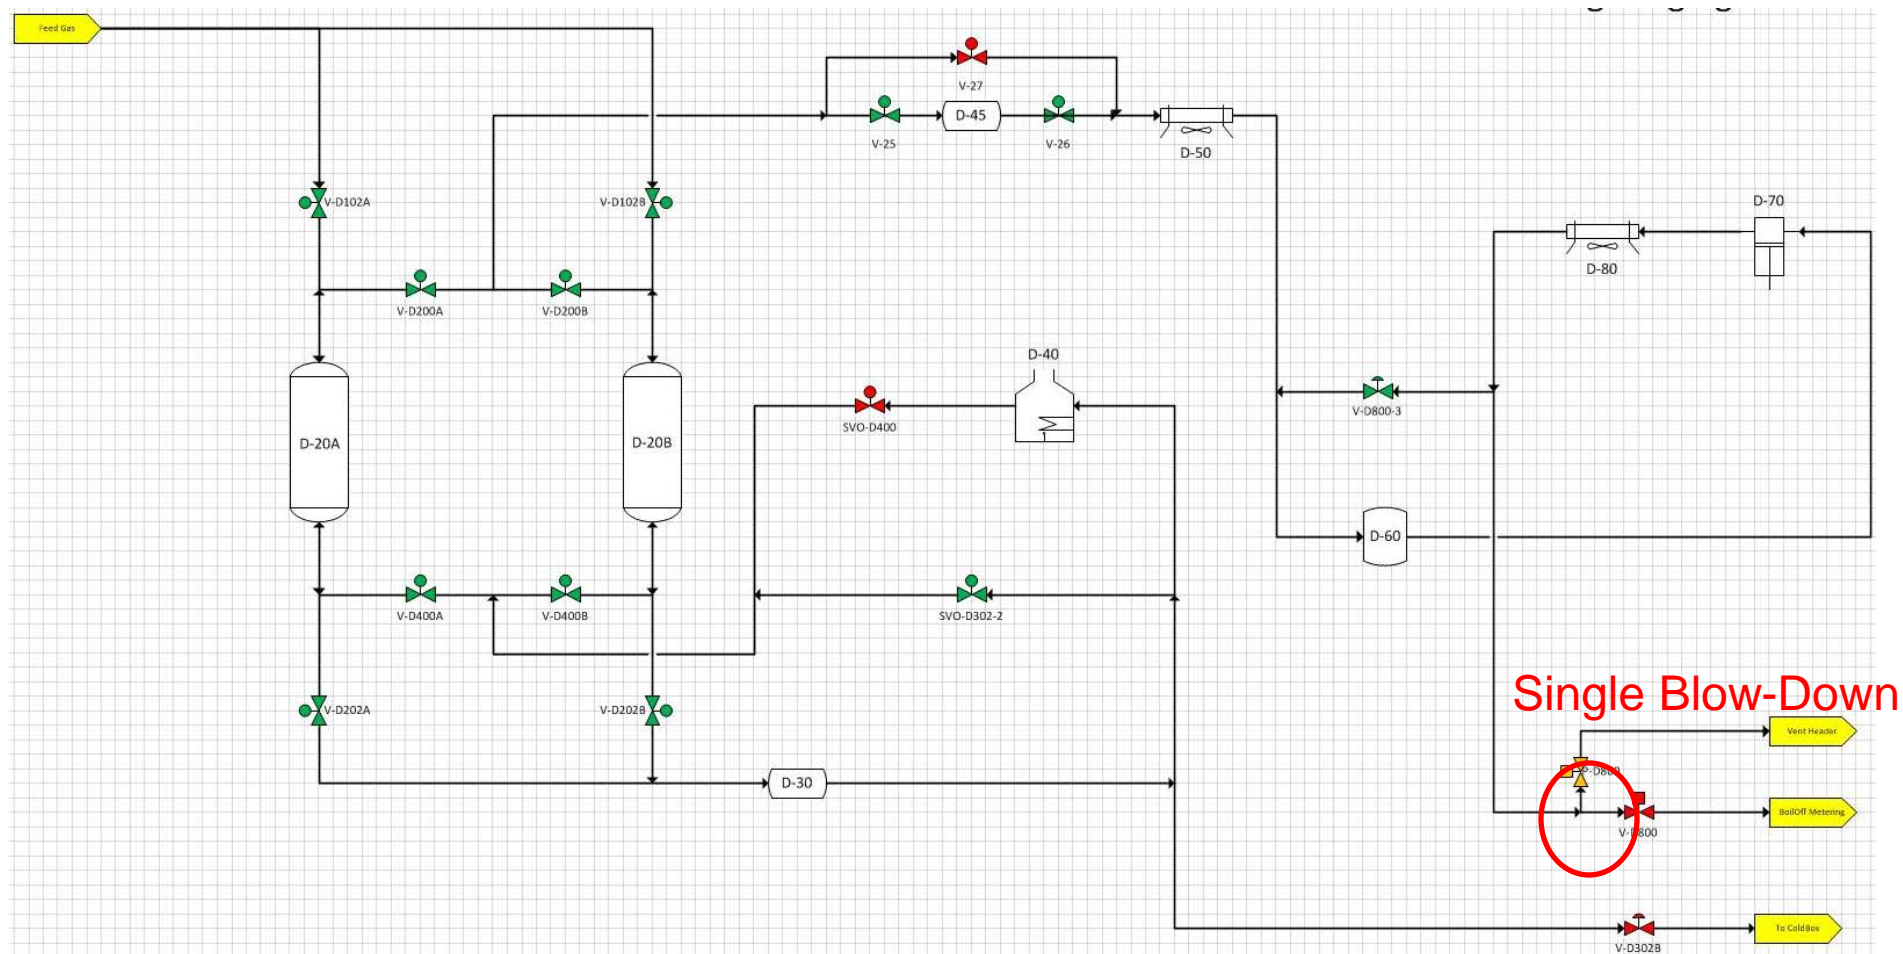
Single Blow-Down

- “Pack and Purge to 100 PSIG 3 times”
  - Valve Alignment allowed for “spring effect” if not blown down to 0 psig
  - AGA: Purging Principles and Practice provides purging guidelines, however it doesn’t prescribe methodology for purging molecular sieve adsorbers.

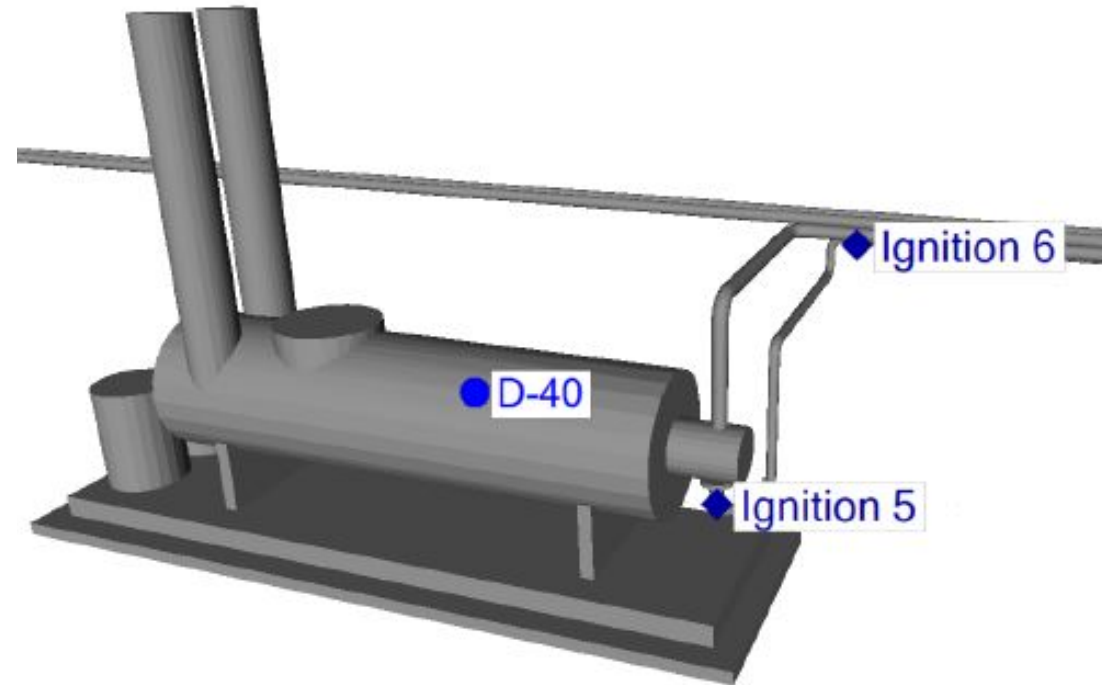
- Results identified the Salt Bath Heater inlet nozzle as the initial ignition location (identified as ignition location 5)

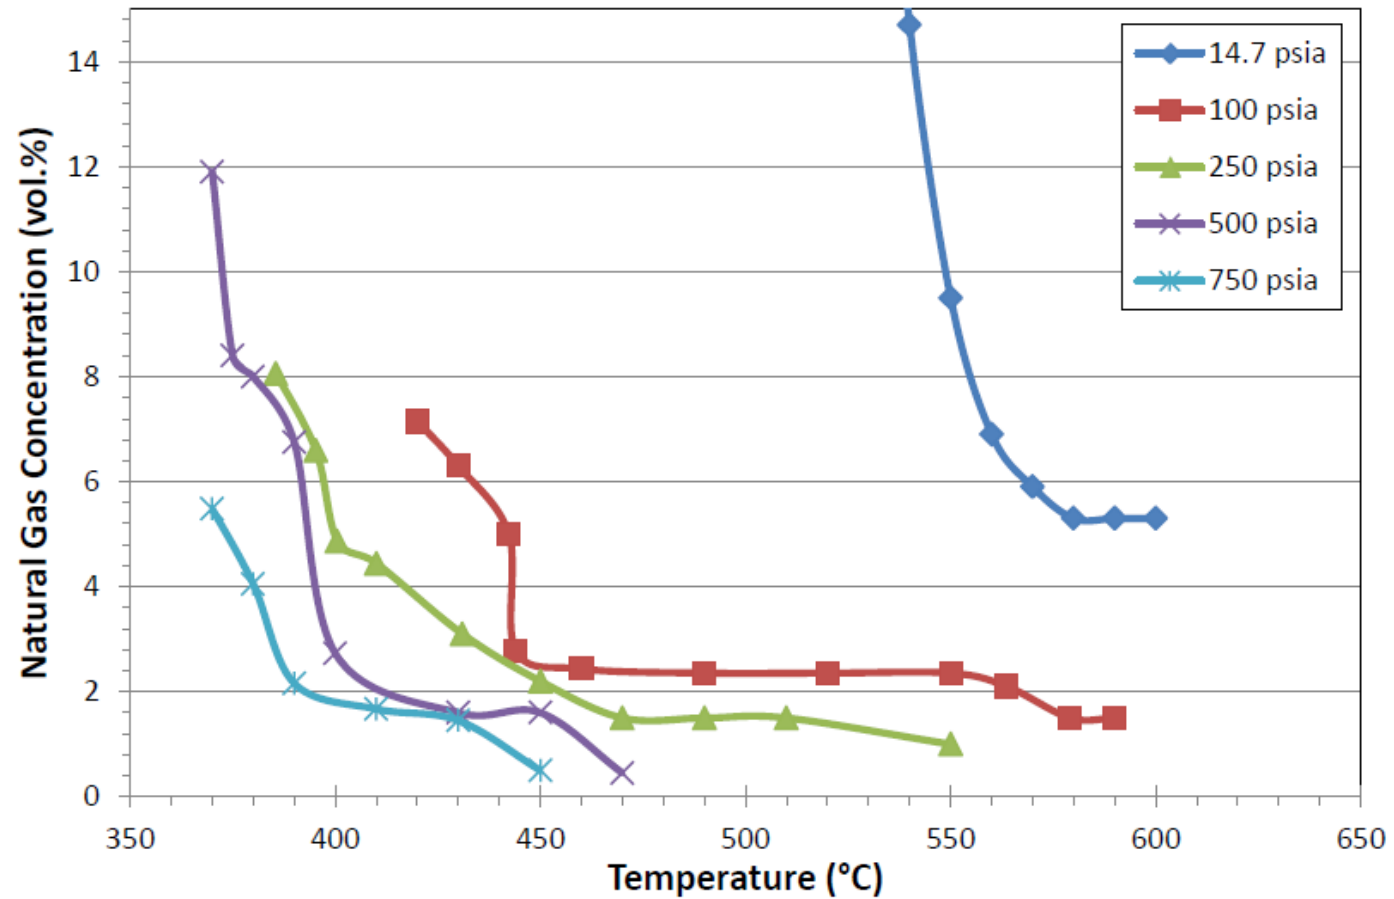
- Concluded that auto-ignition of Plymouth inlet gas at ~700 psig could fall as low as 680 deg F.
- The plant heater was running @ 550 deg F
- Calculated additional heat was provided during pressure up from 53 psig to 685 psig (adiabatic compression) 15 minutes prior to the incident

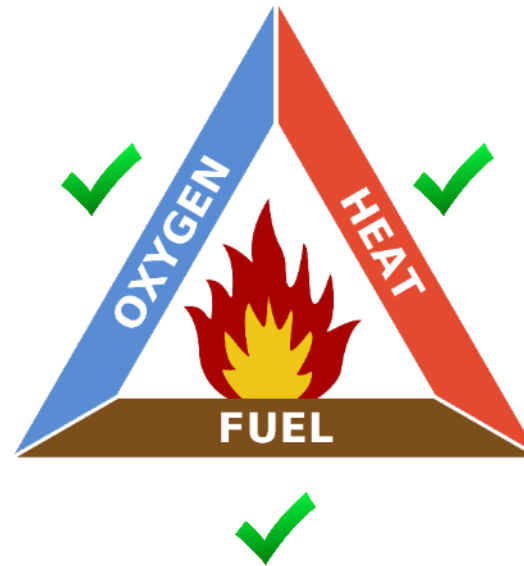
- The lack of a complete purge left an air and natural gas mixture in plant piping downstream of the adsorber towers. During startup the flammable mixture was pulled into the salt bath purification heater where it then ignited, creating a rolling detonation back through the purification piping until it reached adsorber D-20A which then failed, dissipating the energy of the rolling detonation.

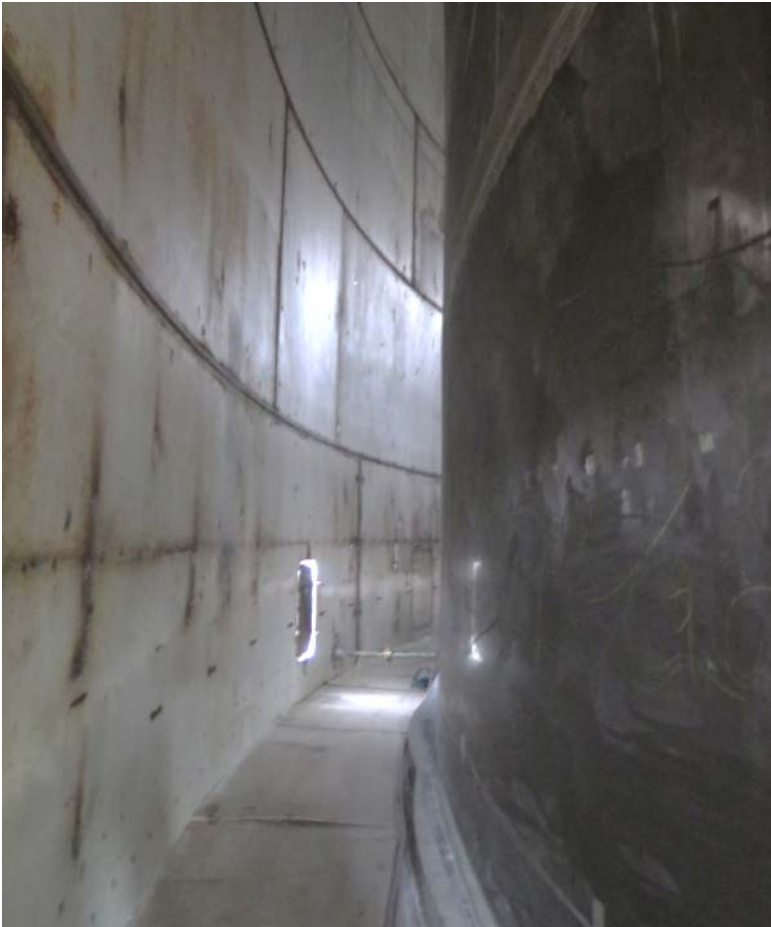
# LNG I Tank Internal Inspection

- Dent indication on east quadrant was characterized using electromagnetic residual stress sensors and laser scanning. Fitness for service was performed by Stress Engineering. The dent was repaired by blend grinding and was made safe for continued operation
- External foundation inspection
- Roof support bolts inspected by Chicago Bridge and Iron
