NTSB National Transportation Safety Board

Importance of

Integrity Verification

Pipeline Integrity Verification
Process Workshop

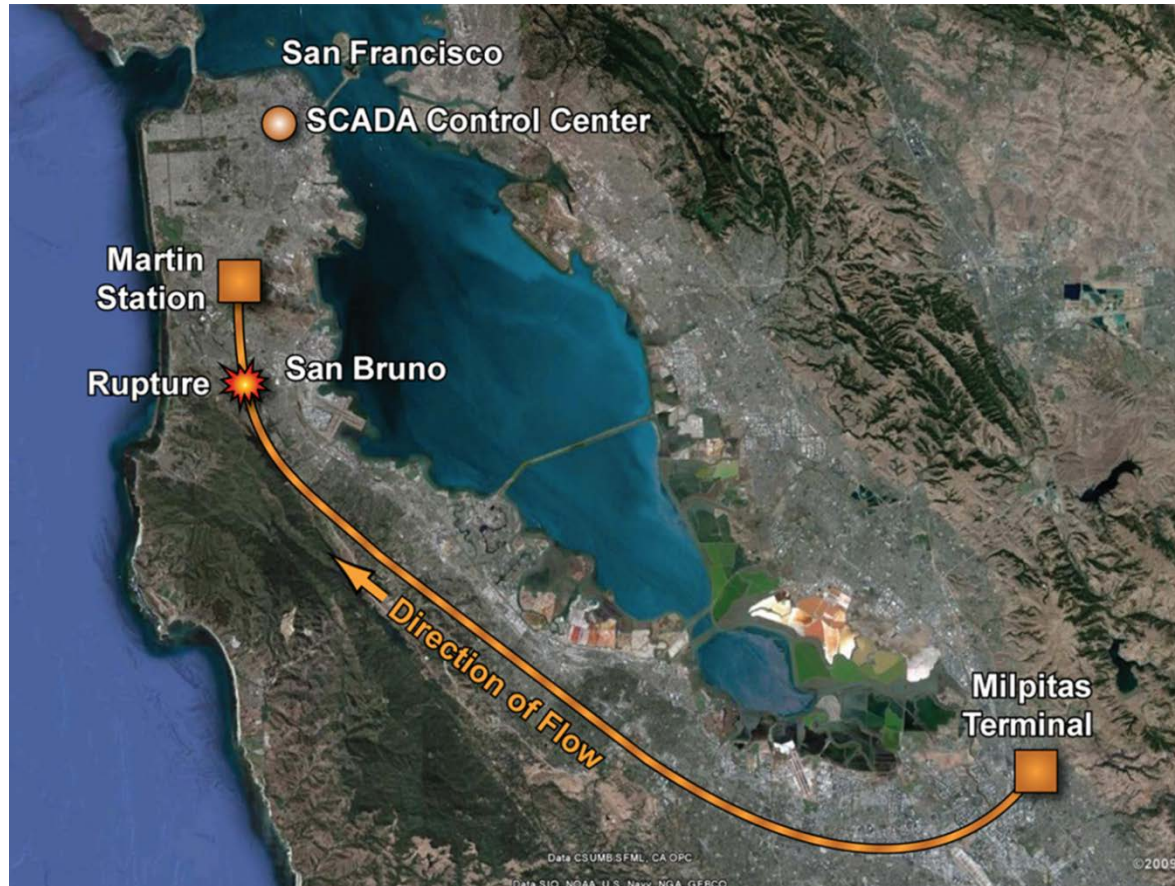
San Bruno: Line 132

Ruptured Portion: Installed in 1956

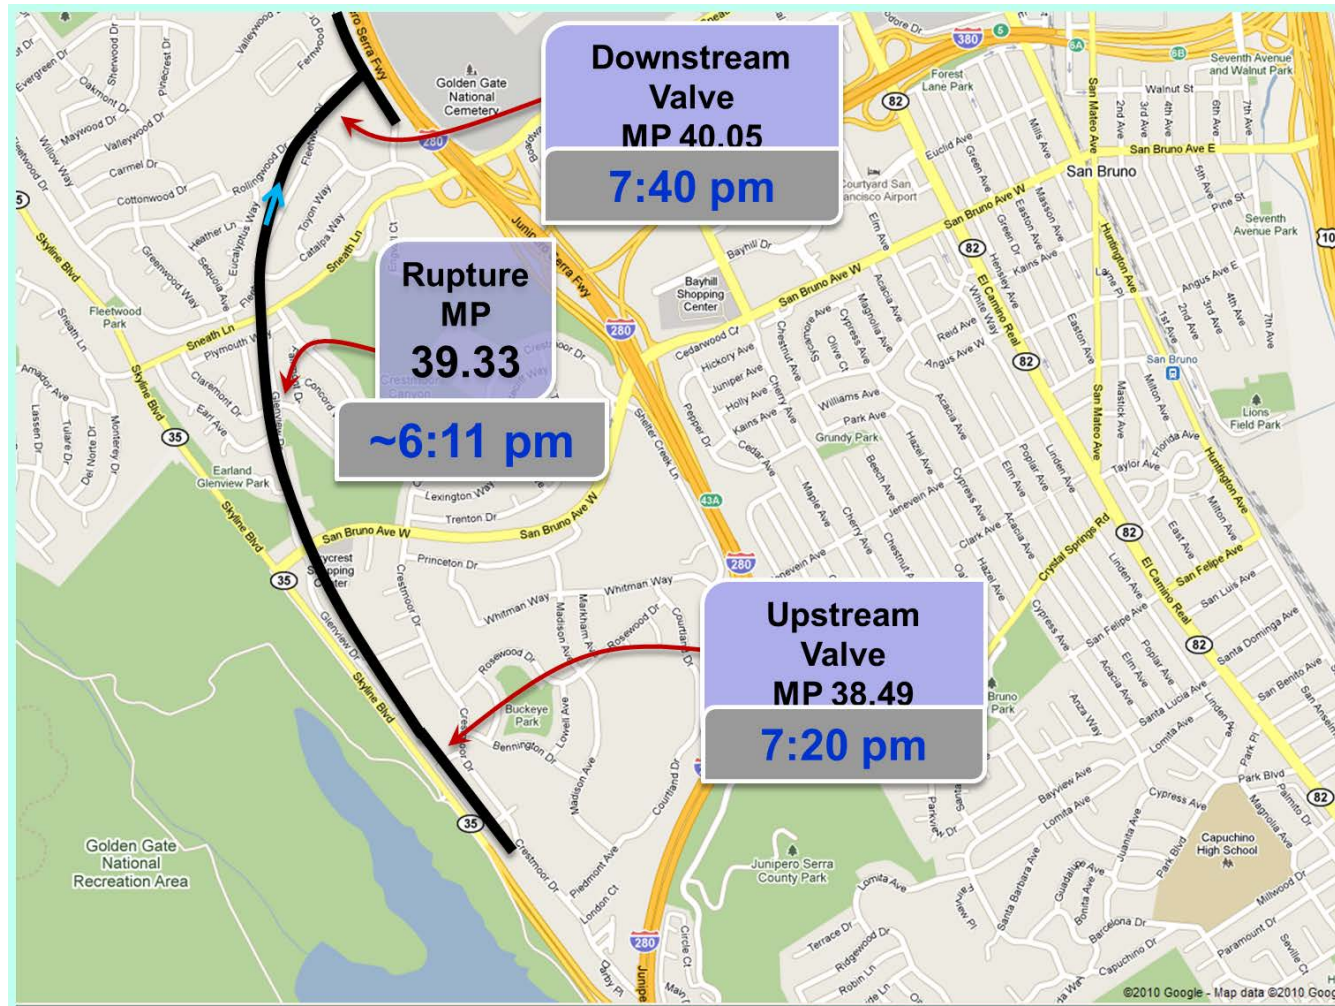
Shutoff Time: More Than an Hour

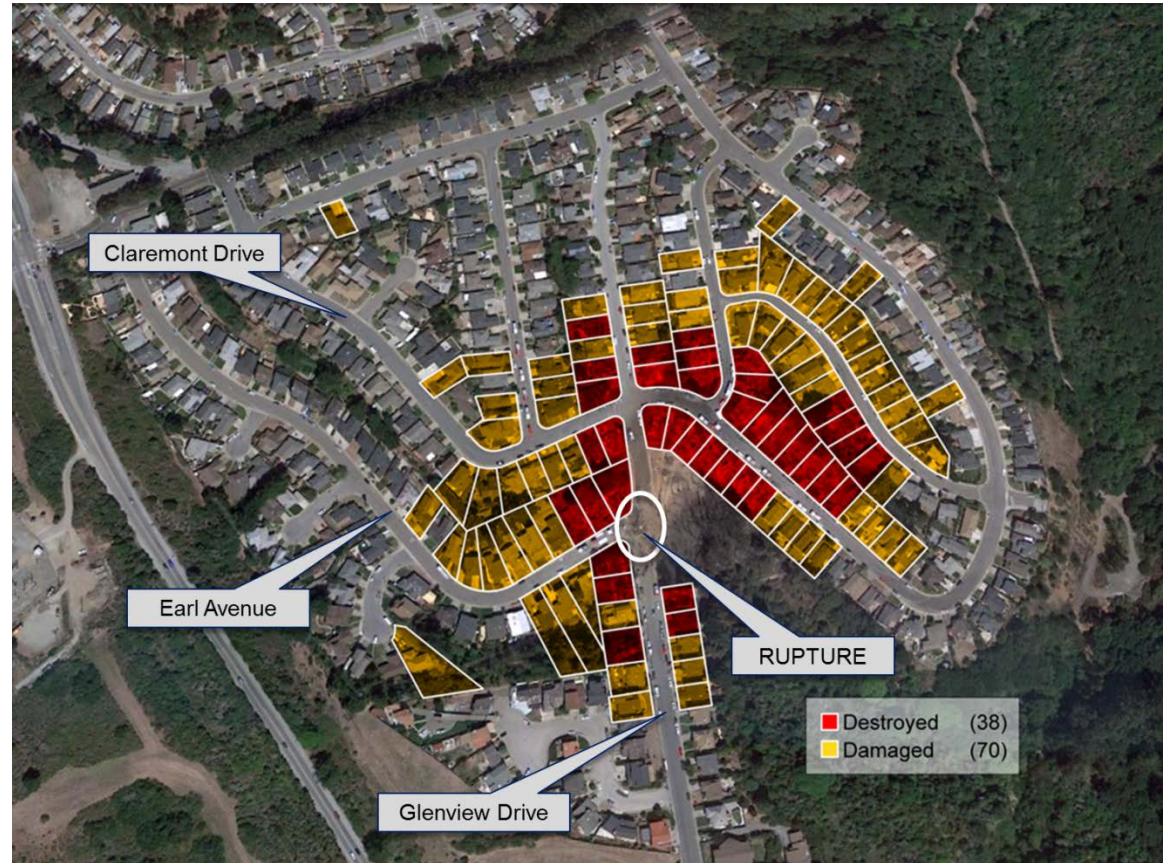
Results of Explosion and Fire

- 8 Fatalities
- 58 Injured
- 38 Homes destroyed
- 70 Homes damaged

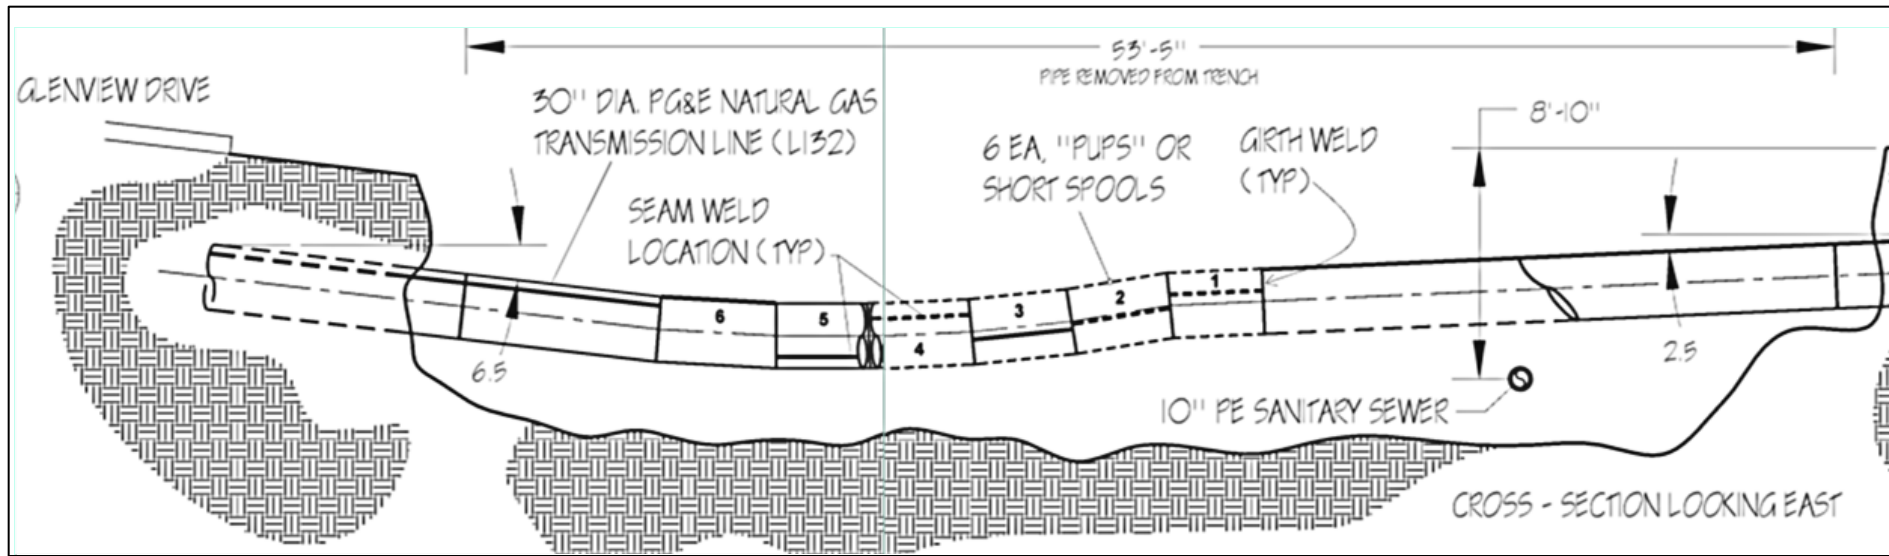
Pup Elevation Detail

Portion of Diagram from San Bruno Docket No. SA-534, Exhibit No. 2-D:
“Schematic Showing Relative Locations of Nearby Services and L132 in the Trench”

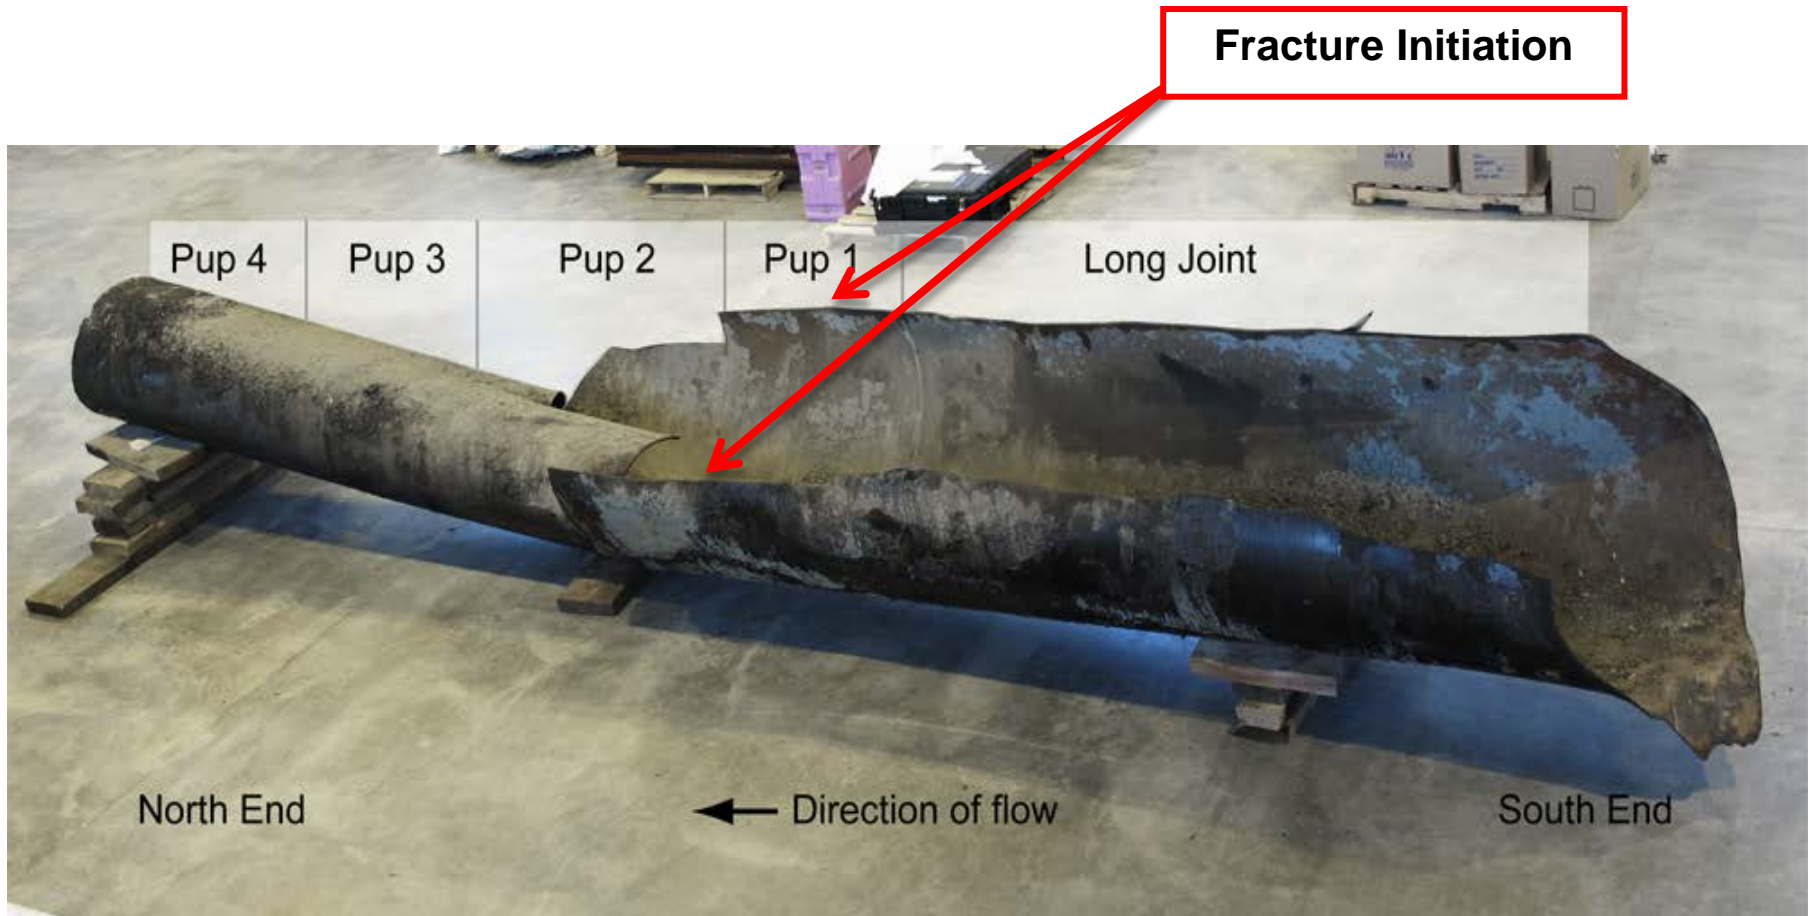
Separated Pipe Segment

- Ruptured portion installed in 1956
- Manufacturing technique and material properties deviated from PG&E specifications
 - Lower yield strength
 - Chemical makeup was sub-specification
 - Plate rolling direction was circumferential, rather than longitudinal
- Unknown manufacturer

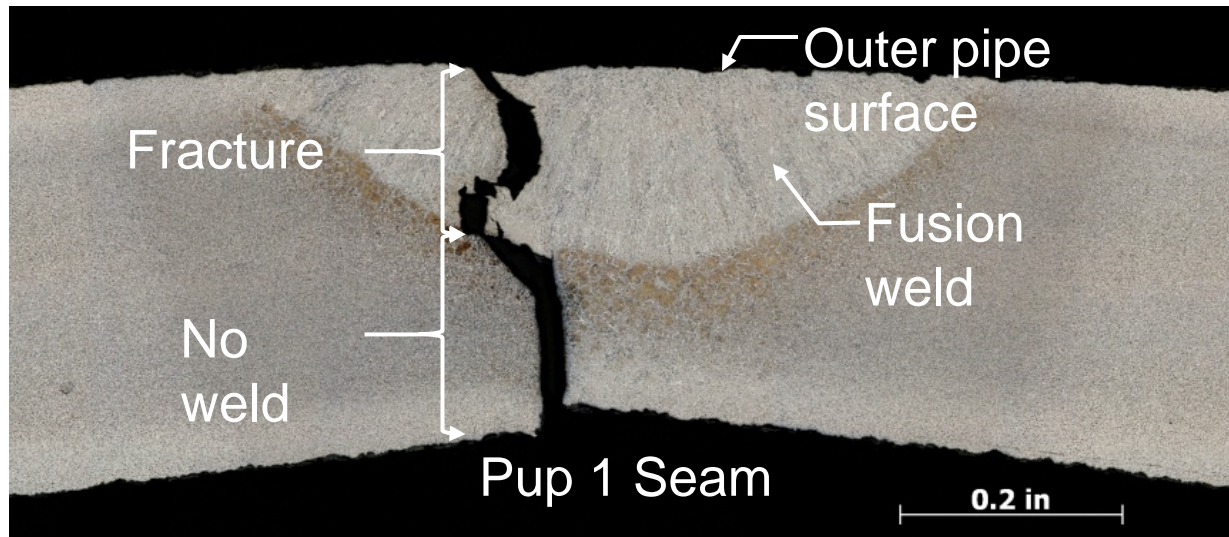
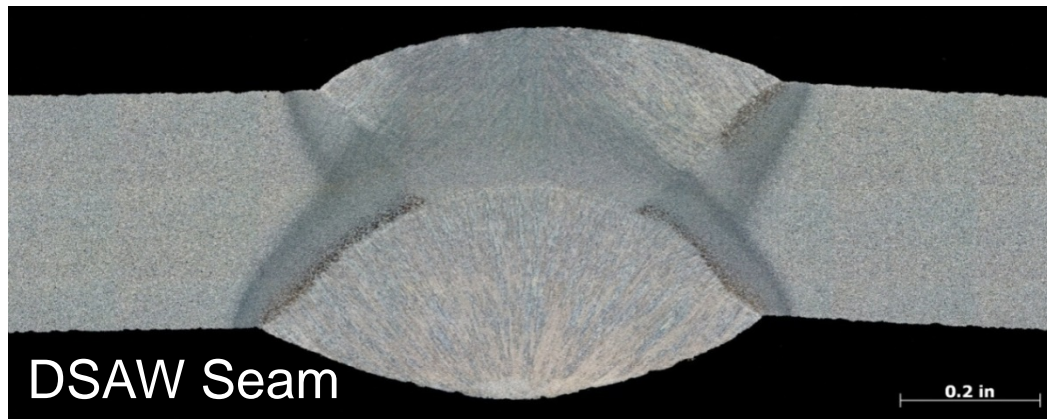
Cross Section of Pup 1 Weld

- PG&E records indicated “seamless pipe” but pipe segments had longitudinal weld seam
- Deficient weld quality
 - Single rather than double
 - Weld size
 - Workmanship

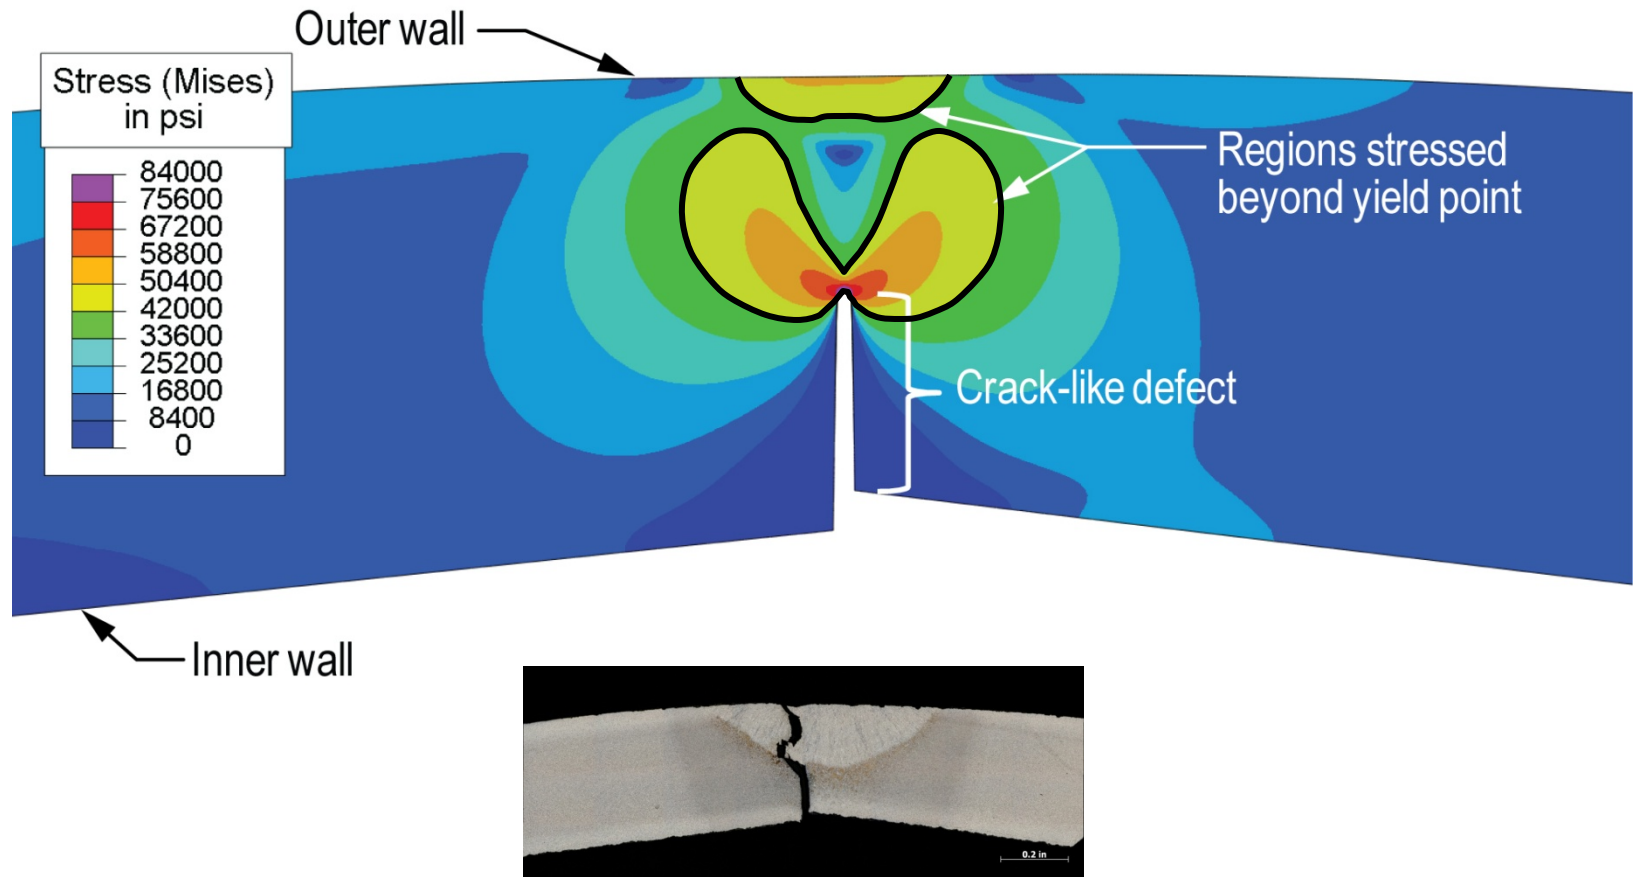
Stresses at Incomplete Weld

- Inadequate QA/QC during construction
- Inadequate integrity management
- Contributing to the accident:
 - Exemption from pressure testing due to grandfathering
 - Inadequate regulatory oversight
- Contributing to the severity of the accident:
 - Lack of automatic shutoff or remote control valves
 - Inadequate emergency response

- Rescind the grandfather clause and require hydrostatic testing at 1.25 MAOP for older pipelines
- Revise integrity management inspection protocols to minimize threat of pipeline ruptures
