# Recent Case Study Hard Spots and NTSB Recommendation P-22-3

Enbridge / Texas Eastern  
Danville, Kentucky

National Transportation  
Safety Board Investigation  
Report Number  
PIR-22-02

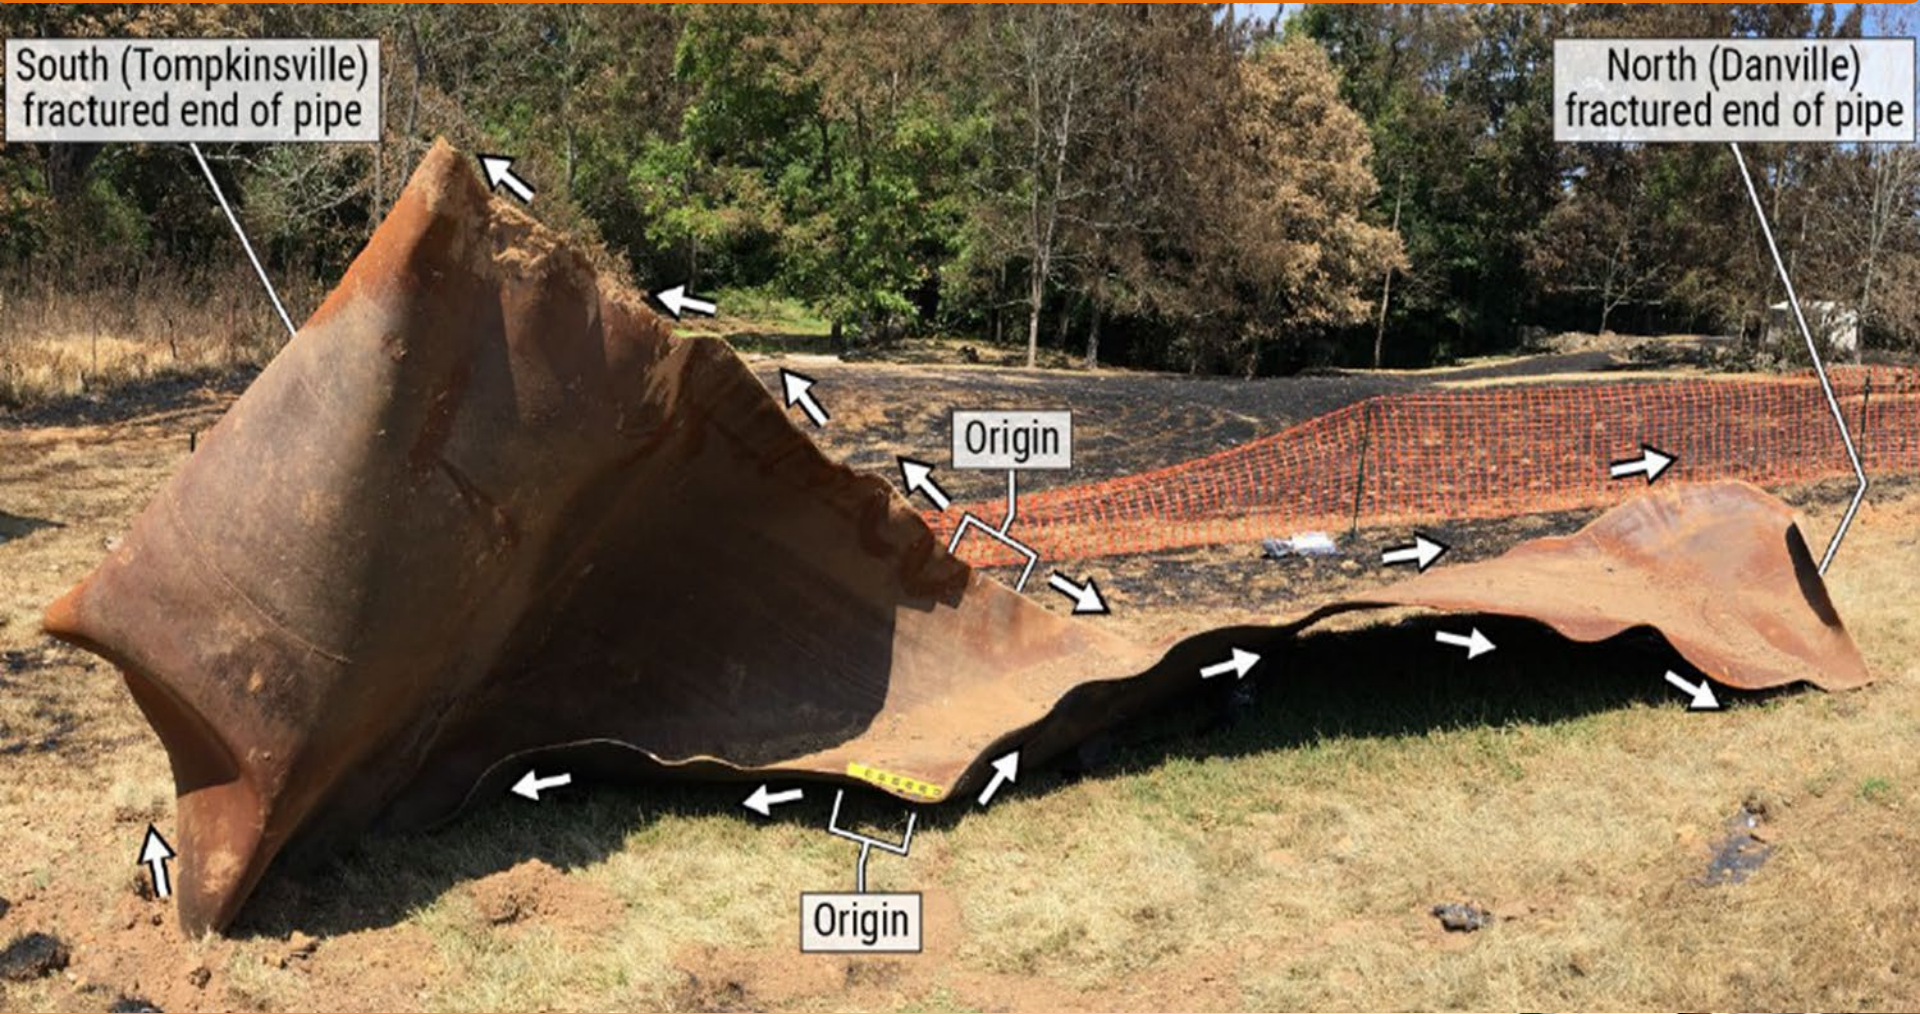
# Origin was found in the ejected pipe

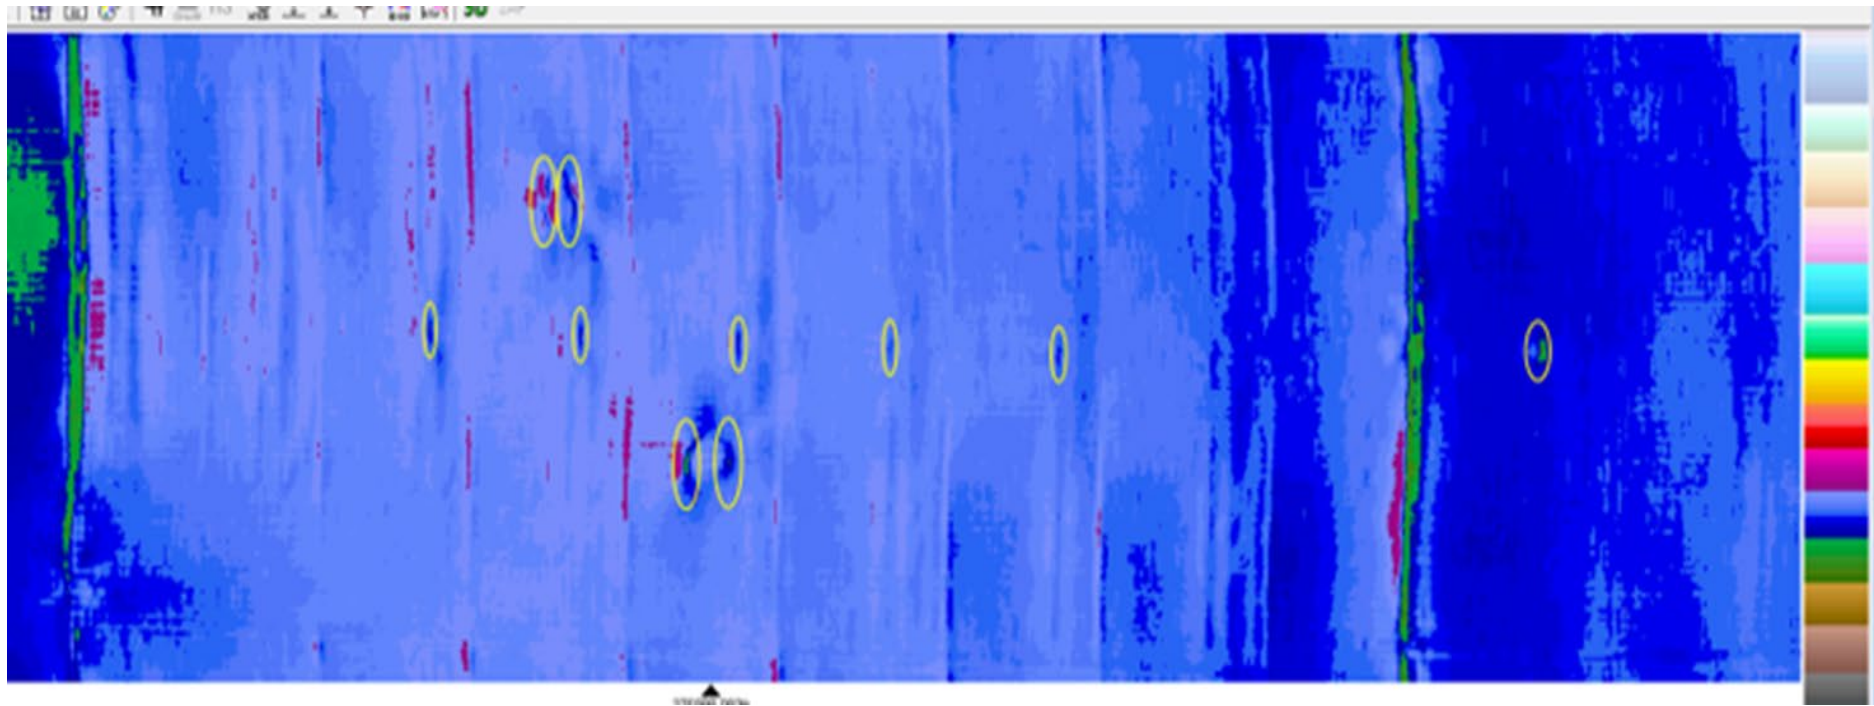
# Analysis of 2011 hard spot ILI scan

Hardness testing by NTSB identified the origin hard spot was 5.85 inches by 3 inches and had hardness values between 362 and 381 Brinell. Hardness readings extended through the wall.
