s & Advisory Bulletin

U.S. Department of Transportation
Pipeline and Hazardous Materials
Safety Administration

Case Study 1: Denbury Satartia, Mississippi

Case Study 2 – Hillsboro, Kentucky

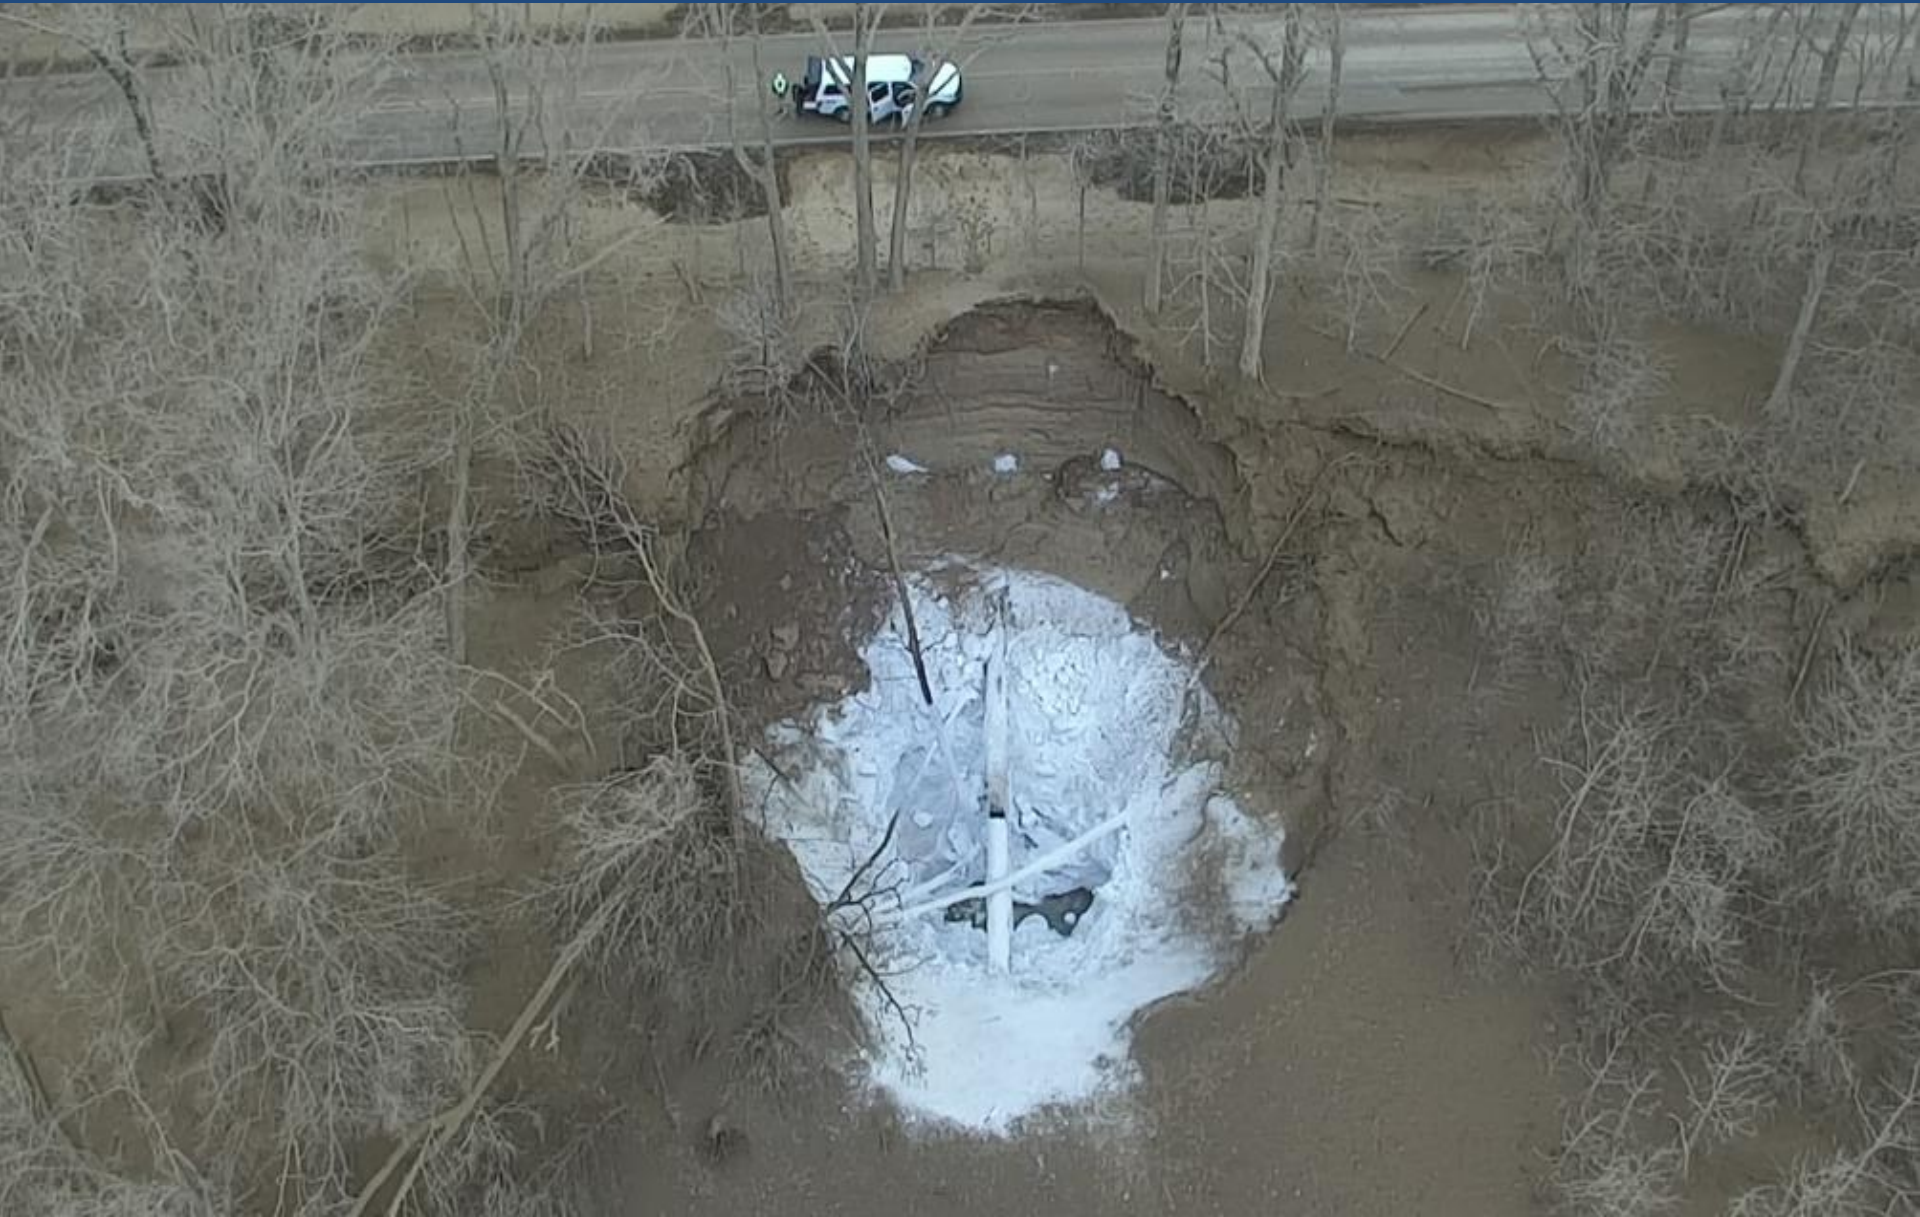
- Occurred 1 mile southeast of Satartia, Mississippi
- 200 people were evacuated
- 45 individuals sought medical attention
- Over 30,000-barrels released

OPID 32545 - Denbury Gulf Coast Pipelines, LLC - Satartia, MS. 2/22/2020

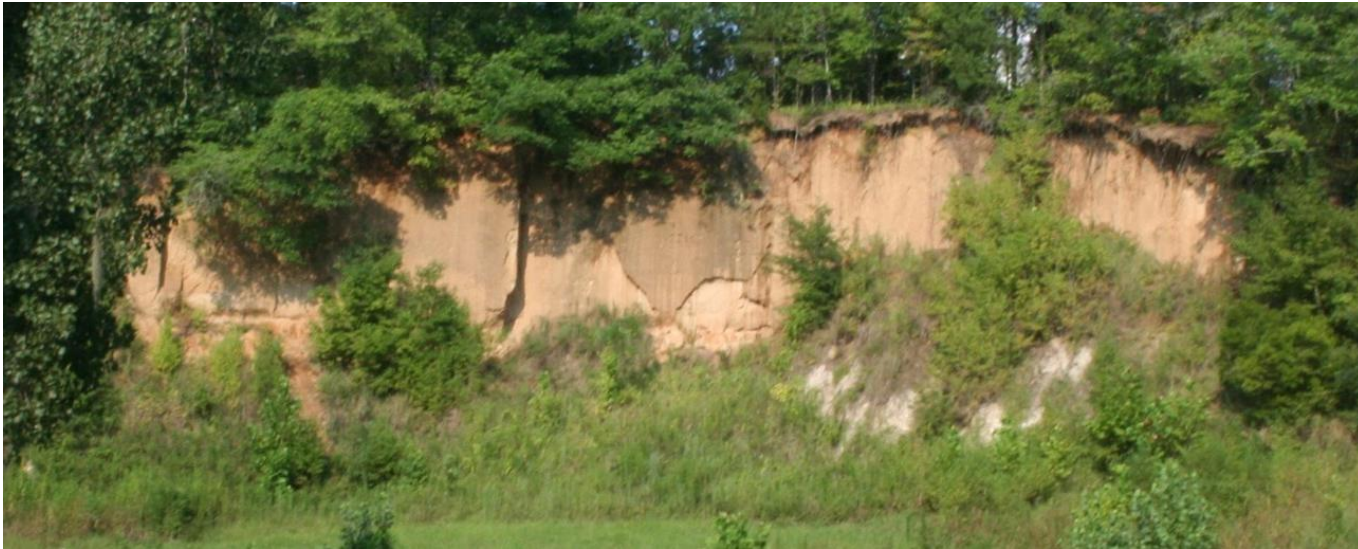
Loess Soil

- Sandy and silty, <20% clay – accumulation of wind-blown dust
- Highly porous with vertical capillaries
- Erodes readily

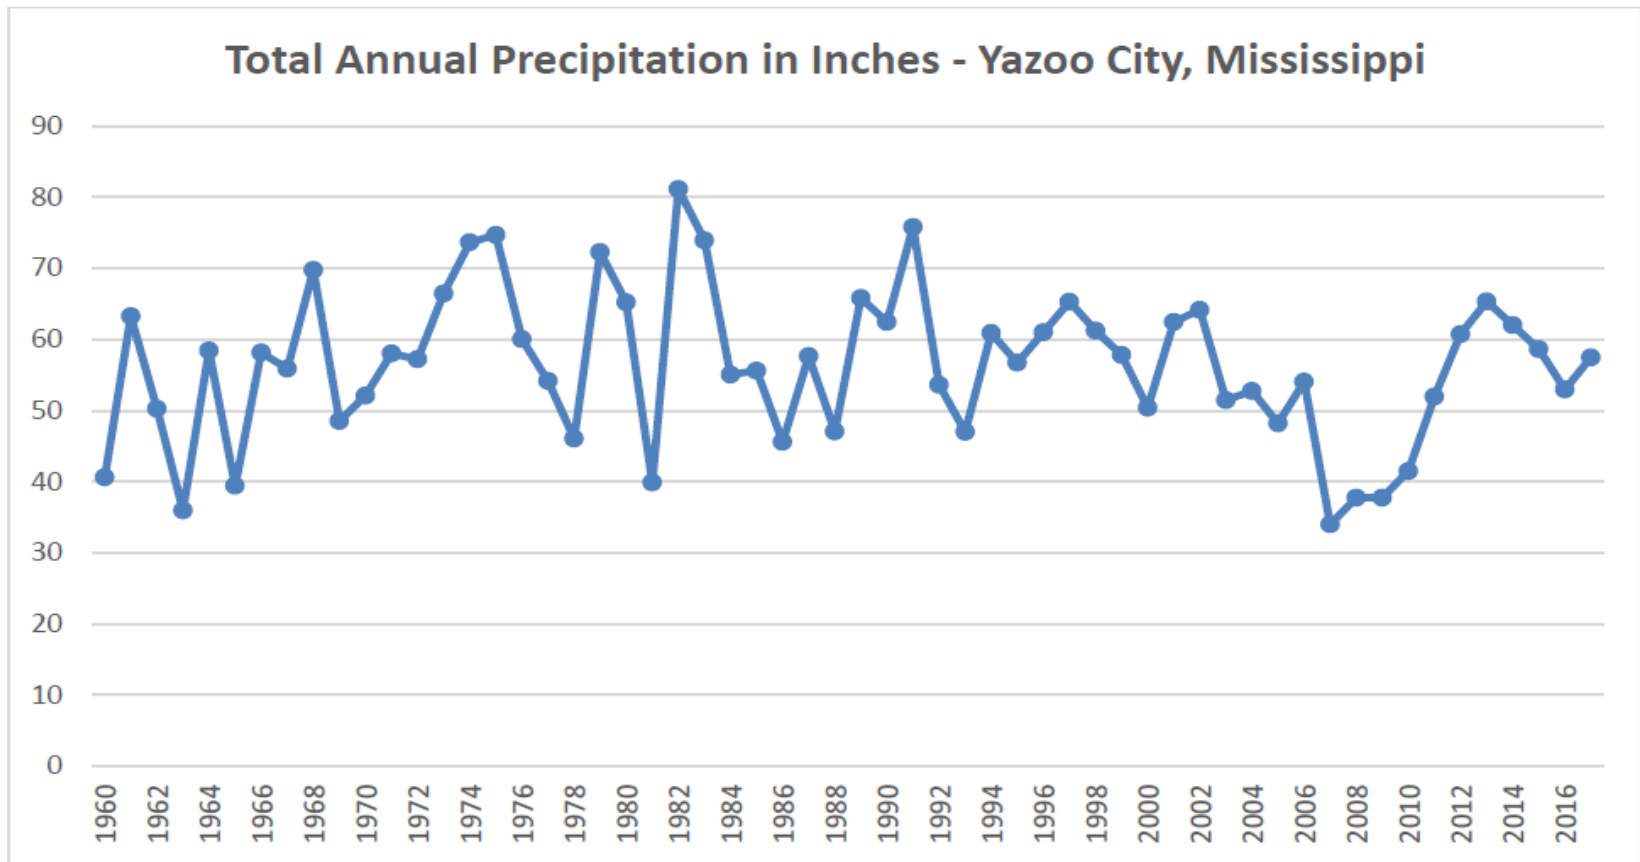
Graph of Annual Rainfall in Yazoo City from 1960 to 2017 – Data averaged for years 1996, 2004, 2008 and 2009

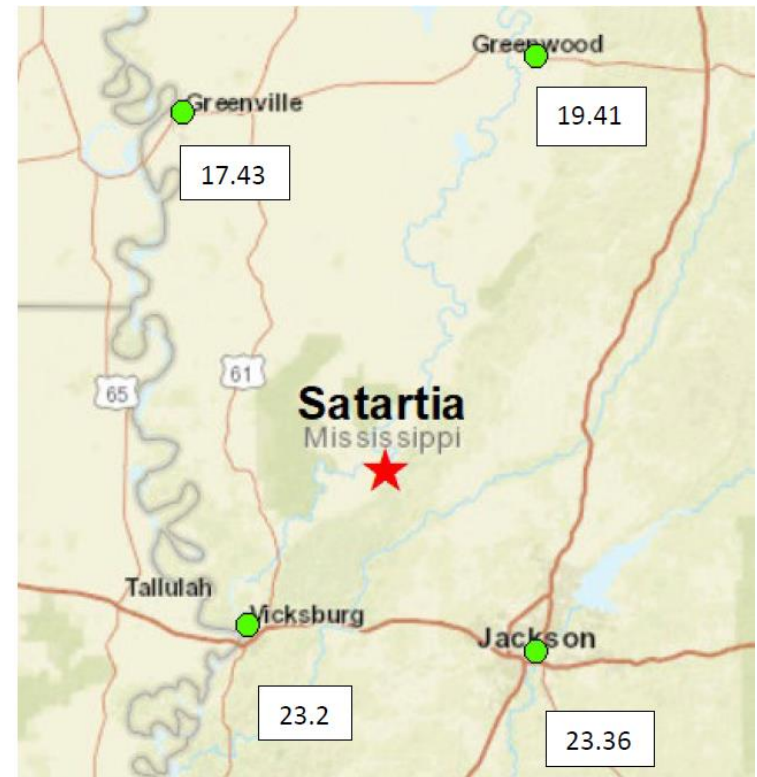
According to the National Weather Service (NWS), accumulated rainfall for each of these cities between January 1, 2020, through February 29, 2020 (60 days) was 17.43 inches, 19.41 inches, 23.2 inches, and 23.36 inches of rain, respectively.

The amount of rain recorded in these four cities was **between 7.44 and 13.63 inches above the annual historical average** for the same 60-day timespan.

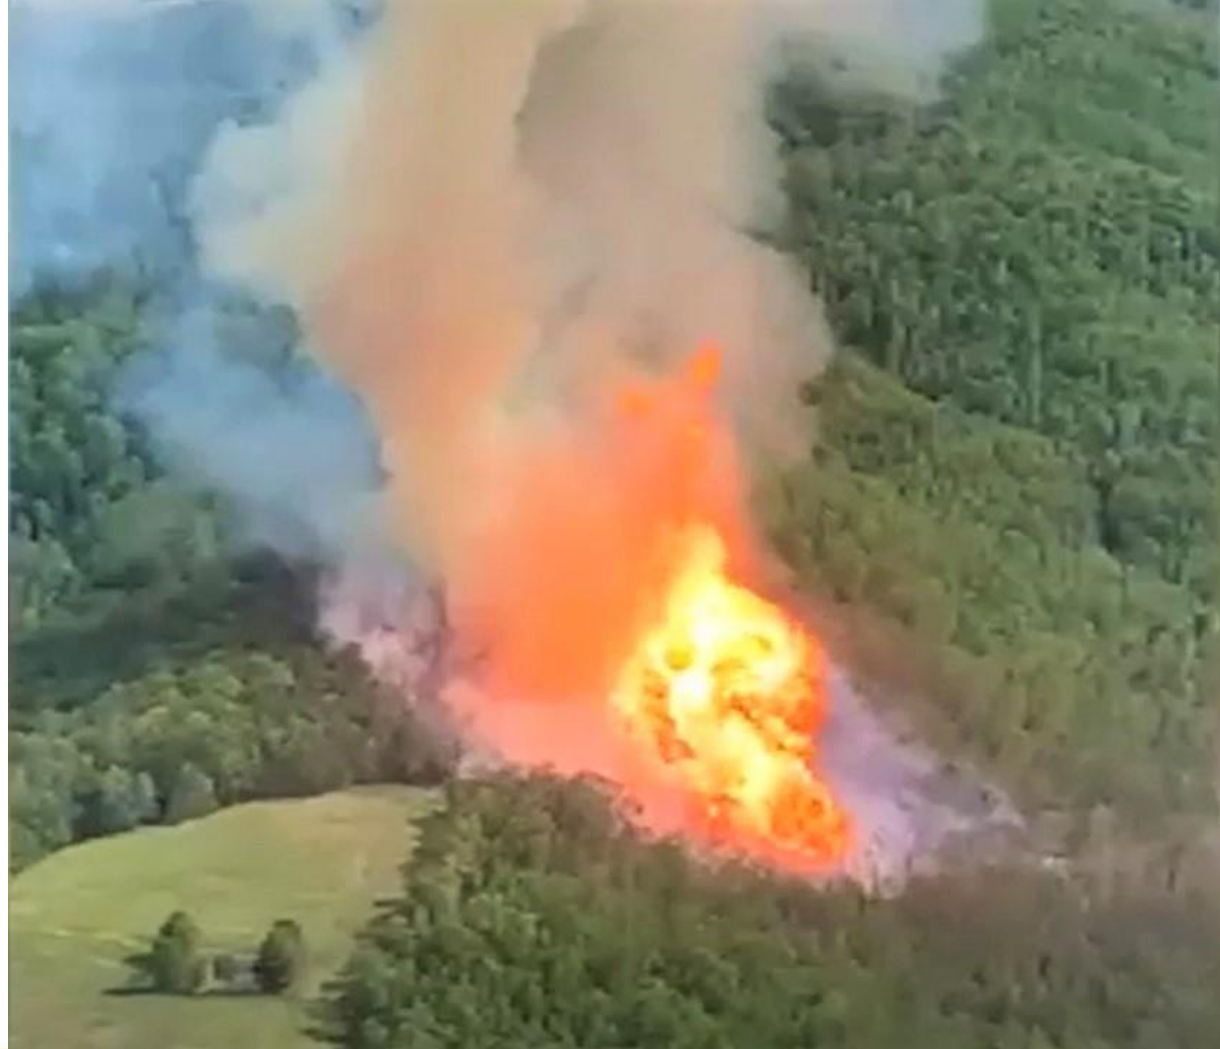
- May 4th, 2020, rupture and fire
- 1952 vintage Line 10
- 30-inch diameter 0.375 wall thickness
- Known geohazard site
- Operator made site visits prior to the rupture
- Multiple IMU data sets available
- Site was on a list to remediate

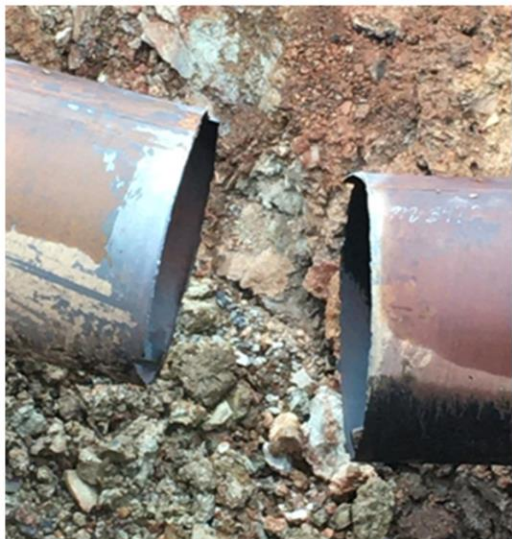
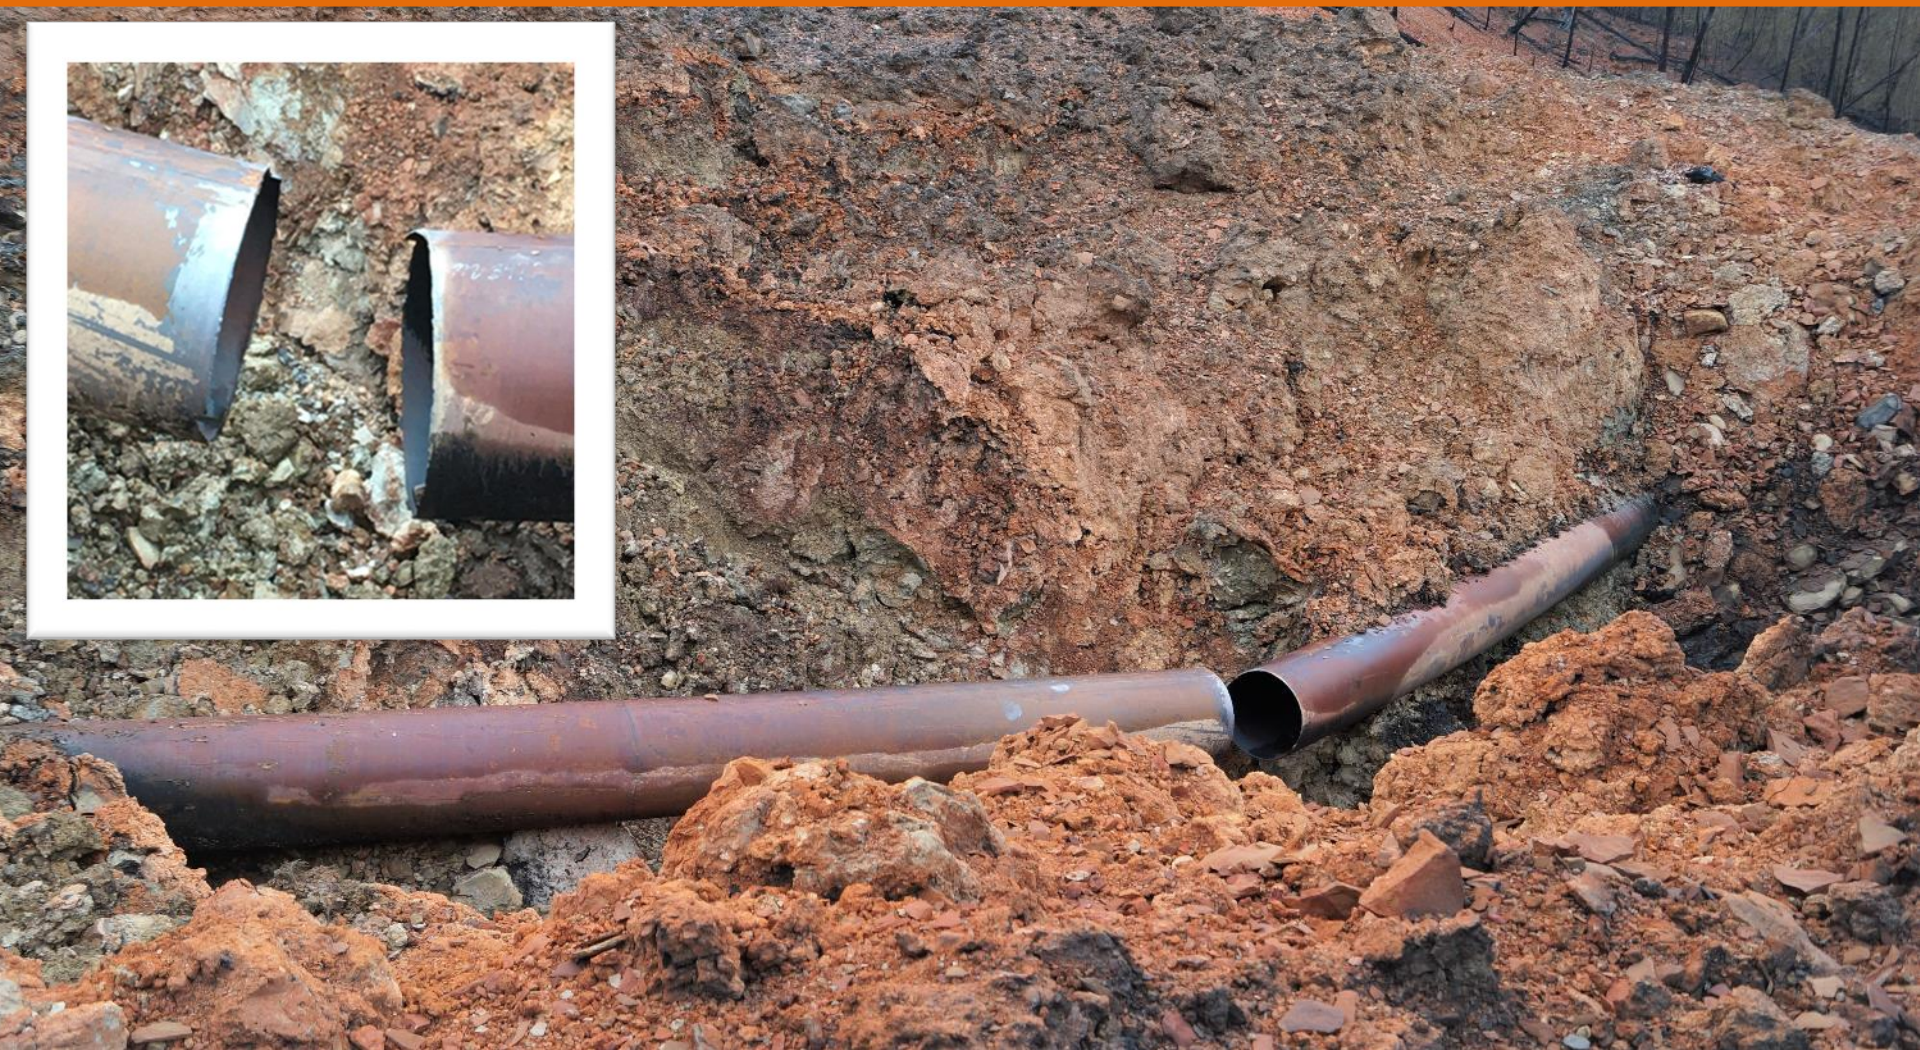
Ruptured Girth Weld

The pipeline failure was a result of **soil movement**, which caused excessive loading leading to the rupture of a girth weld.

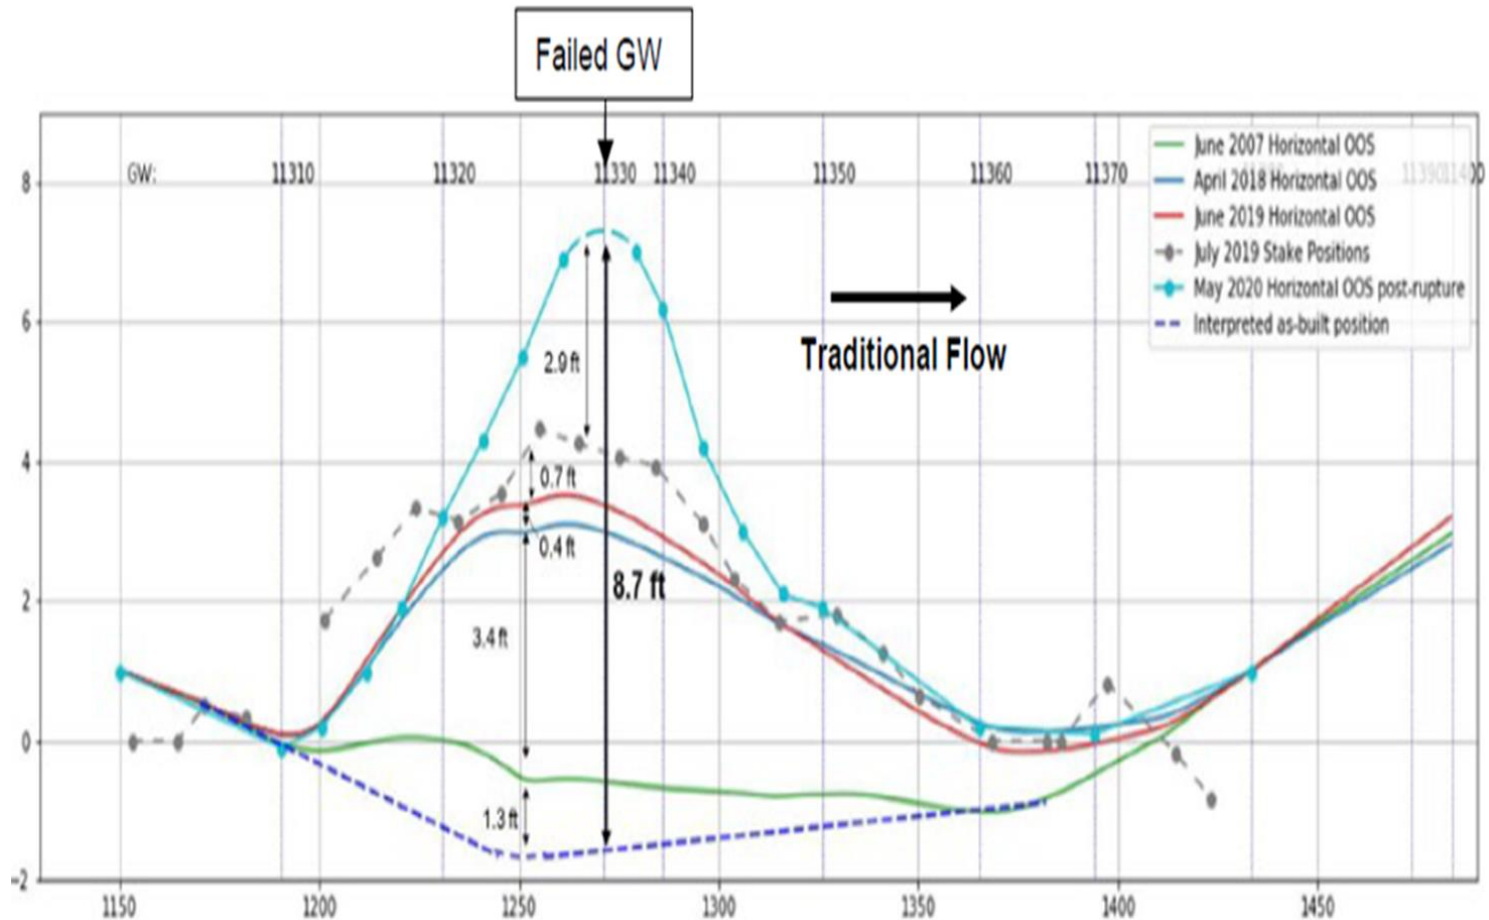
Pipeline Movement

History of pipeline movement. Vertical axis is “Horizontal out of straight” measured in feet. The horizontal axis is the location on the right-of-way. Note the location of the girth weld.

The operator's procedures were inadequate, and the operator's analysis of the active landslide did not fully address uncertainties associated with the strain-carrying capacity of girth welds, the pipeline loading due to land movement, and the pipeline response.
