Construction & Pipeline Coatings

Greg Ochs PHMSA Central Region

Pipeline and Hazardous Materials

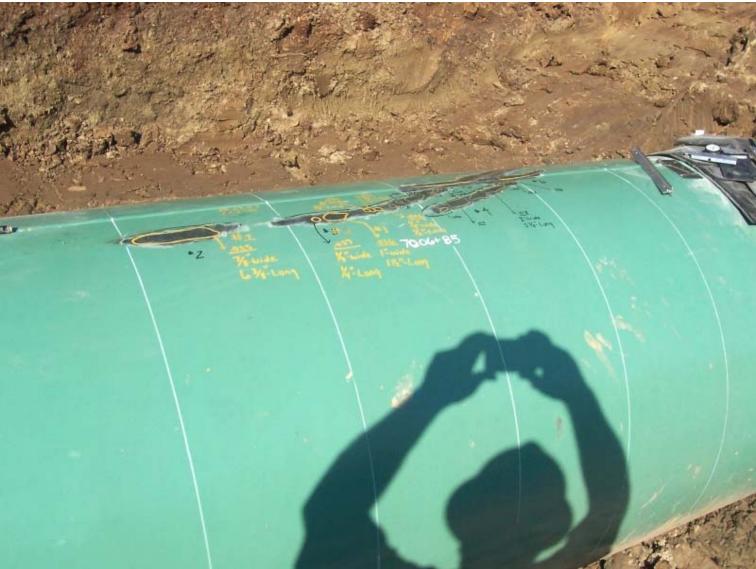
d Less than One Year of Service

Corrosion Found

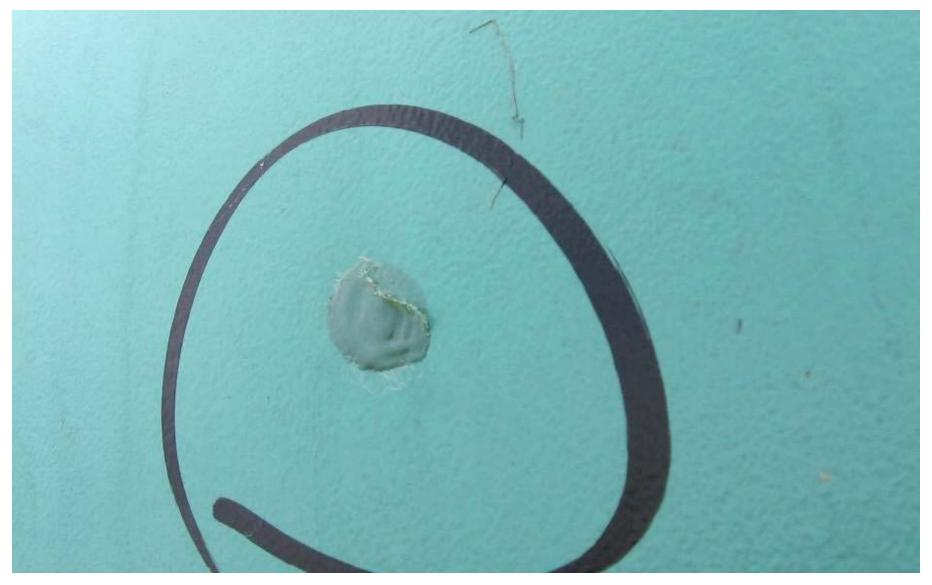
Poor Patch Stick Application Lack of Adhesion

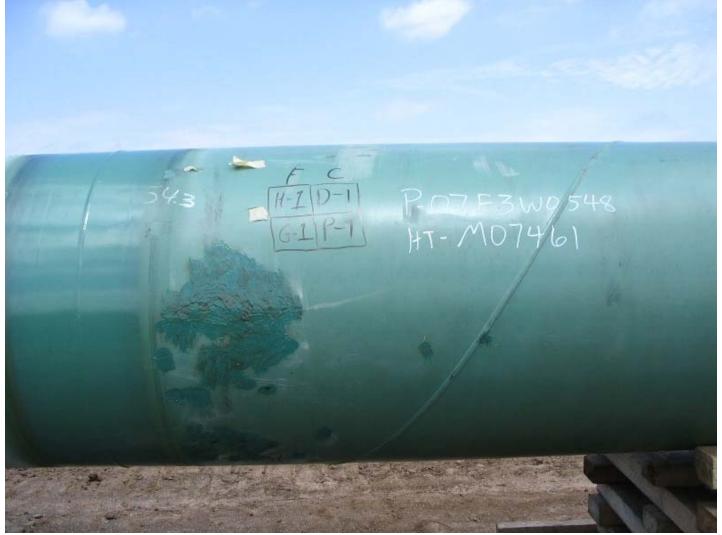
Excessively Large Patch Stick Application Use for Pinholes Only on 42" Pipe

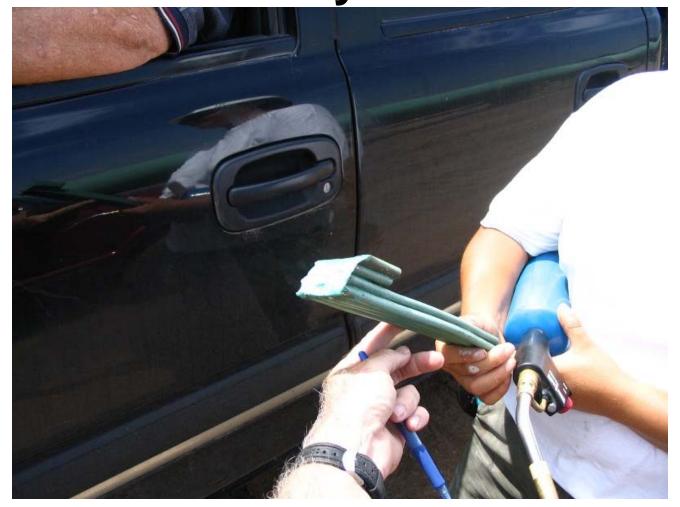
Inappropriate Bundling of Patch Sticks Use One Only-Small Areas

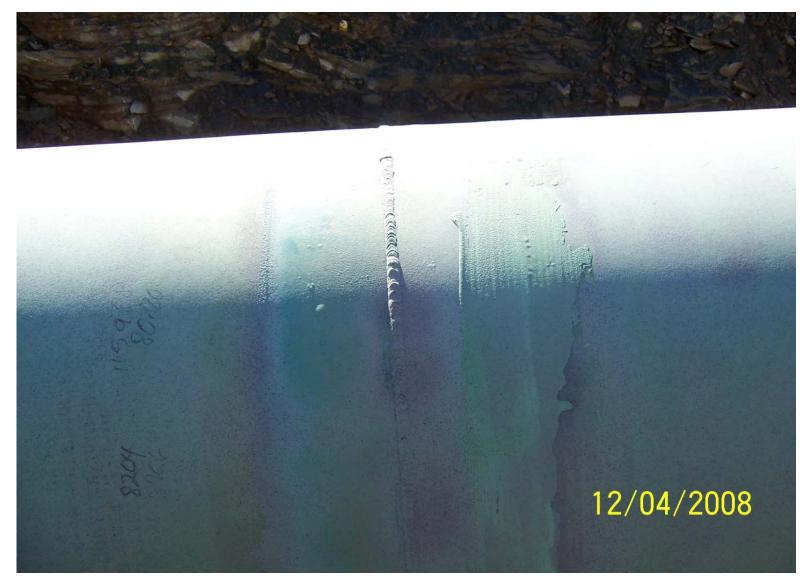
Thin Field Joint Coating

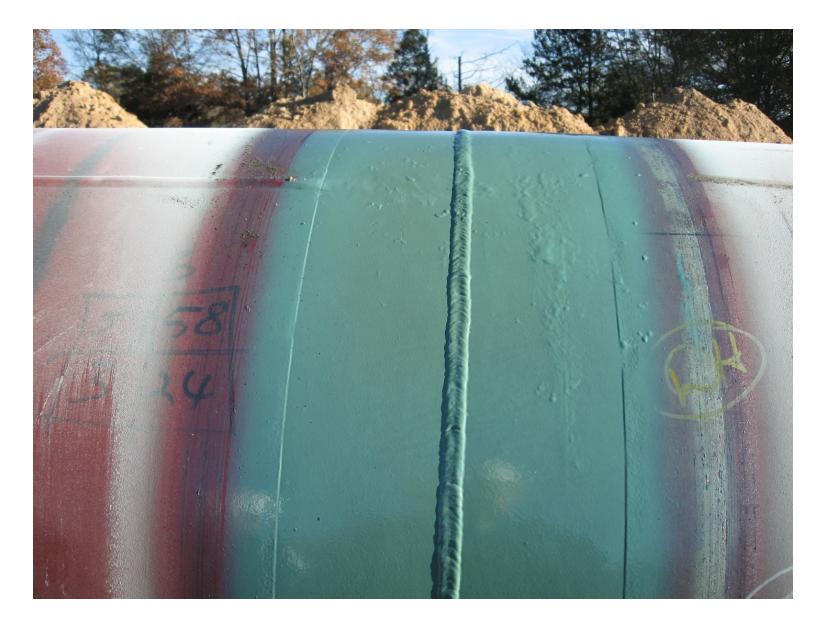
Joint Coating Applied over Dirt/Debris

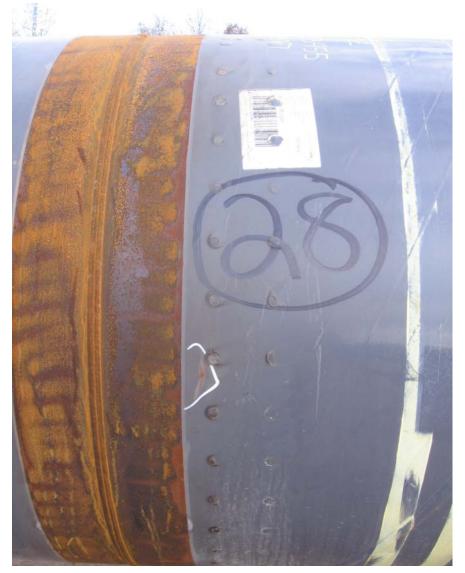
Coating Damage Cause by Welding Band (Jeeper did not indicate holiday)

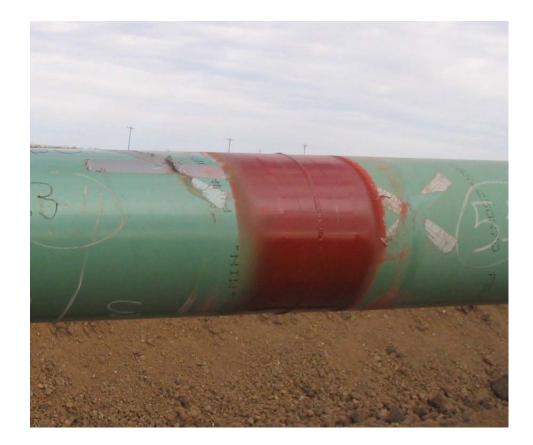
Tape on Pipe Preventing proper Holiday Detection

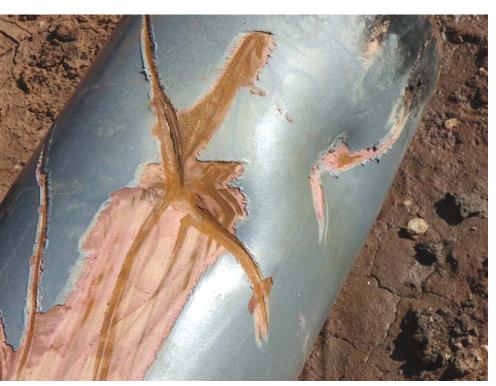
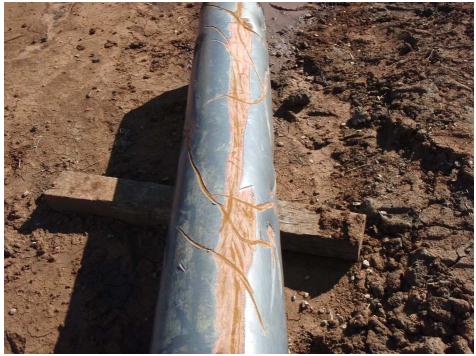
Bored Crossing – Failed Hydro Test

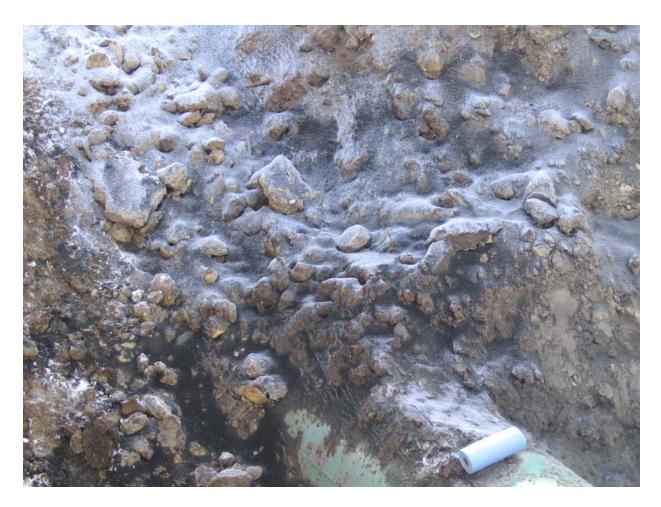
Rocks against pipe (No screening for over 1 mile)

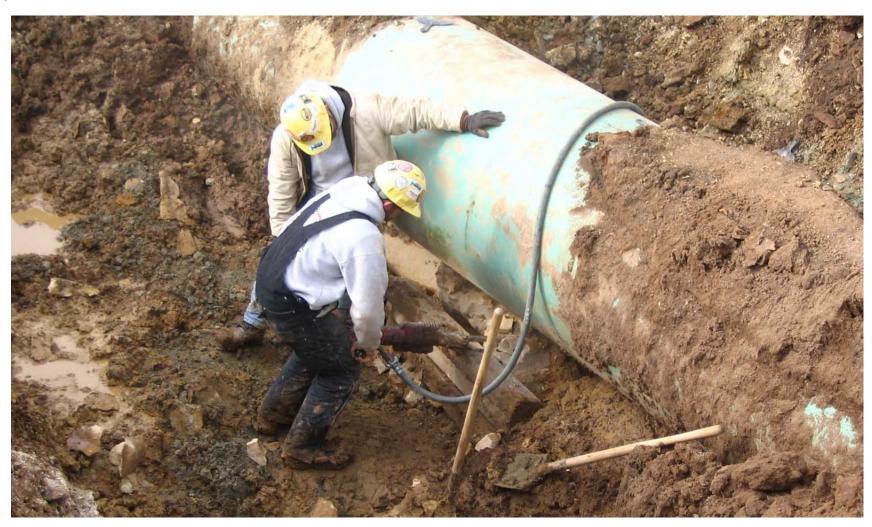
Pipe laid directly on solid rock

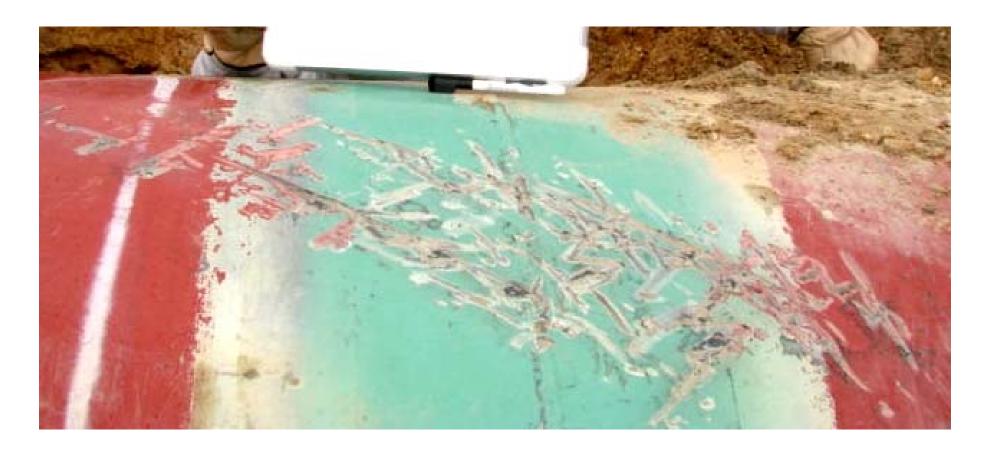
Construction Damage Section of Pipe was Replaced (found by DCVG Survey-Line was in Service)

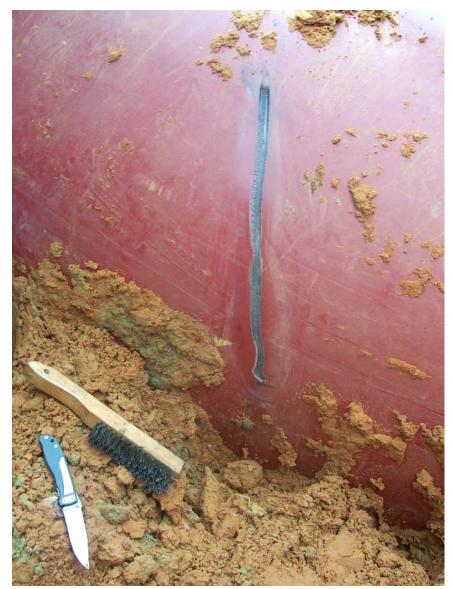
Gouge in Pipe

(found by DCVG Survey-Line was in Service)
