Harpur Hill, Buxton
Derbyshire, SK17 9JN
T: +44 (0)1298 218000
F: +44 (0)1298 218590
W: www.hsl.gov.uk

Review of Vapor Cloud Explosion Incidents

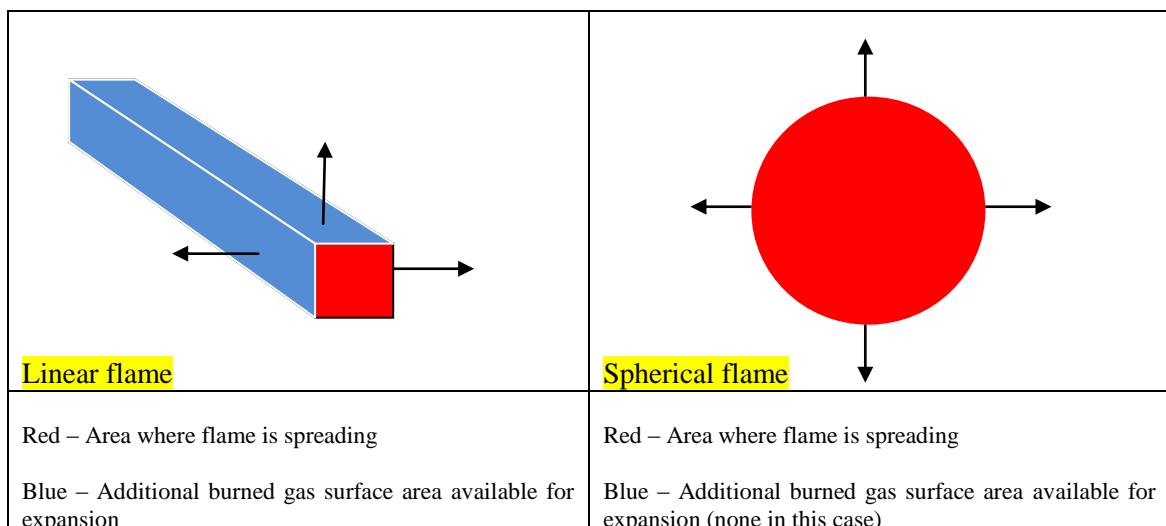
Figure 1: Areas available for flame spread and gas expansion

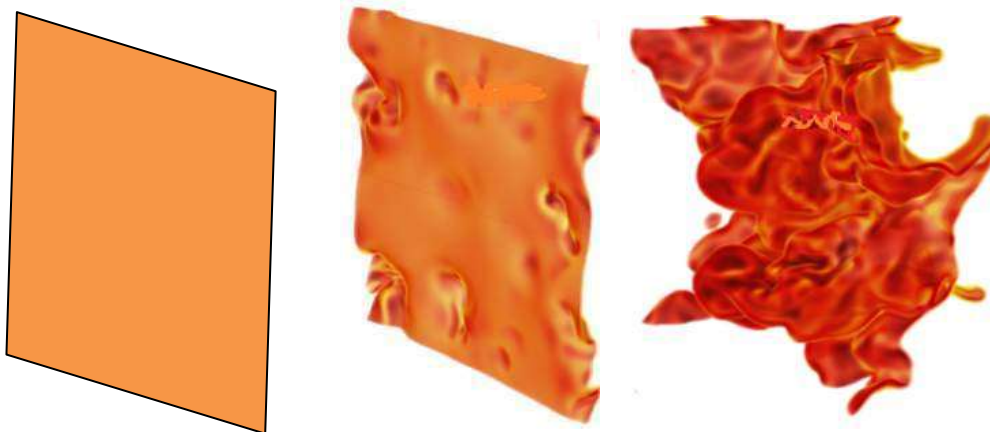
Figure 2: Laminar flame, flame with minor wrinkling and flame deformed by strong turbulence

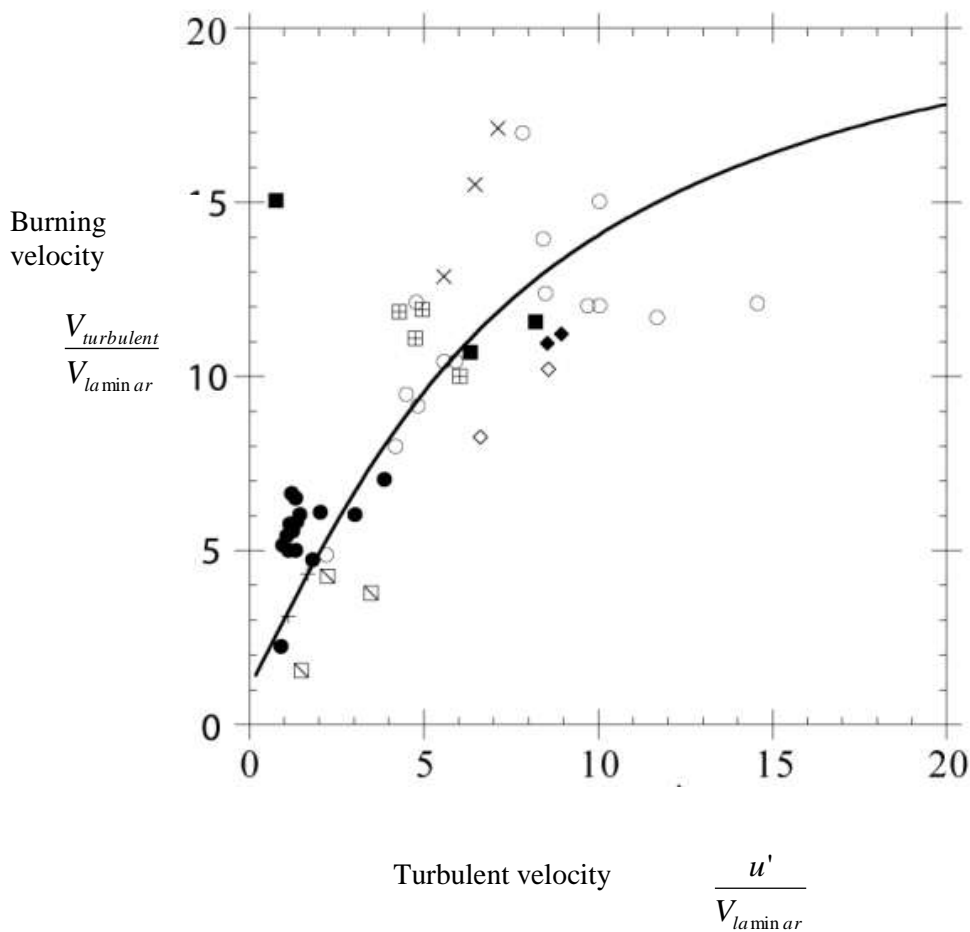
Figure 3: Turbulent burning velocity $V_{\text{turbulent}}$ as a function of turbulence velocity u' (both expressed as ratios of laminar burning velocity V_{laminar}).

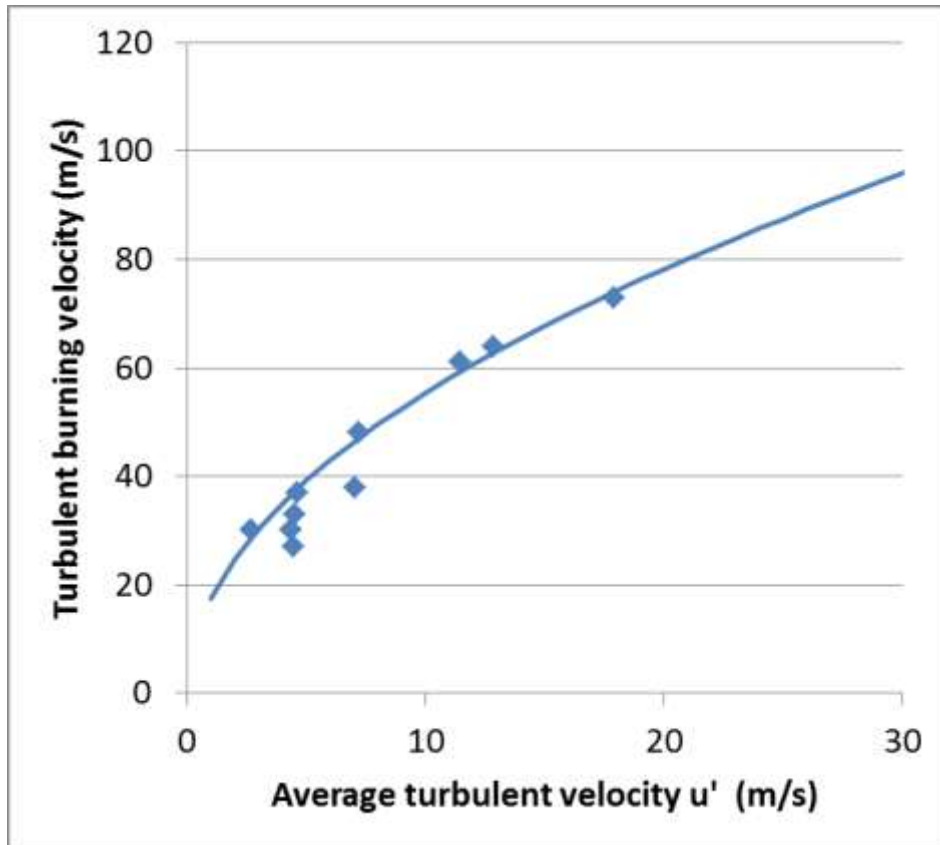
Figure 4: Increases in burning velocity with turbulent velocity.

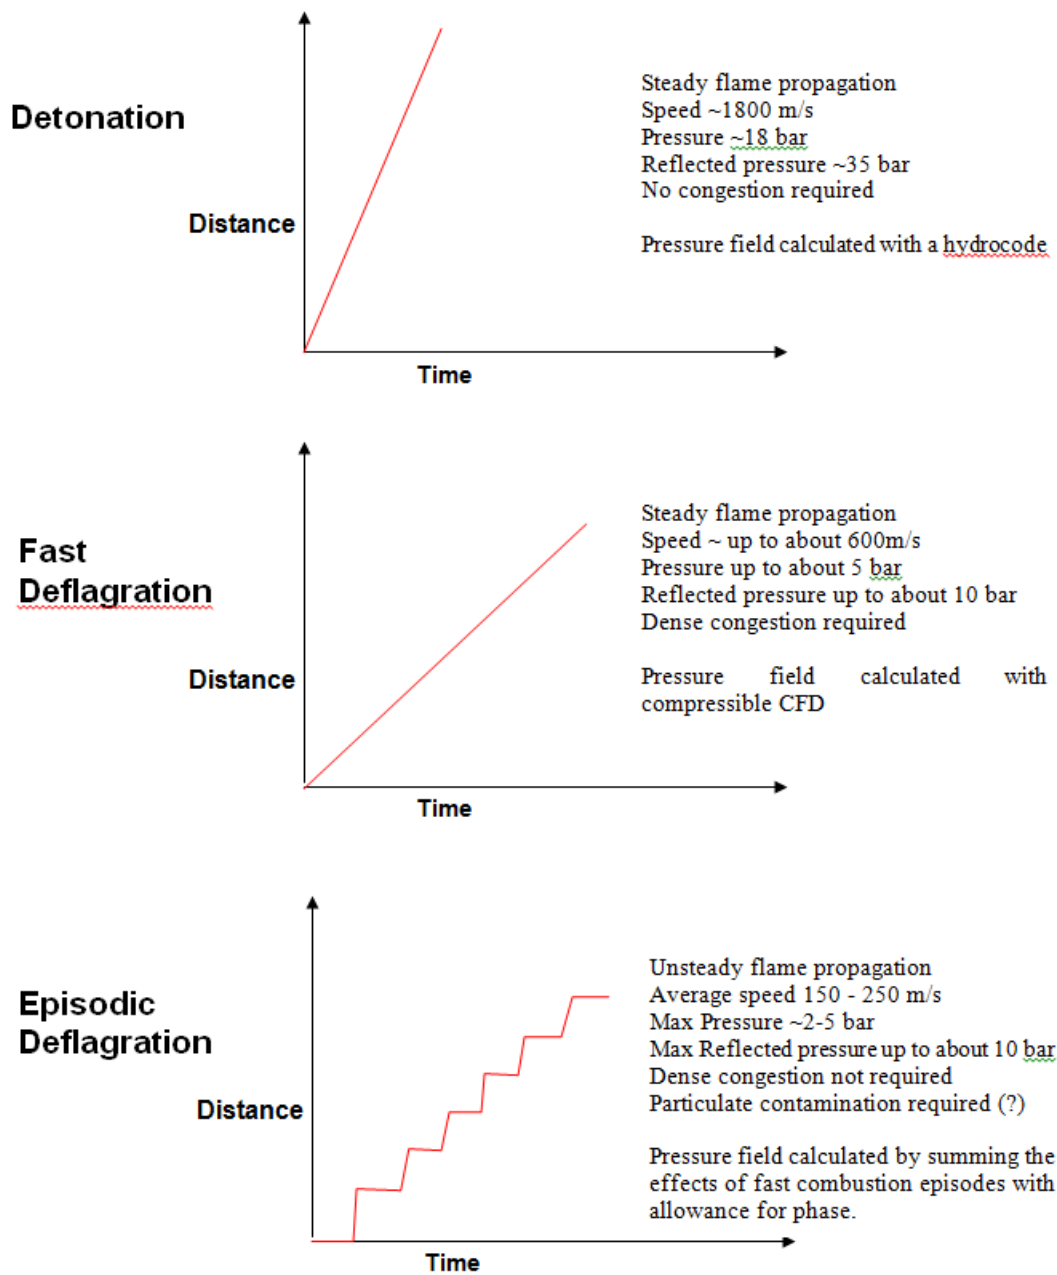
Figure 5: Summary of properties of three types of severe VCE that can cause blast damage

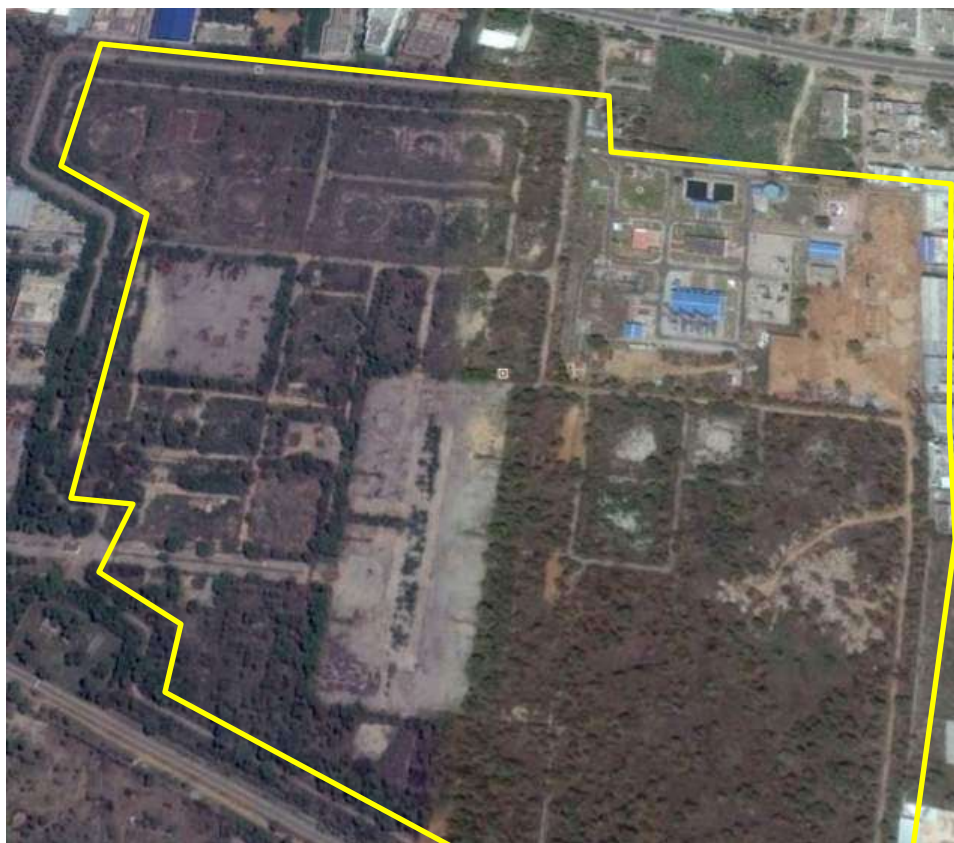
Figure 7: IOC Terminal site in 2015

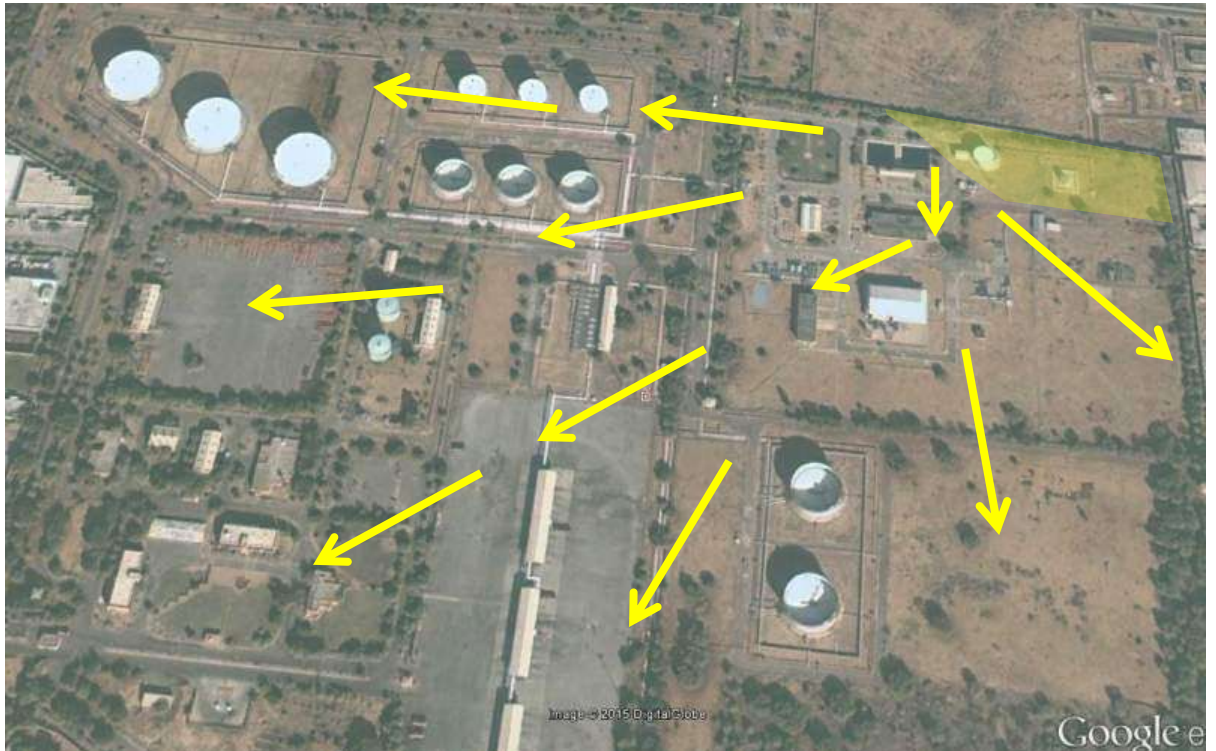
Figure 9: Explosion development

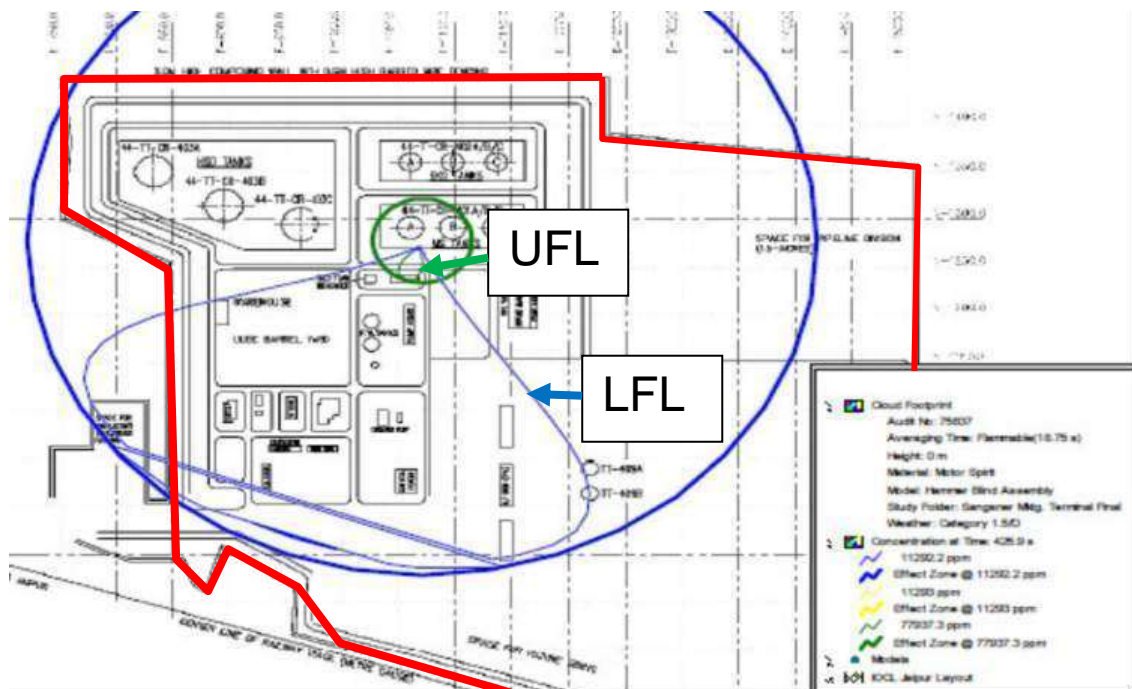
Figure 10: IOC committee modelling of vapor dispersion using PHAST (1.5 m/s). Cloud boundary observed in the incident marked in red.

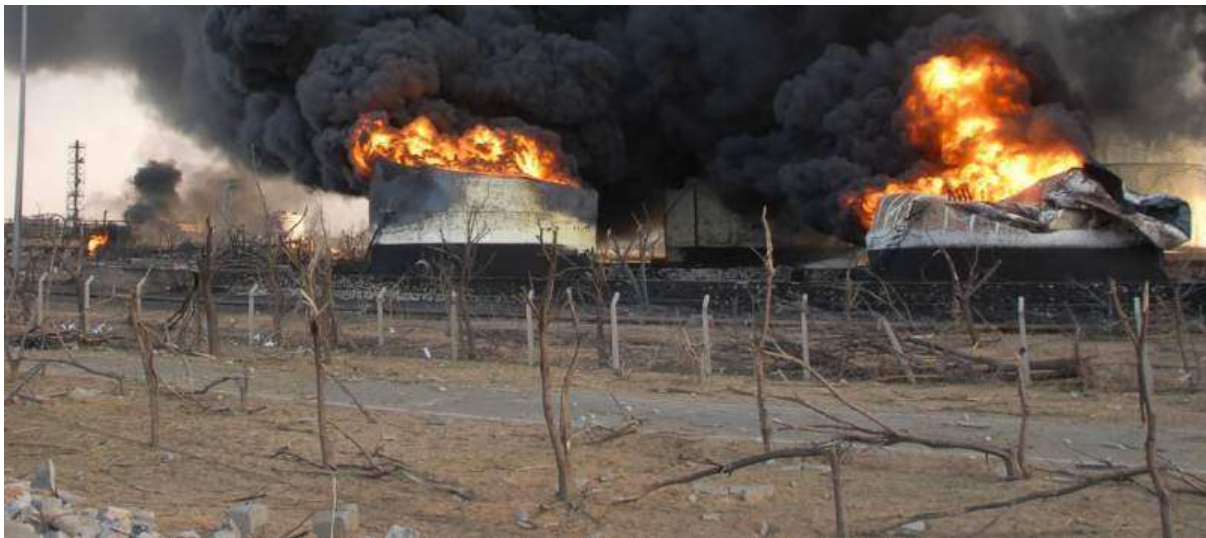
Figure 11: Small trees indicating explosion direction in open areas (explosion passed from left to right)

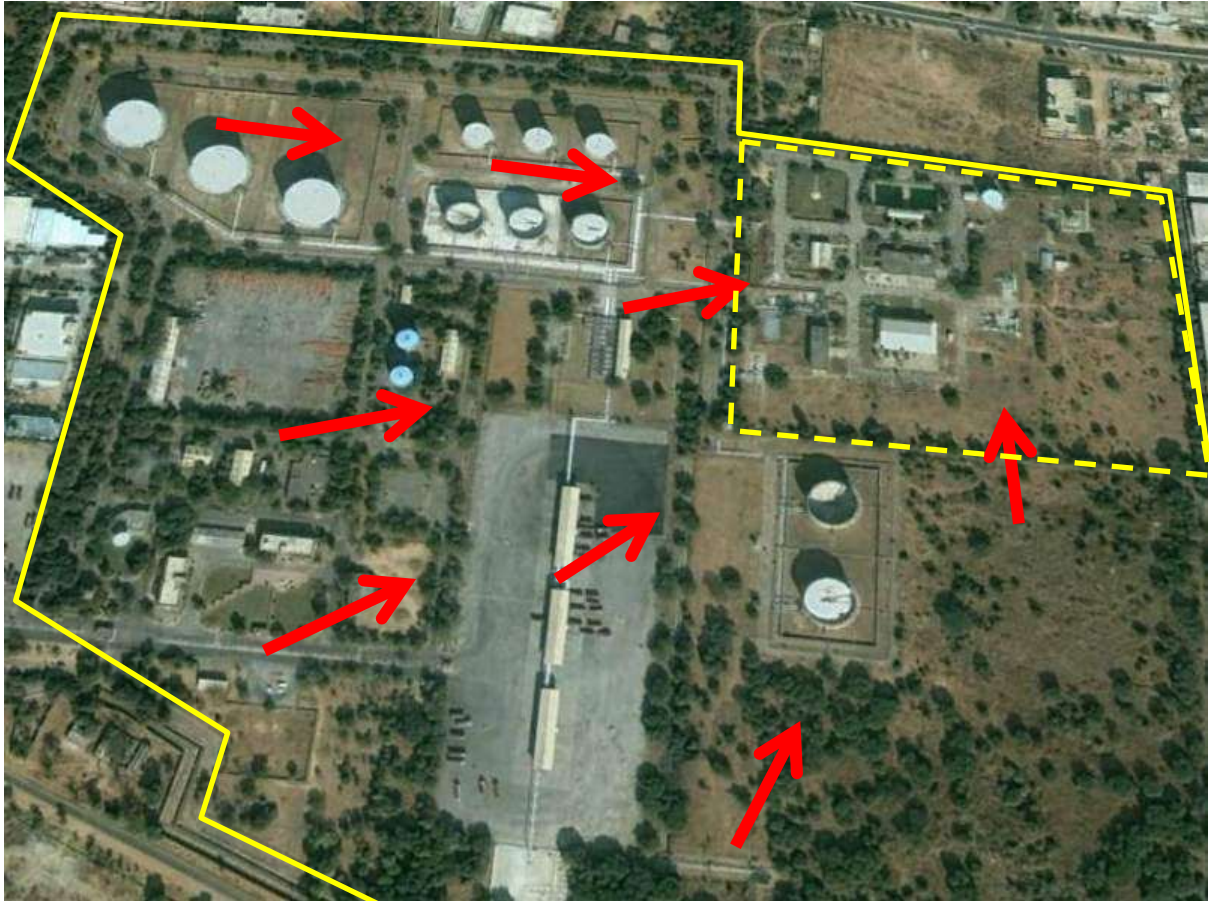
Figure 12: Summary of site-wide directional evidence at Jaipur. *Yellow line indicates site boundary. Dashed line indicates the Pipelines Division Area in the NE part of the site.*

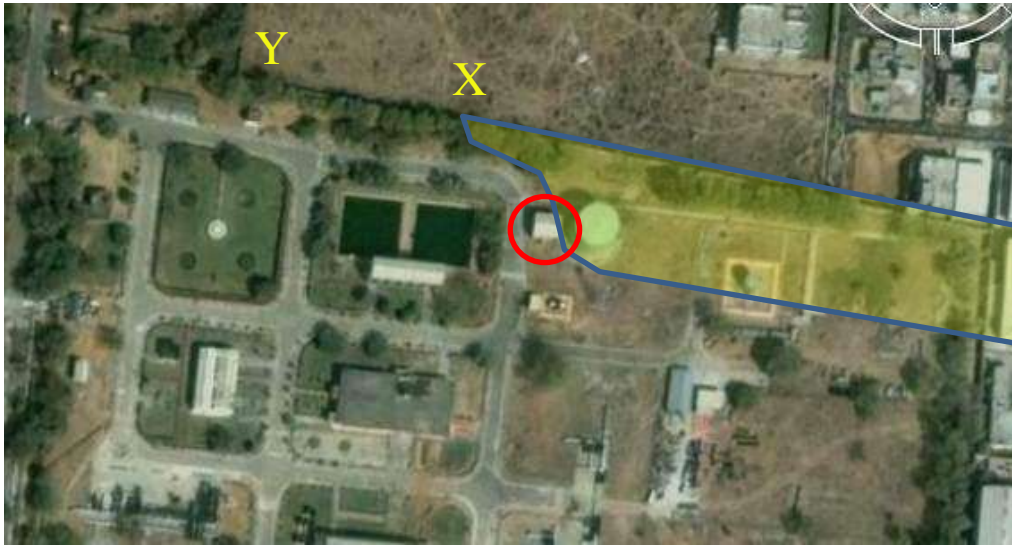
Figure 13: Area shaded in yellow was burned but showed no signs of a severe explosion. Pump house circled in red.

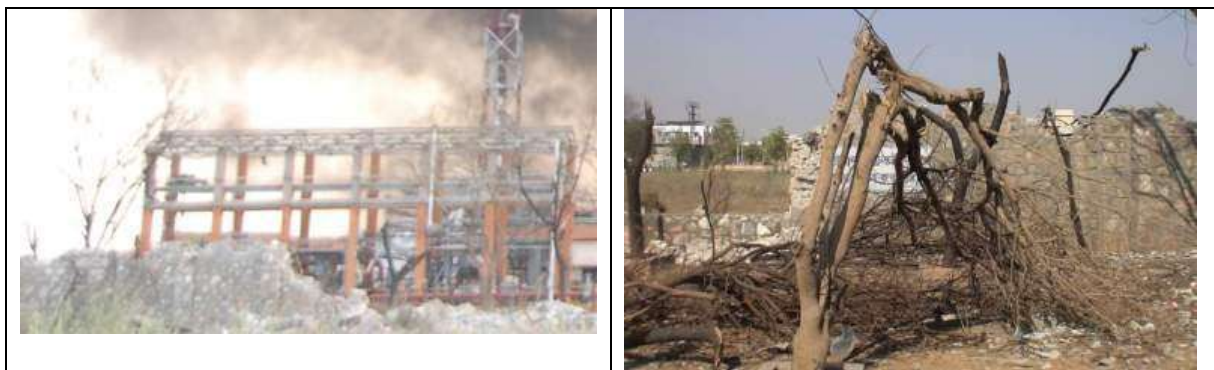
Figure 14: Views of the end of the stretch of intact wall in the NE corner of the Jaipur site – marked X on Figure 13 . *From the North (left) and from the South (right)*

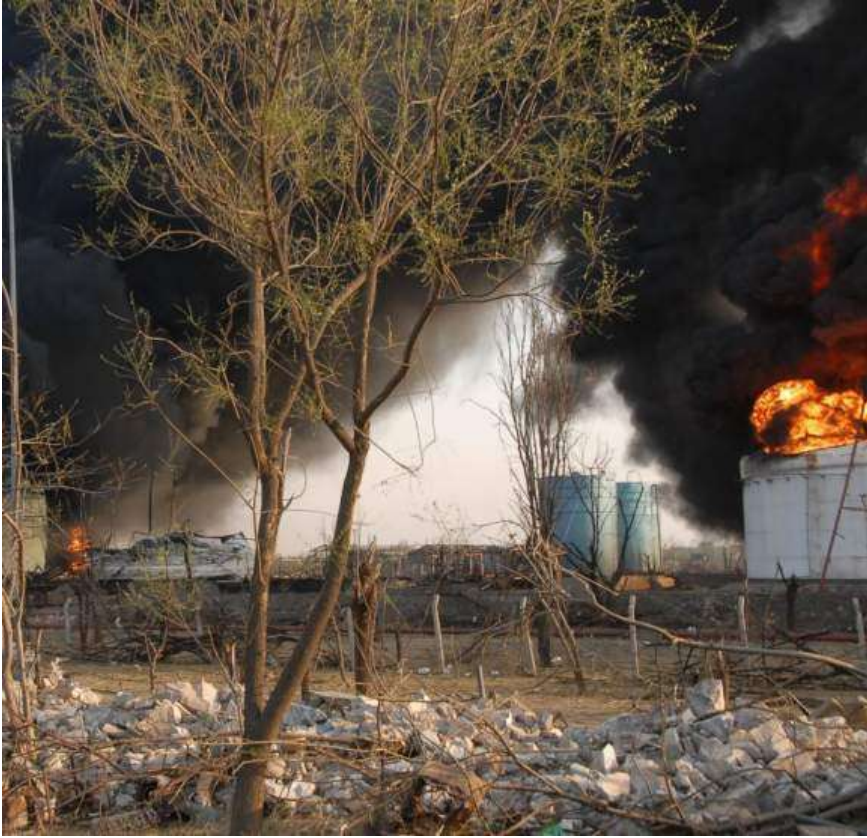
Figure 16: Rapid decline in drag related damage with distance from the explosion

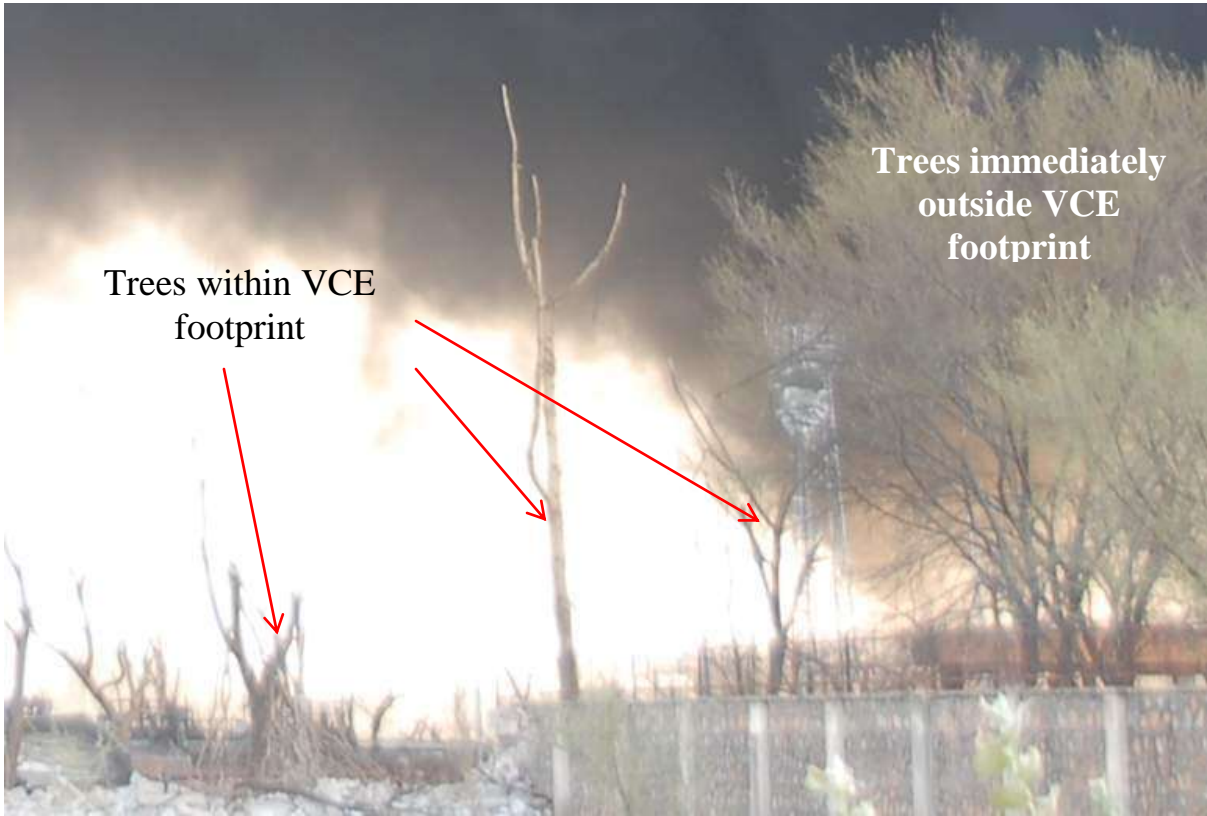
Figure 17: Rapid fall off in damage to trees near point Y (see Figure 13)

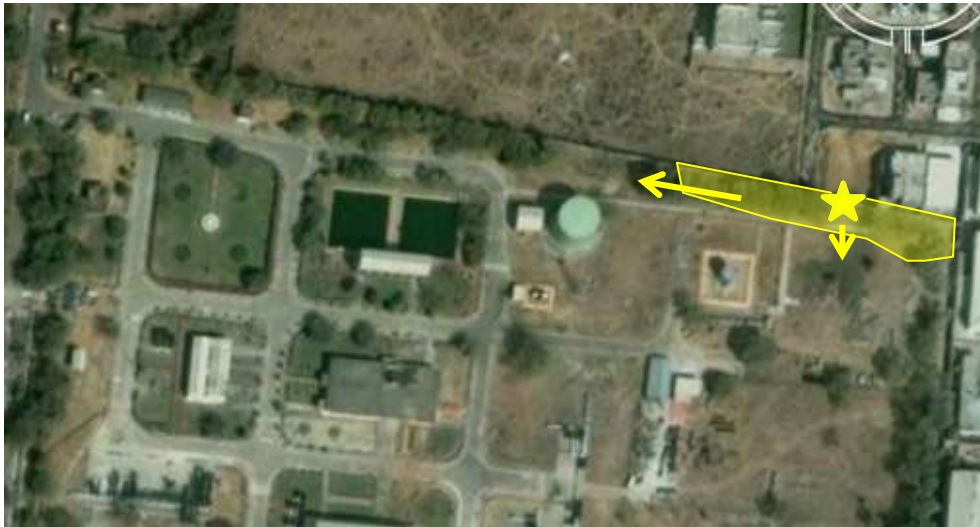
Figure 18a: Ignition near the NE corner of the site. Flame spread along the wall/tree line

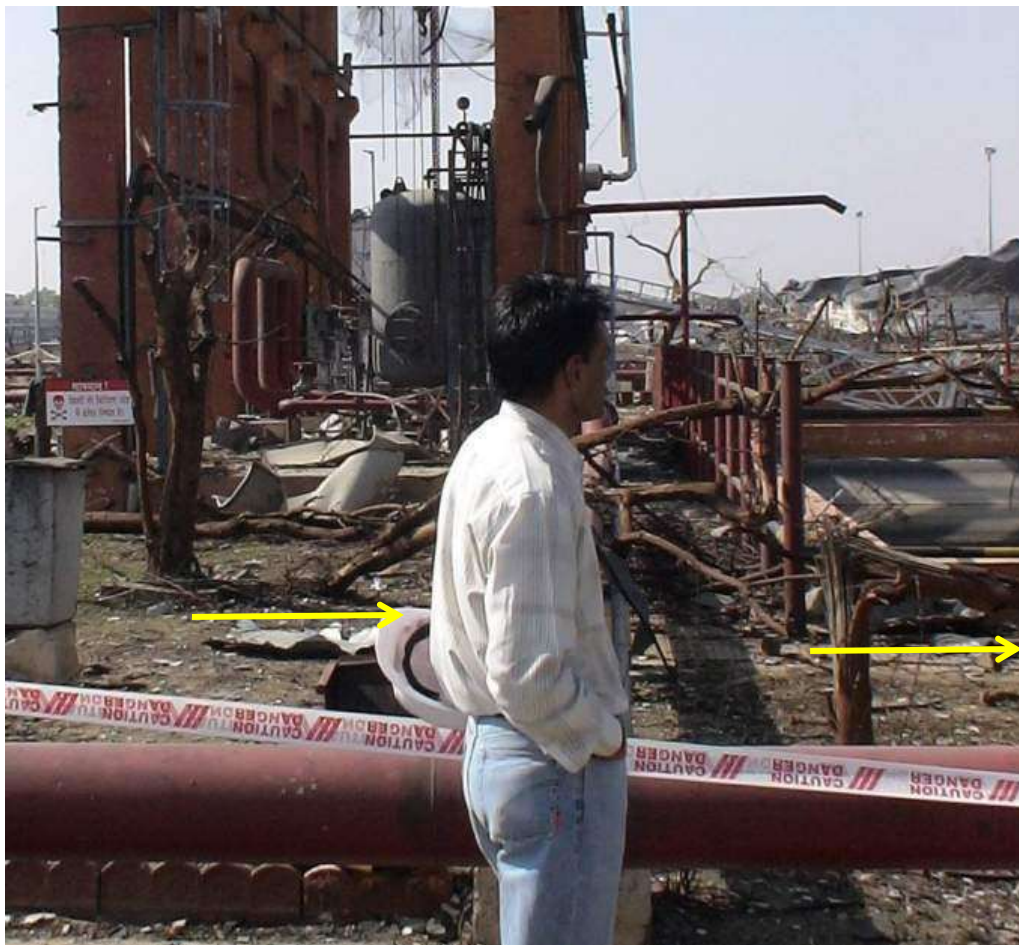
Figure 22: Broken trees near the pump house. Arrows show direction indication

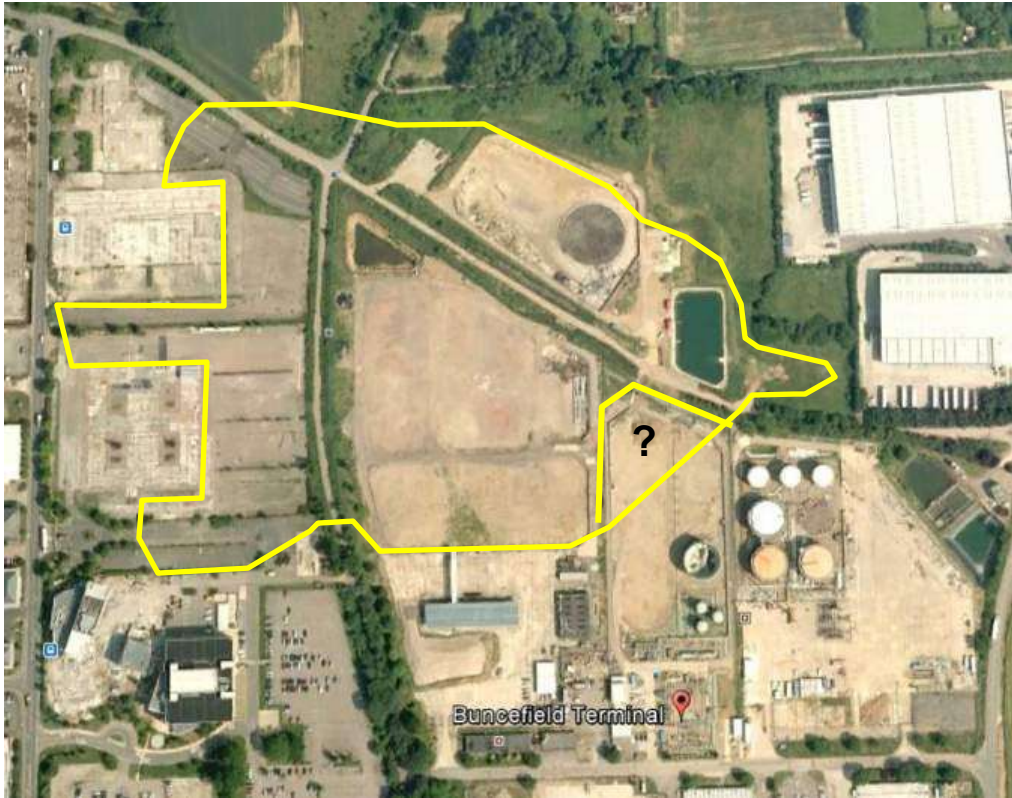
Figure 24: Terminal site and wider area after the explosion – final extent of vapor cloud explosion marked in yellow.

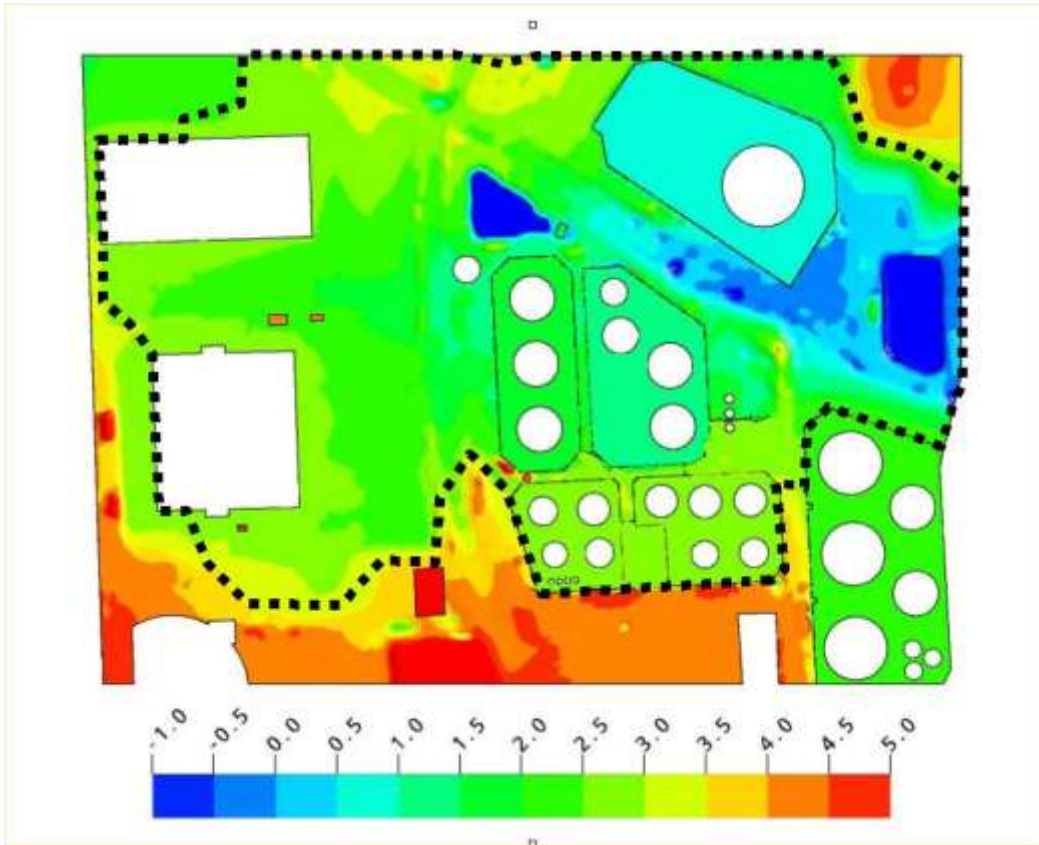
Figure 25: Correspondence between cloud geometry and topography.
Scale shows terrain height in metres

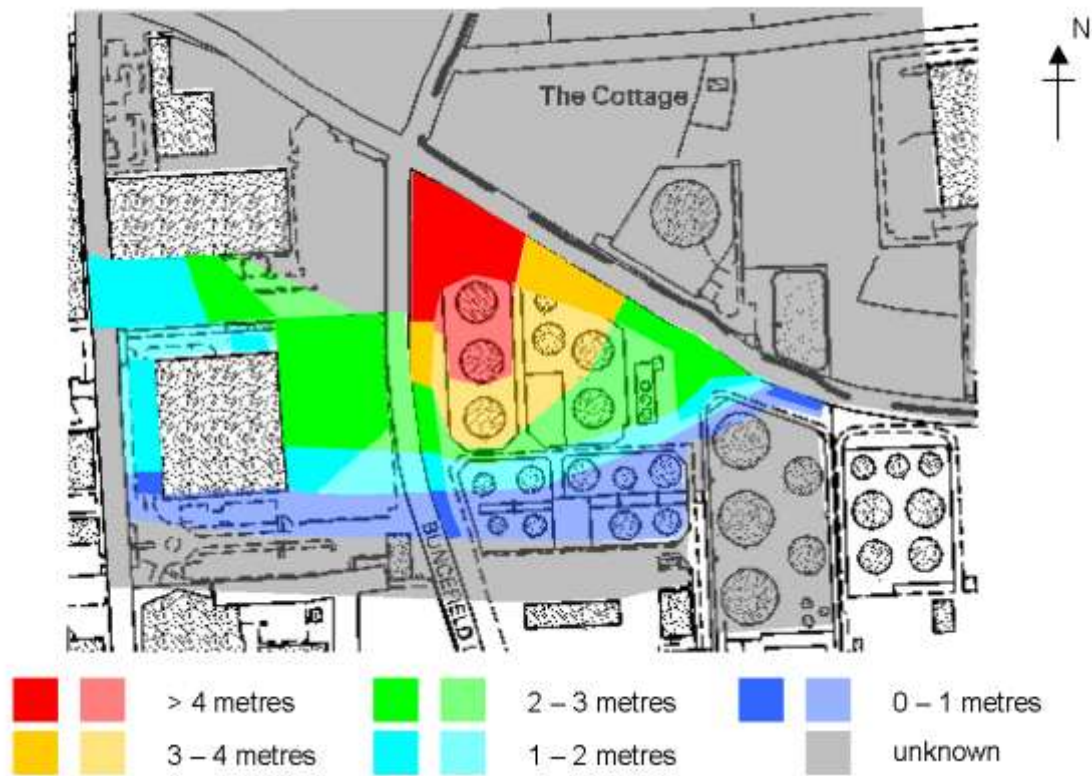
Figure 26: Approximate final depths of the visible mist. Solid colours indicate observed depths of the mist taken directly from the CCTV cameras. Transparent colours indicate cloud heights inferred from the surrounding levels.

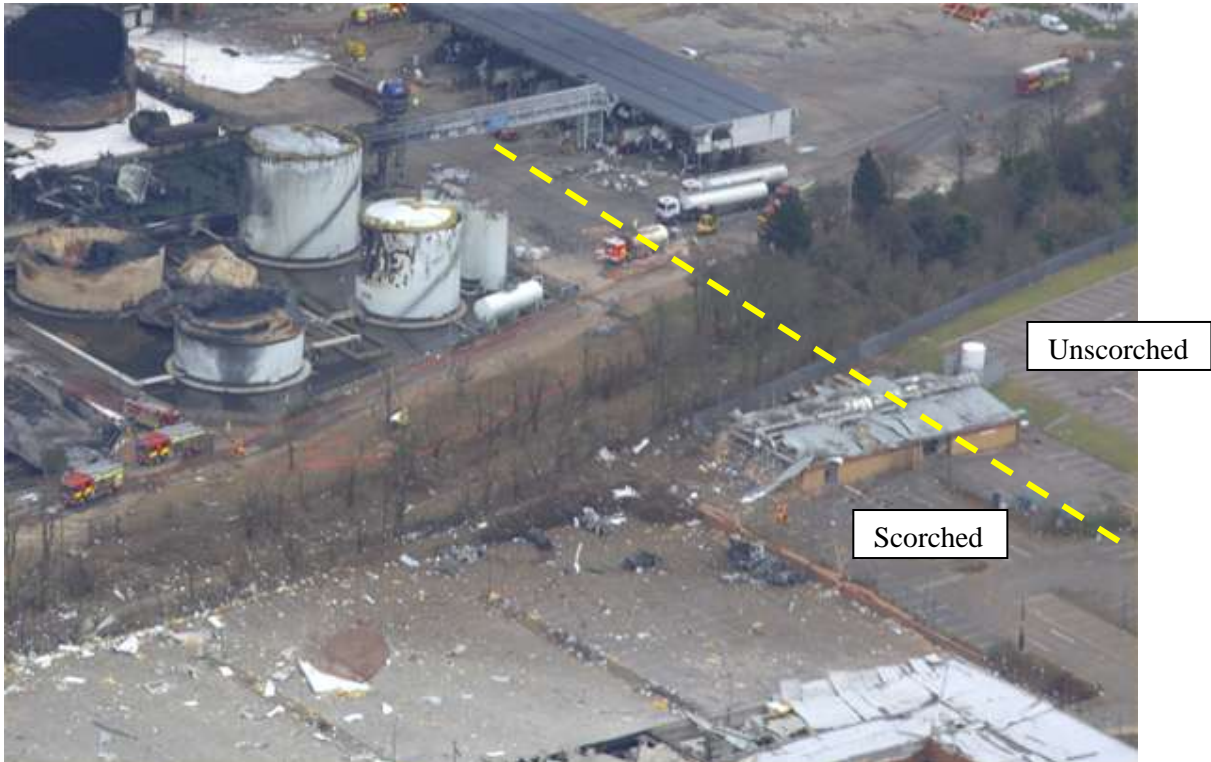
Figure 27: The edge of the vapor cloud marked by scorching and blast damage

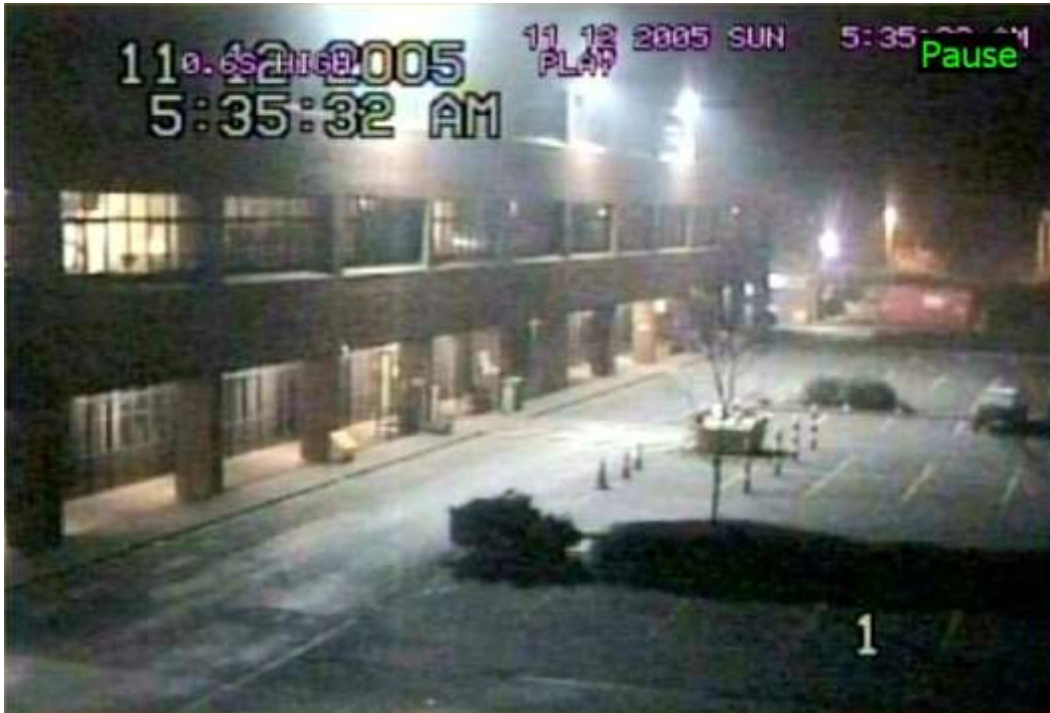
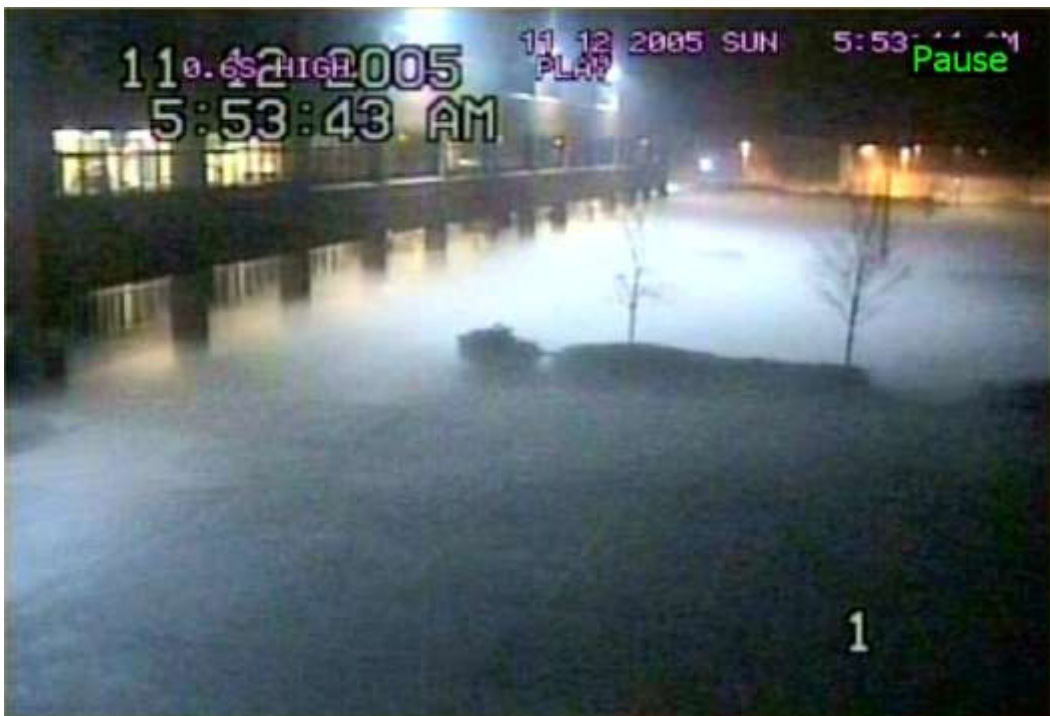
Figure 28: Accumulation of vapor cloud around the lowest parts of the Northgate Building

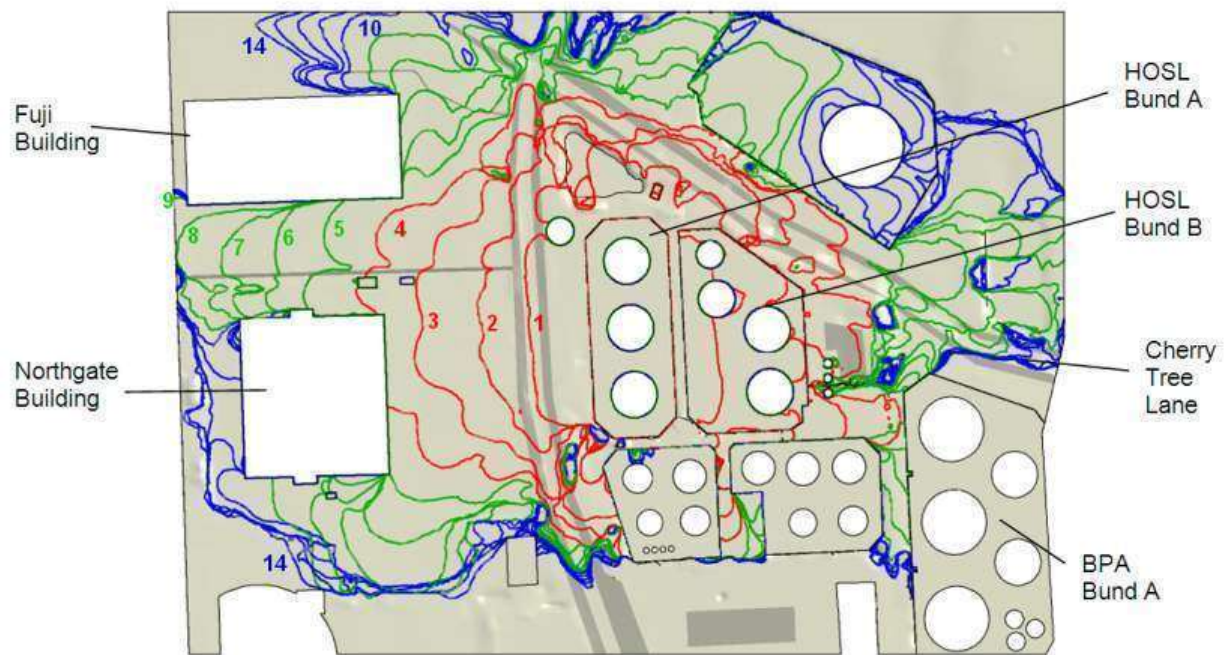
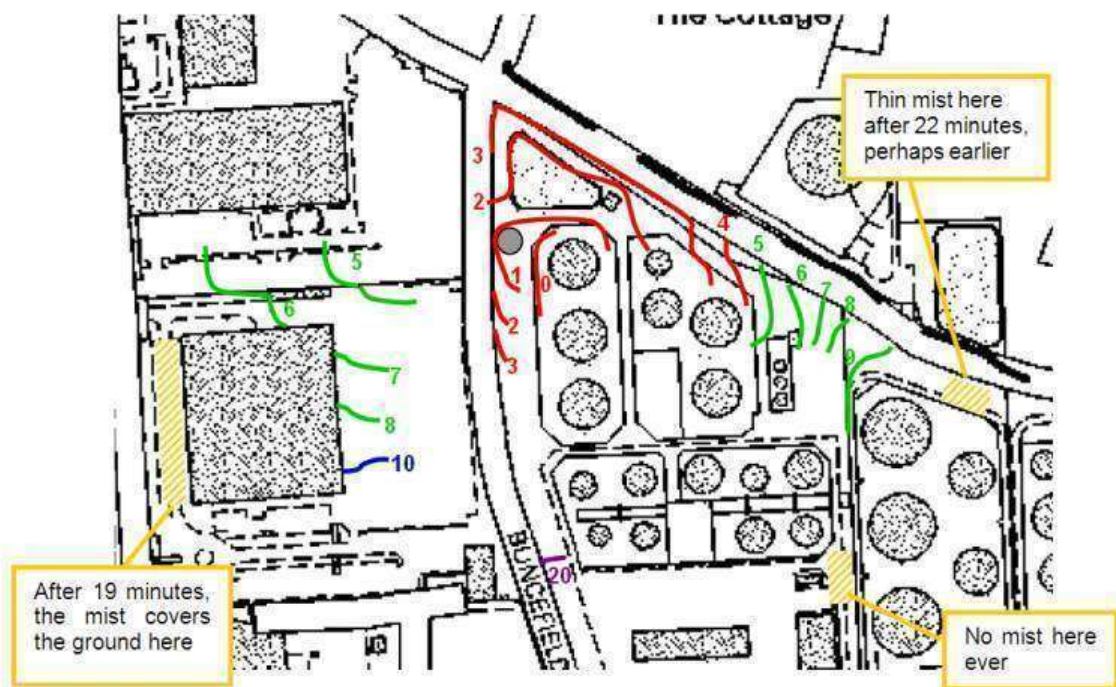
Figure 29: Comparison of CFD predictions (top) and CCTV observations (bottom) for the progress of the vapor cloud or mist across the Buncefield site - Gant and Atkinson (2011). Times shown are in minutes from the moment the mist appeared over the wall of Bund A,

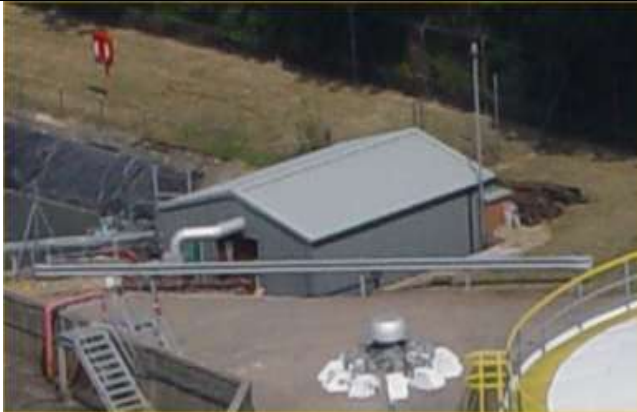
| | <p>Pump house prior to the incident</p> |

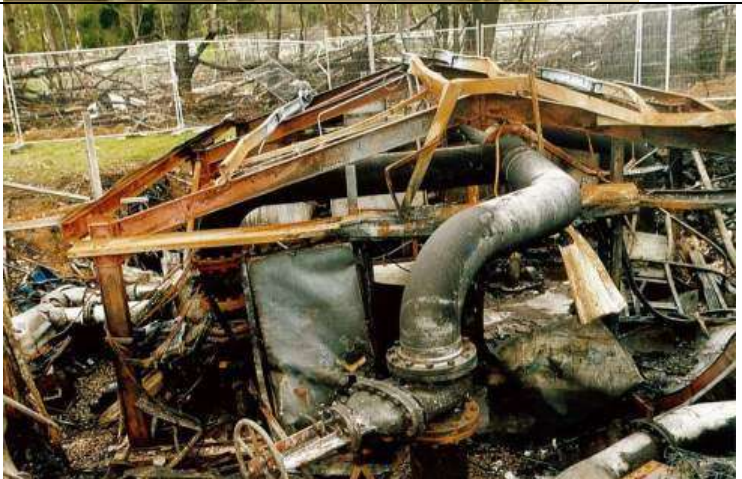
| | <p>Front view after the explosion. Remains of hedge in the background The front half of the building was affected by a fire – caused by seepage of hydrocarbons from a nearby bund after the explosion.</p> |

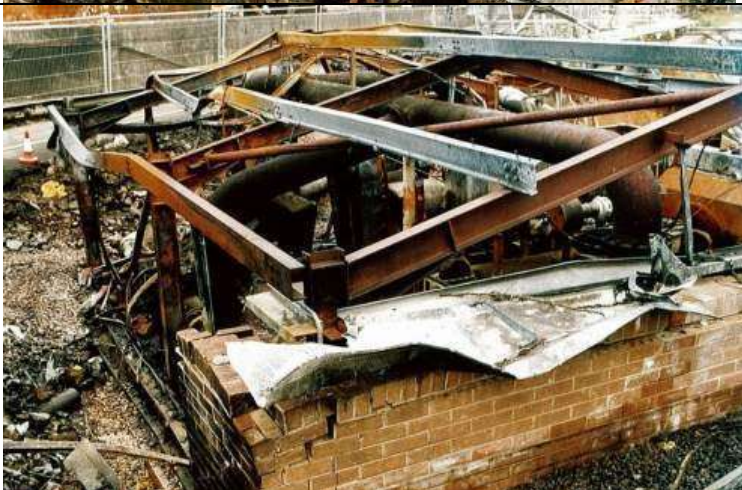
| | <p>View of the rear of the pump house. The rear half of the building escaped fire damage. All of the cladding sheets had been lost without purlin deformation.</p> |

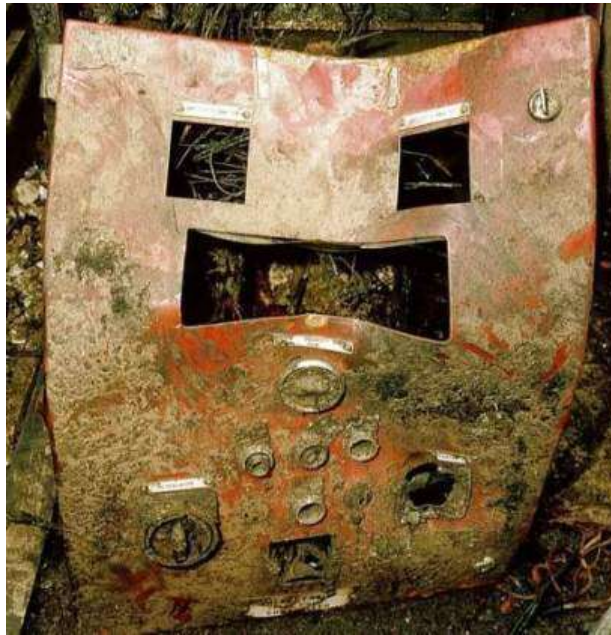
Figure 32: Pressure damage to the front of the enclosure of the diesel pump starter

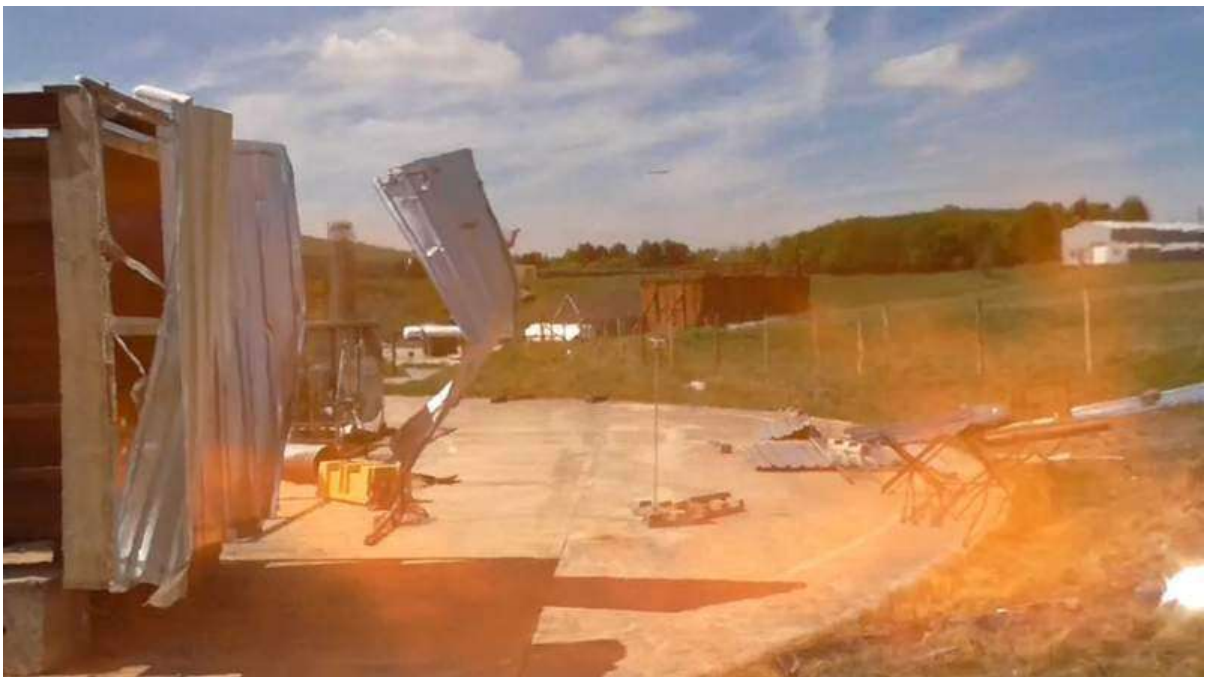
Figure 33: Explosion test in a steel clad structure

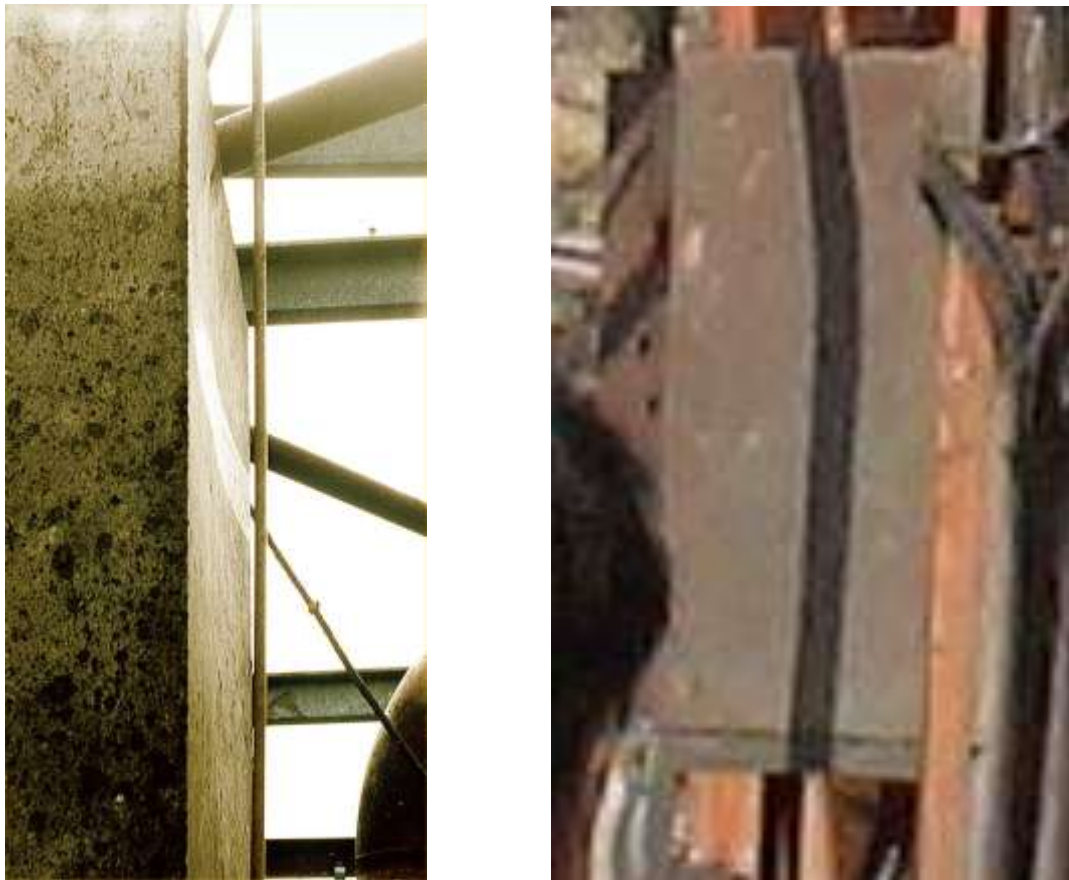
Figure 34: Steel enclosures in pump houses at Buncefield (Left) and Jaipur (Right)
