Harpur Hill, Buxton
Derbyshire, SK17 9JN
T: +44 (0)1298 218000
F: +44 (0)1298 218590
W: www.hsl.gov.uk

Review of Vapor Cloud Explosion Incidents

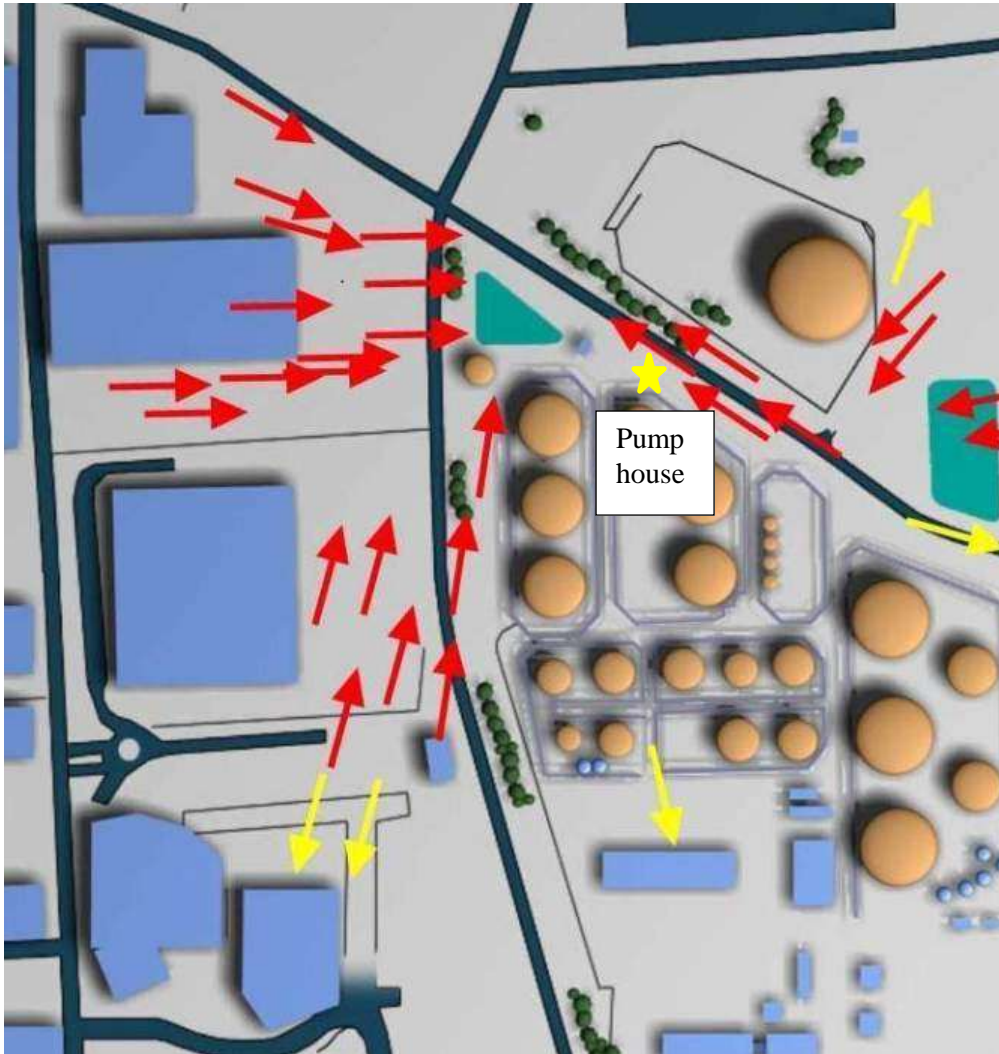
Figure 35: Directional evidence from the Buncefield site. Outward indicators (yellow arrows) are found within about 5m of the edge of the cloud.

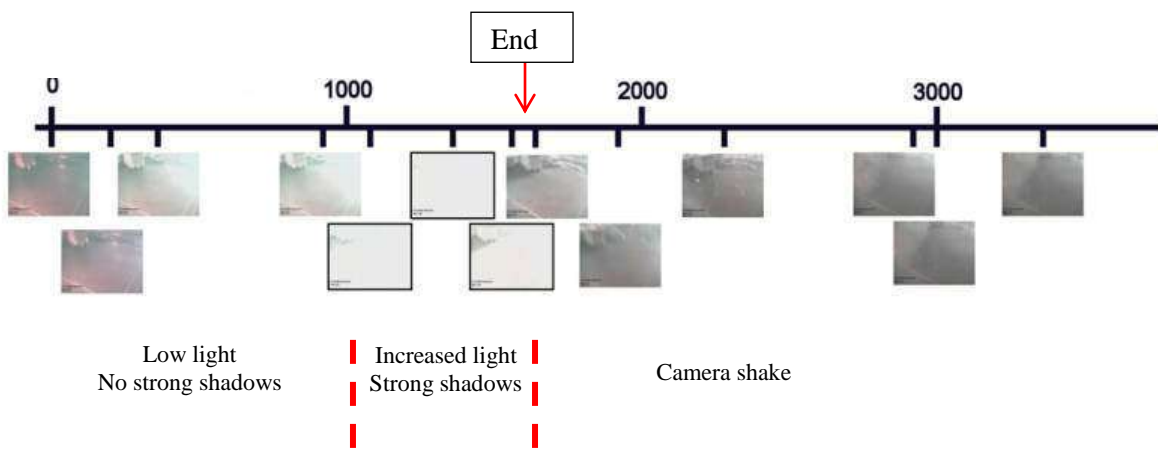
Figure 41: Time line of images from a Furnell camera.
Scale indicates time in milliseconds. $T=0$ is the appearance of first light.

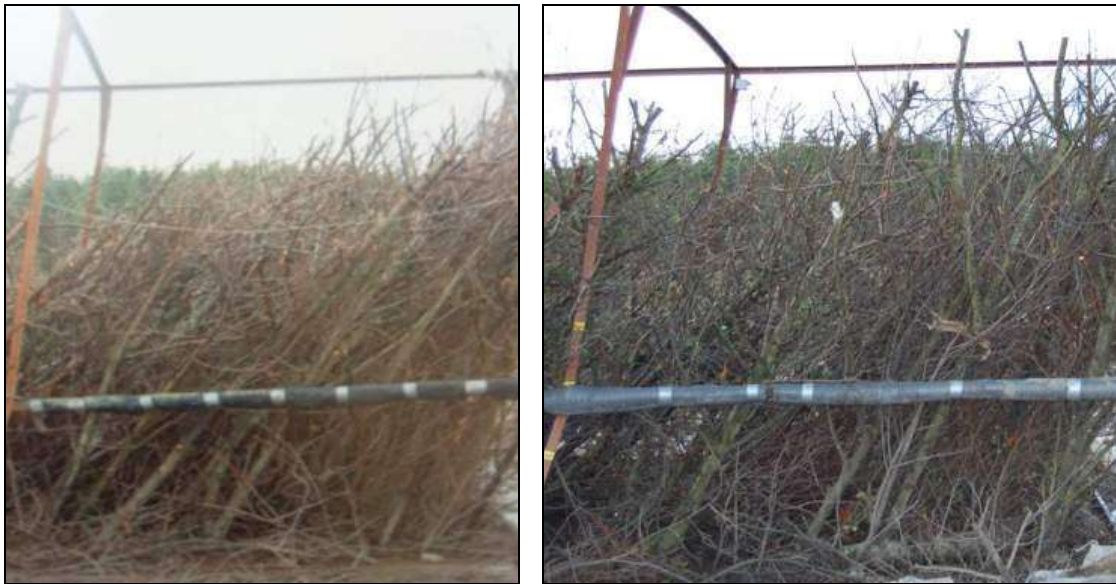
Figure 47: Vegetation post-explosion near the point of ignition in the two JIP tests that gave DDT

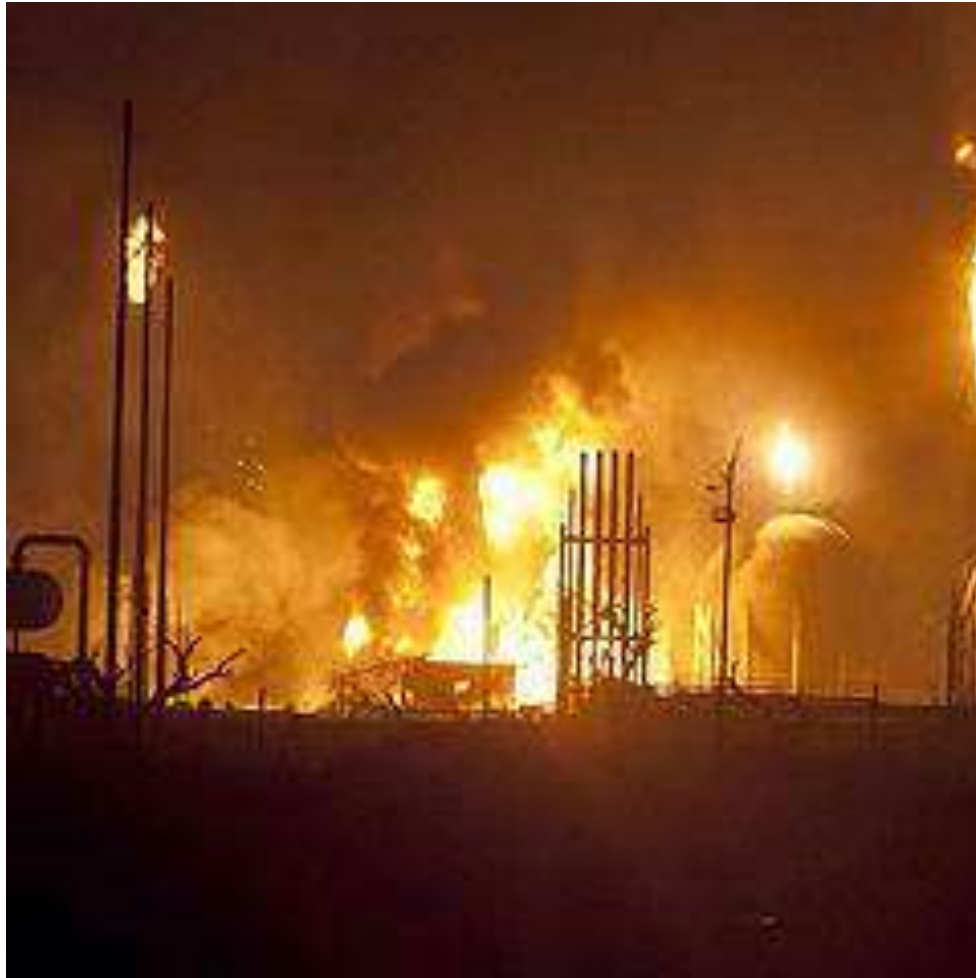
Figure 54: Ongoing fire around the site of the leak

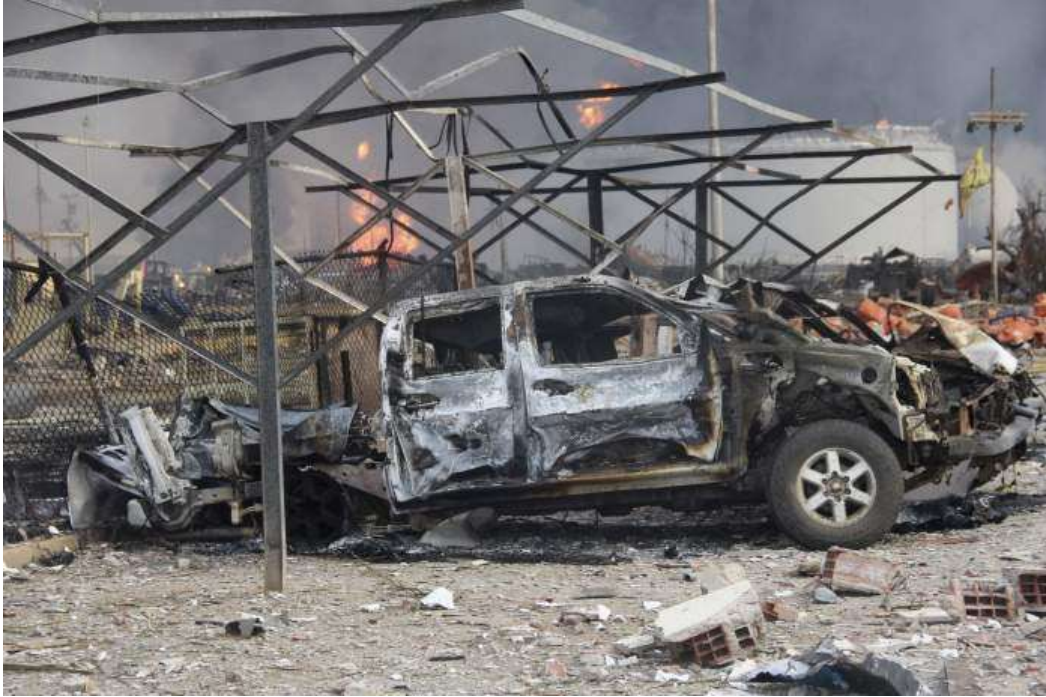
Figure 55: Directional damage to a car shelter (main supports) and fence post. Suggests severe explosion propagation from left to right. Location marked A in Figure 57

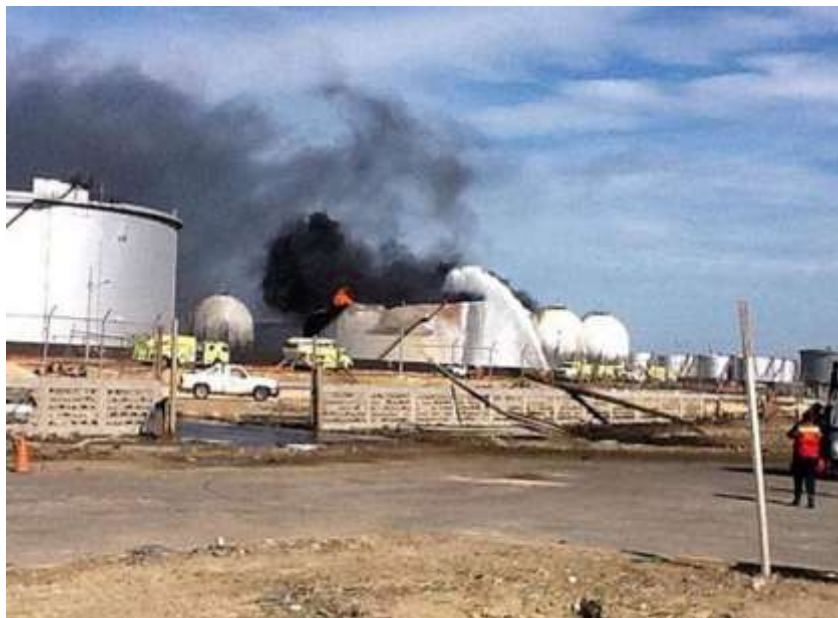
Figure 56: Angled posts (some leaning on a wall). Marked B in Figure 57

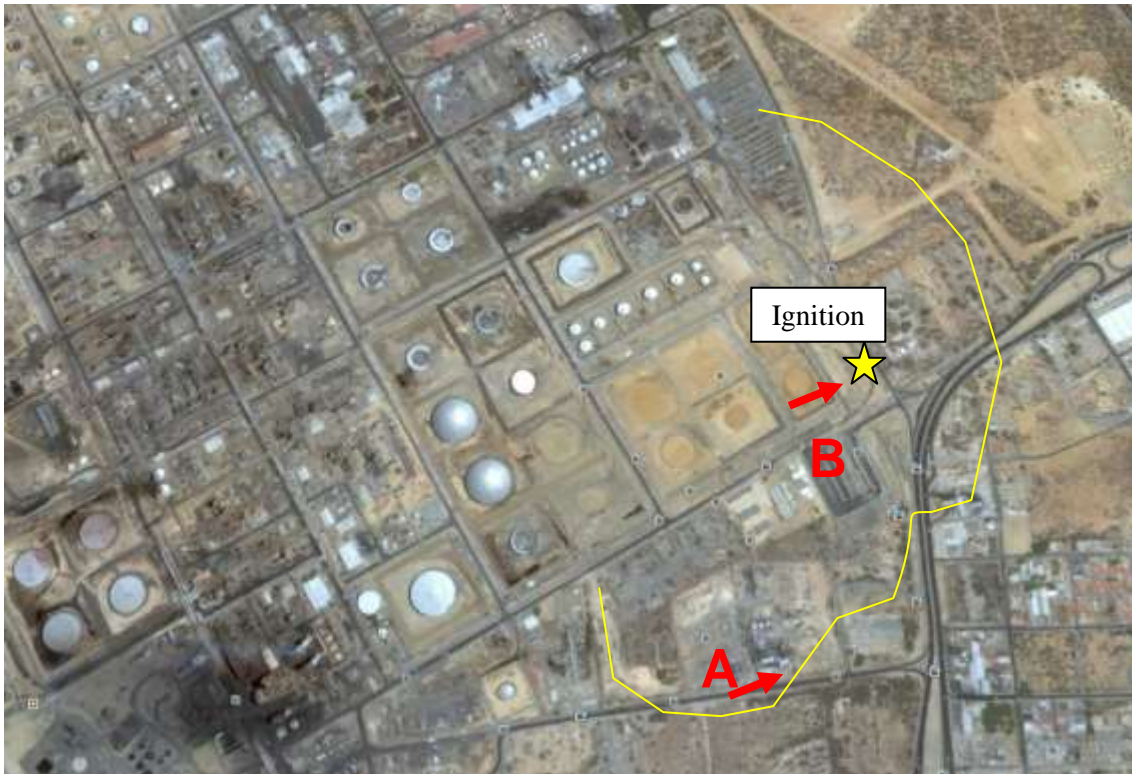
Figure 57: Limited indicators of direction of explosion propagation at Amuay – inconsistent with the observed location of ignition point.

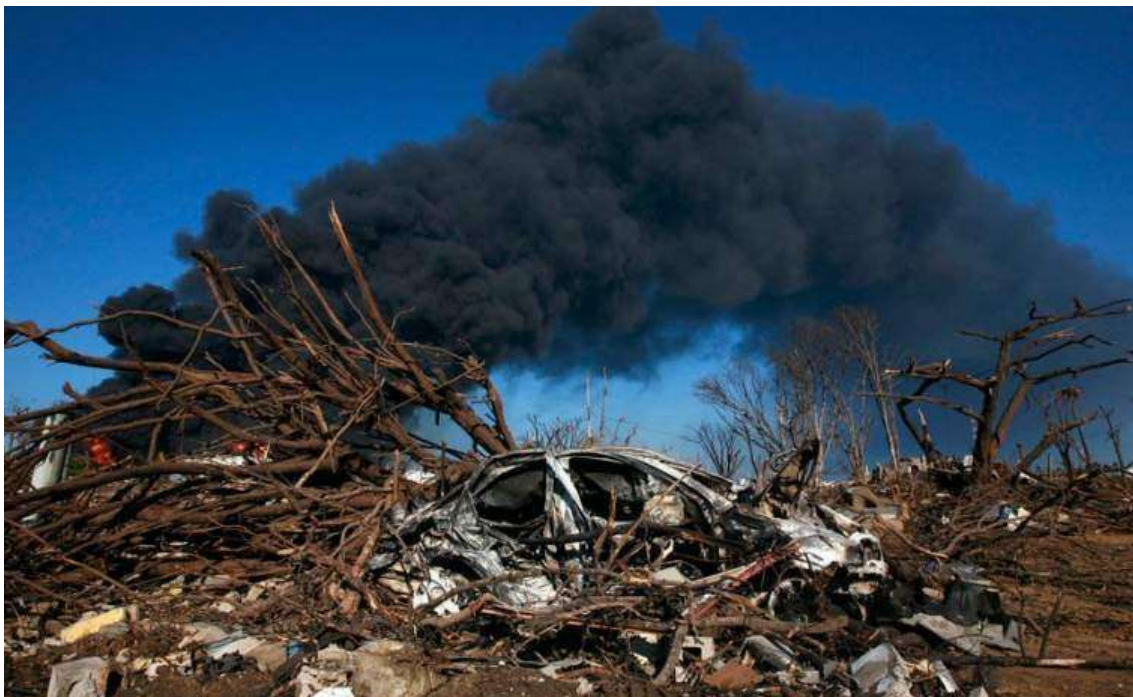
Figure 58: Explosion damage towards the NE edge of the cloud at Amuay

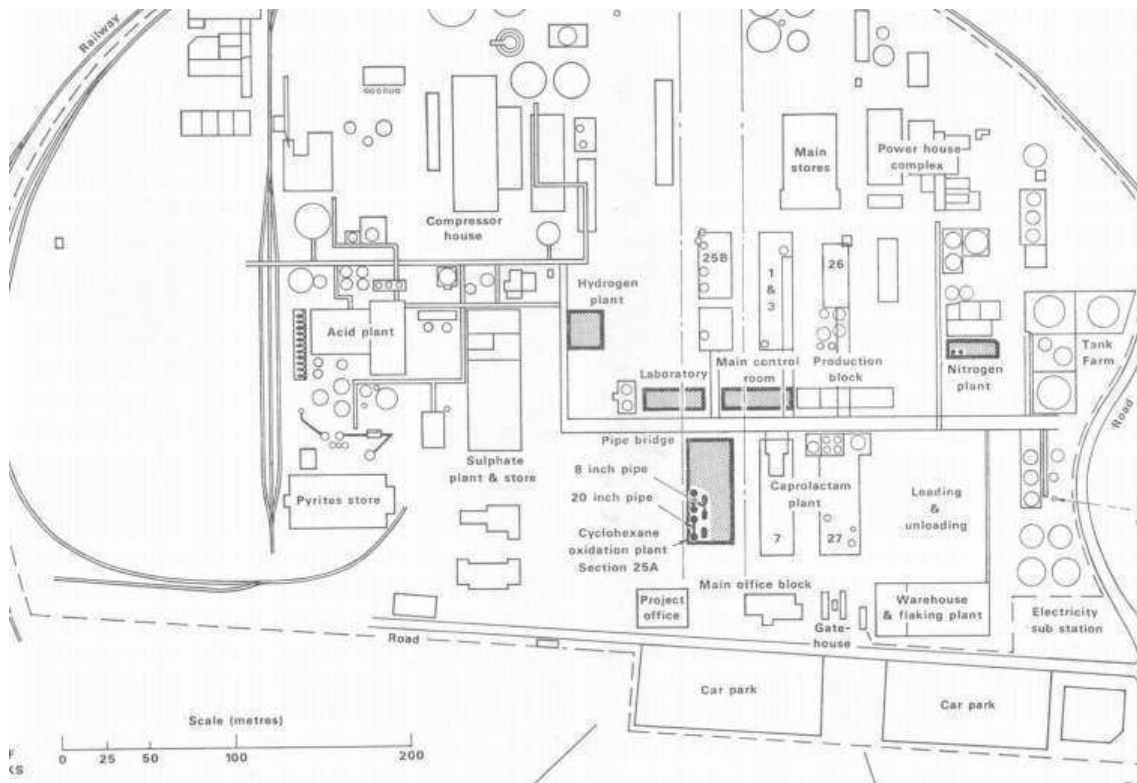
Figure 59: Overall view of Flixborough site

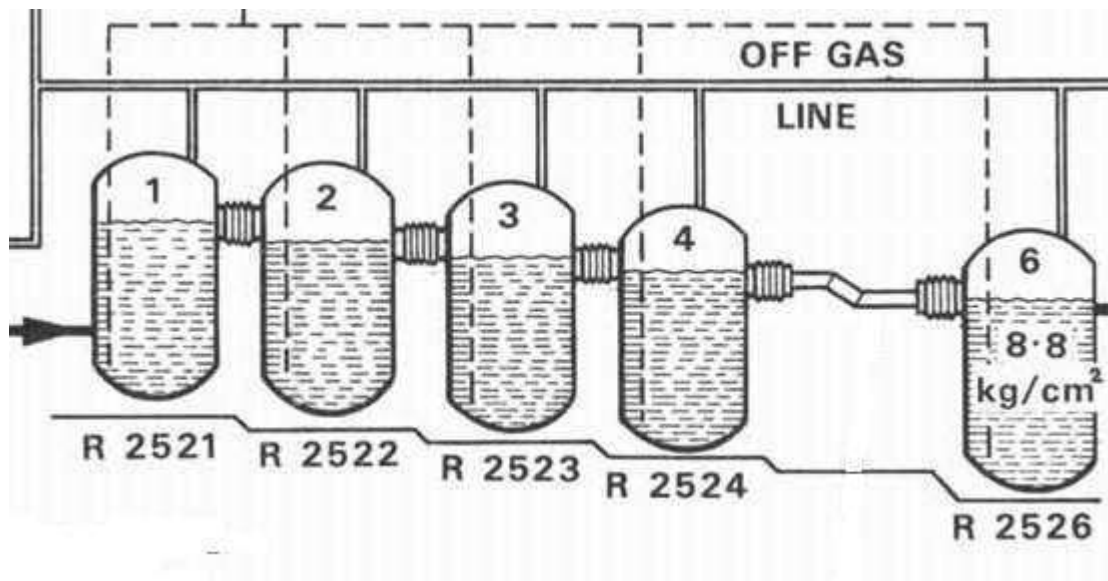
Figure 65: Schematic of reactor train including by-pass

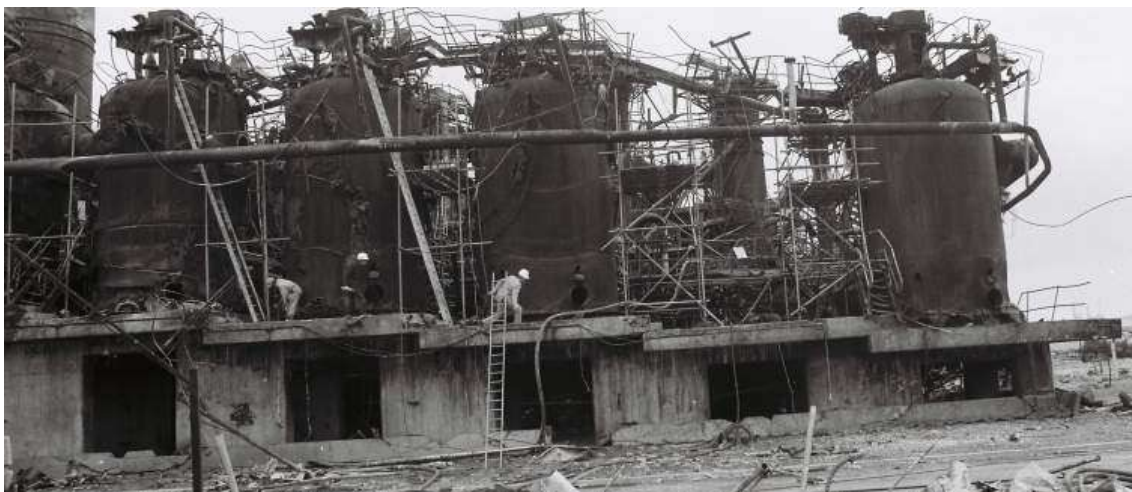
Figure 66: Photograph of part of the reactor train after the incident the dog leg bypass was lost completely. Scaffolding has been erected after the incident.

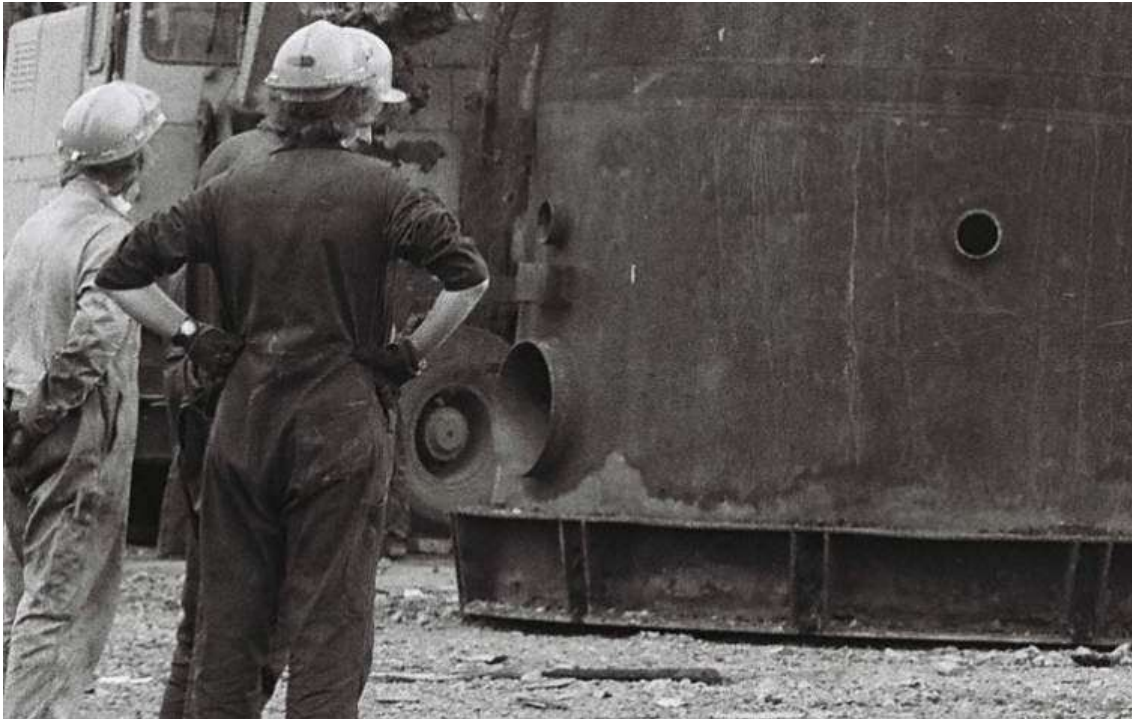
Figure 68: Reactor 2. Limited pressure damage to reactor skirt

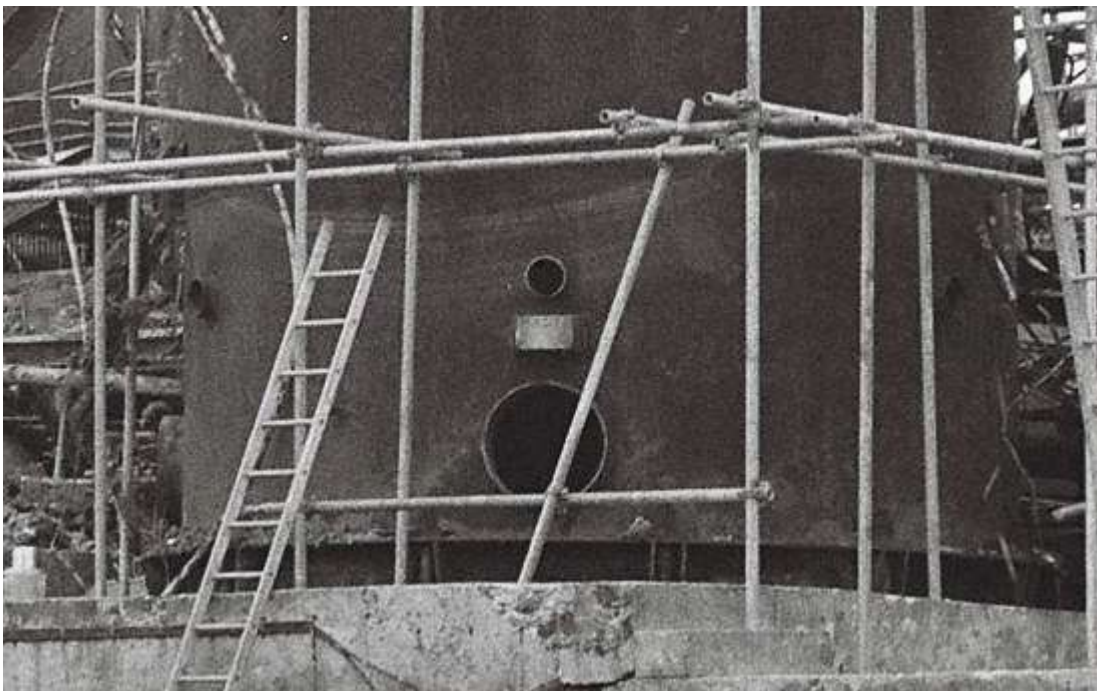
Figure 69: Reactor 3. Limited pressure damage to reactor skirt

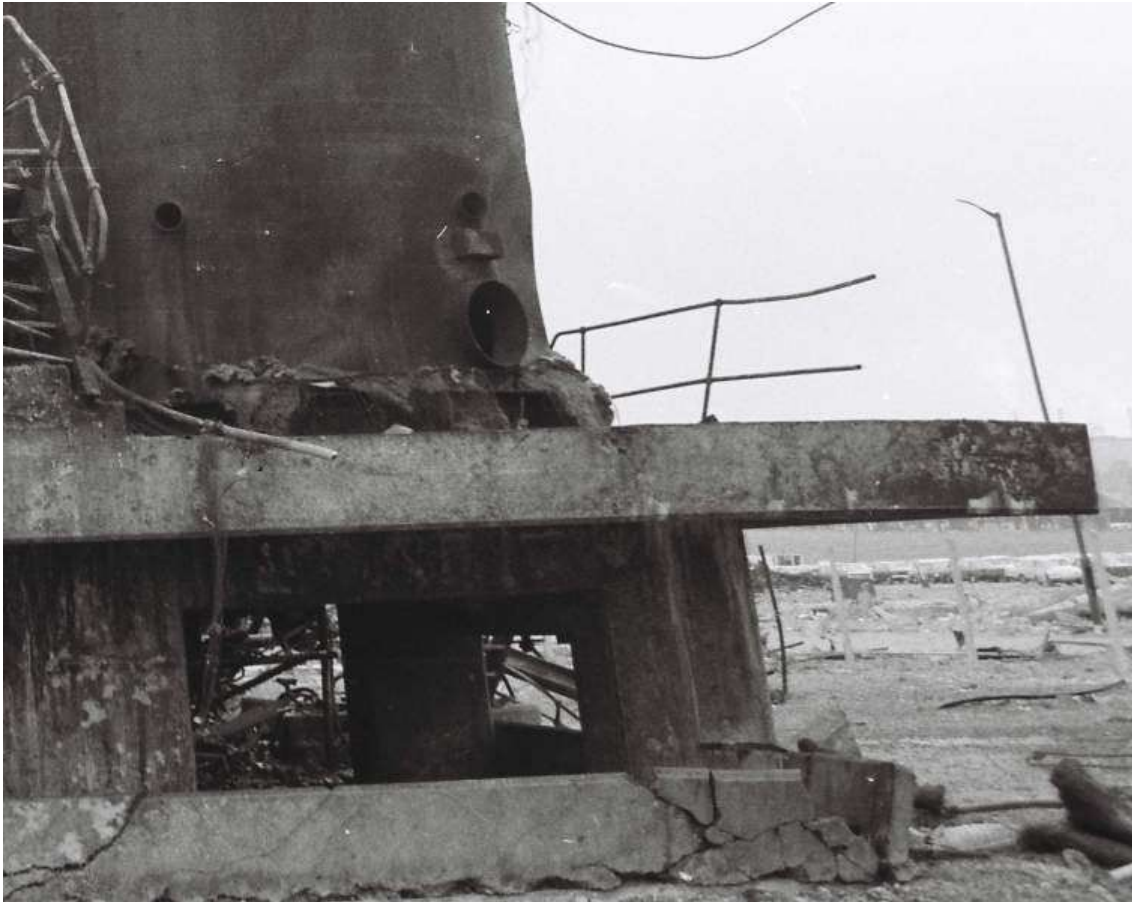
Figure 70: Reactor 6 (Number 5 missing). Significant pressure damage to the skirt

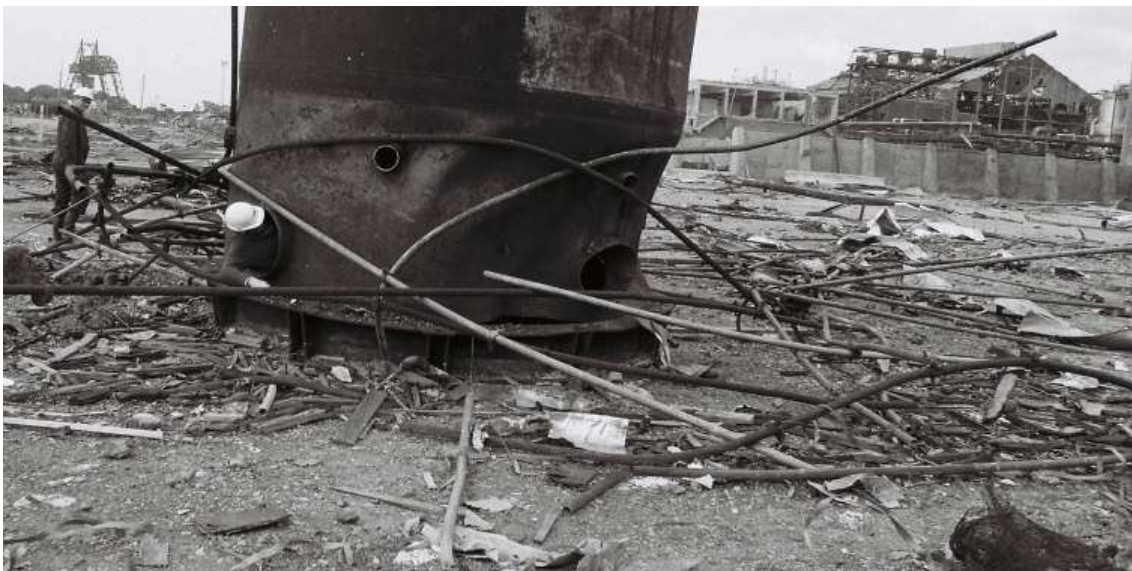
Figure 71: Reactor 5 - Located in open ground approximately 40 m (131 ft) from the leak. Substantial damage to the reactor skirt on the side facing the plant

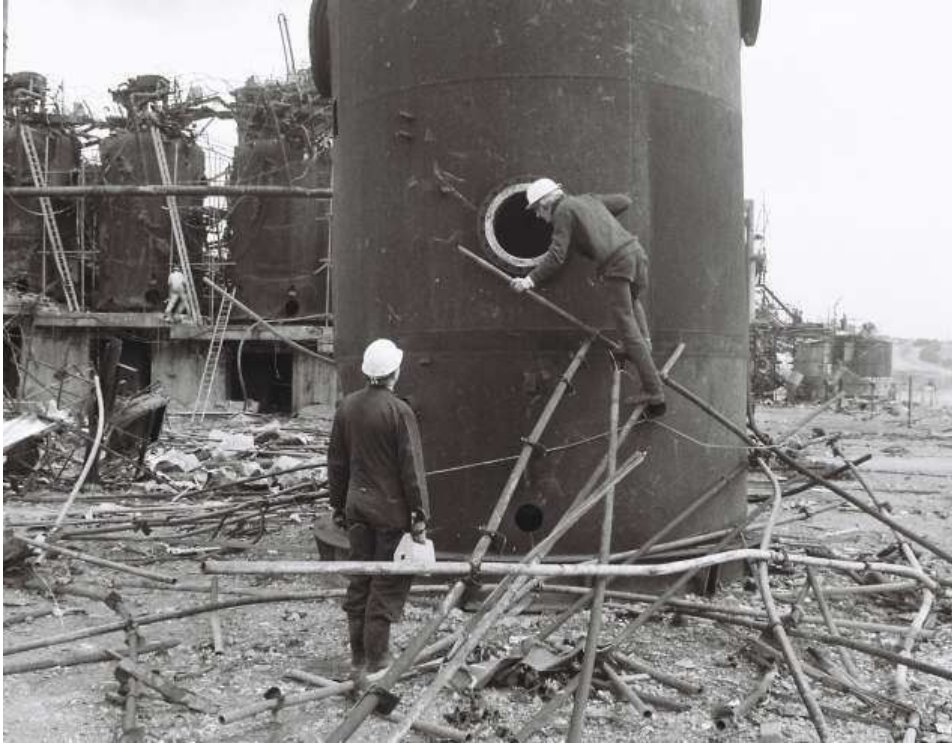
Figure 72: Reverse face of Reactor 5 showing asymmetry in damage

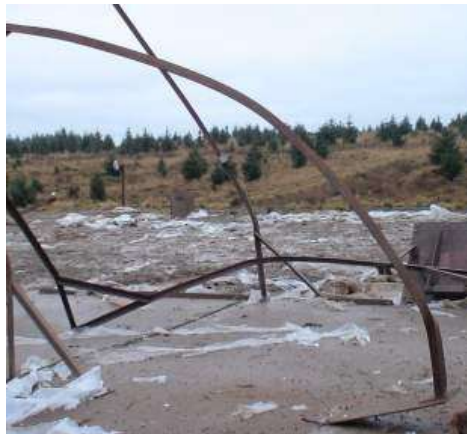
Figure 73: Angle iron deformed by a detonation (depth 3m)

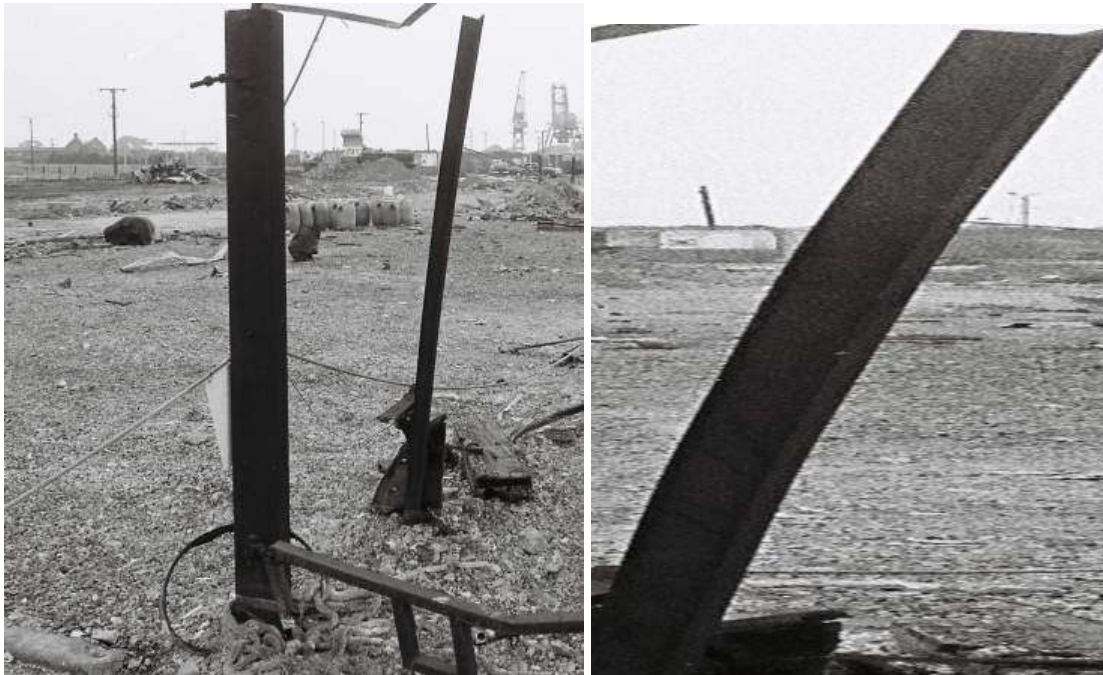
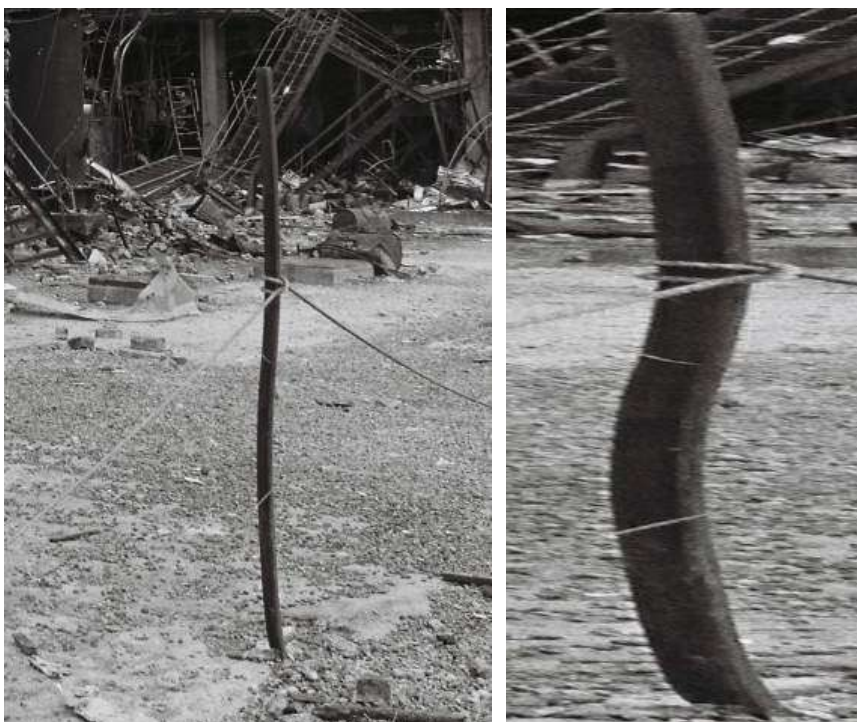
Figure 74: Curved fence posts in open areas to the south of the cyclohexane oxidation plant

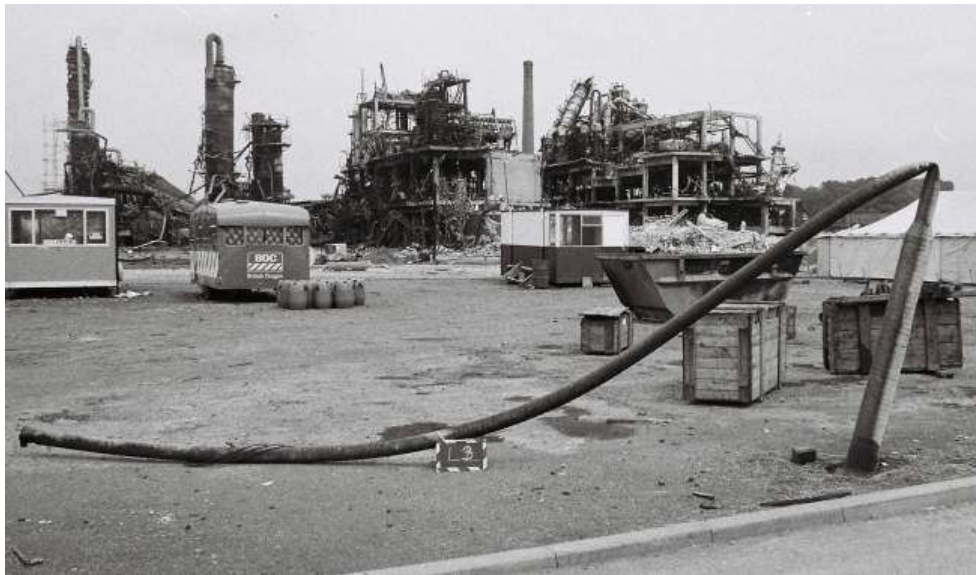
Figure 77: Lamp post within the cloud – approx. 130 m (426 ft) south of vapor source

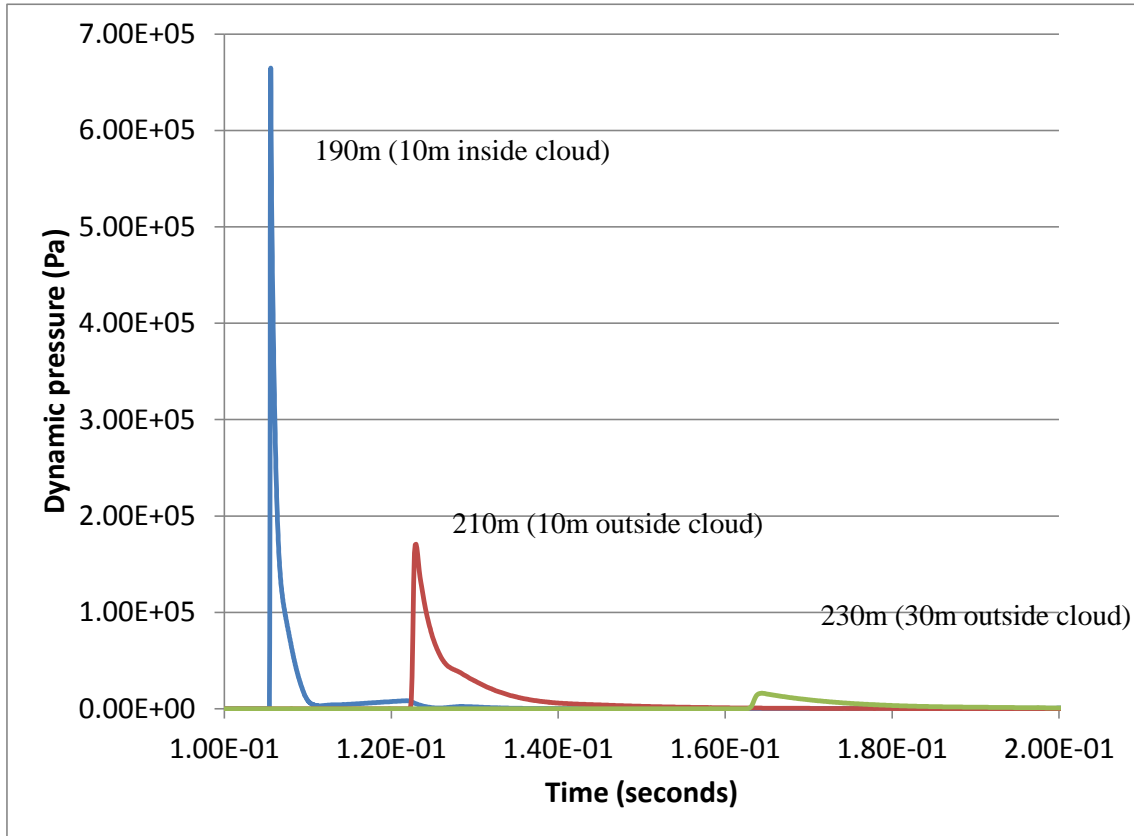
Figure 81: Dynamic pressure in and close to the edge of a 3m deep detonation (cloud radius 200m, measurement height 1.5m, measurement radius 190, 210 and 230 m)

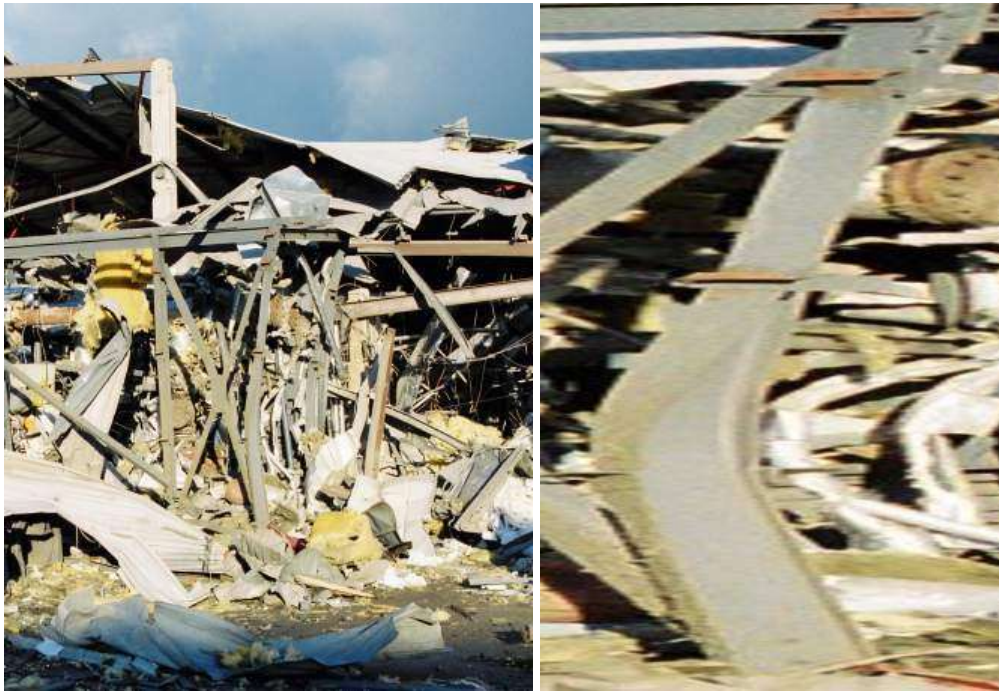
Figure 82: Deformed steels outside and within the Buncefield cloud exhibit hinged failure – characteristic of loads applied over a long period relative to the natural frequency

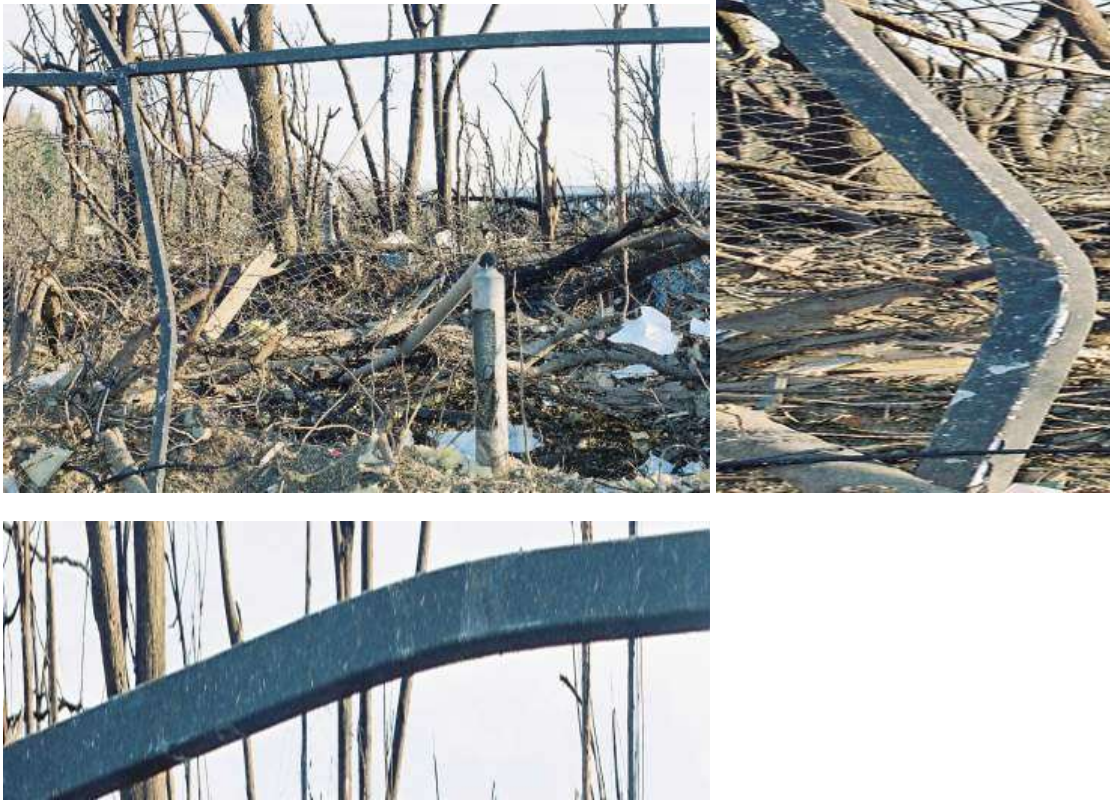
Figure 83: Deformed steels at Buncefield exhibit hinged failure – characteristic of loads applied over a long period relative to the natural frequency. Images on the right and below stretched digitally in the horizontal and vertical directions respectively – to visualise strain distribution.

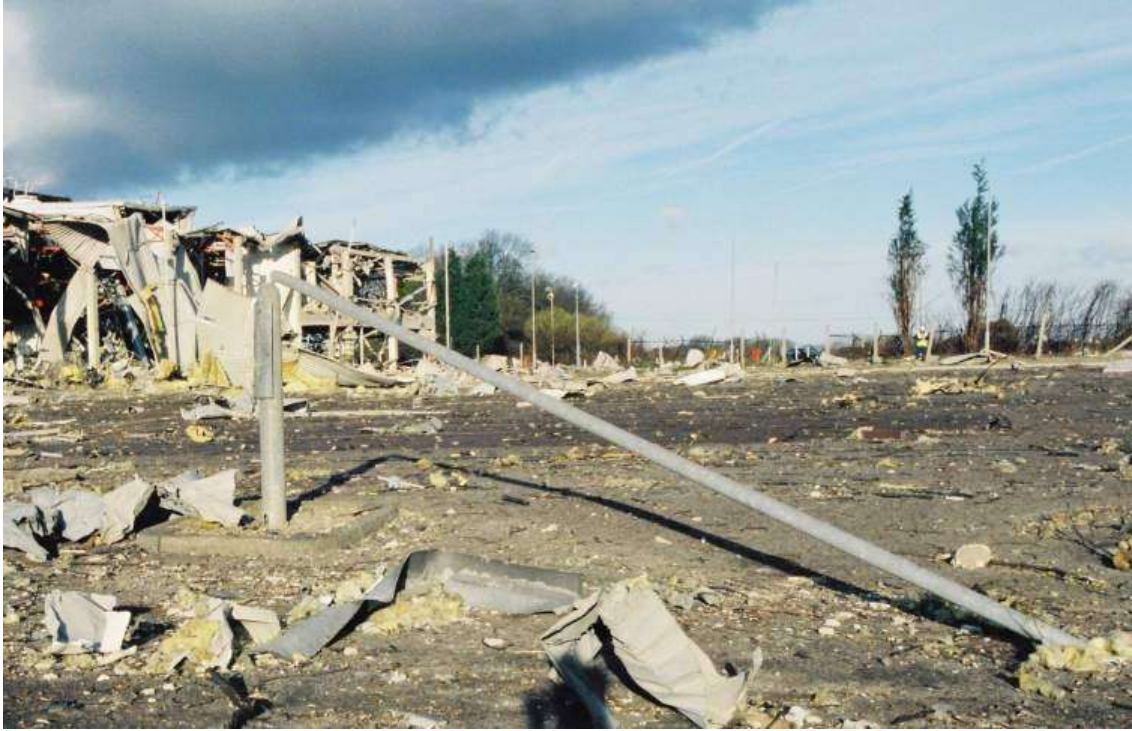
Figure 84: Typical deformation of a lamp post at Buncefield

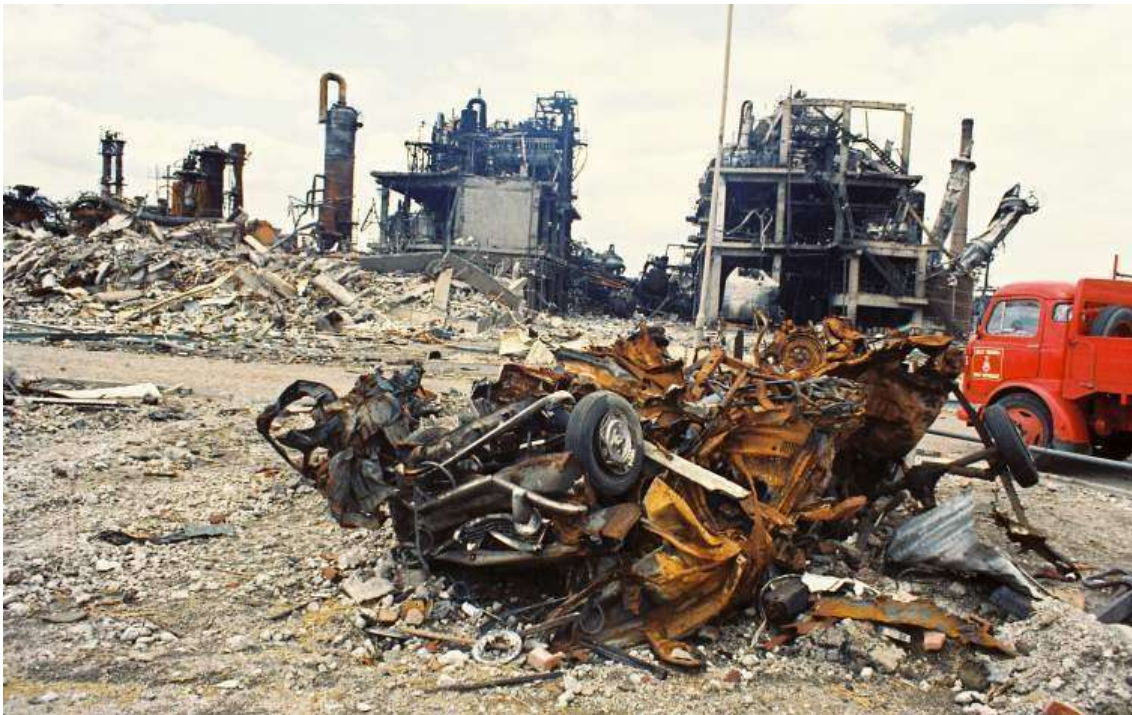
Figure 86: Low levels of deformation and deflection damage to LP 9

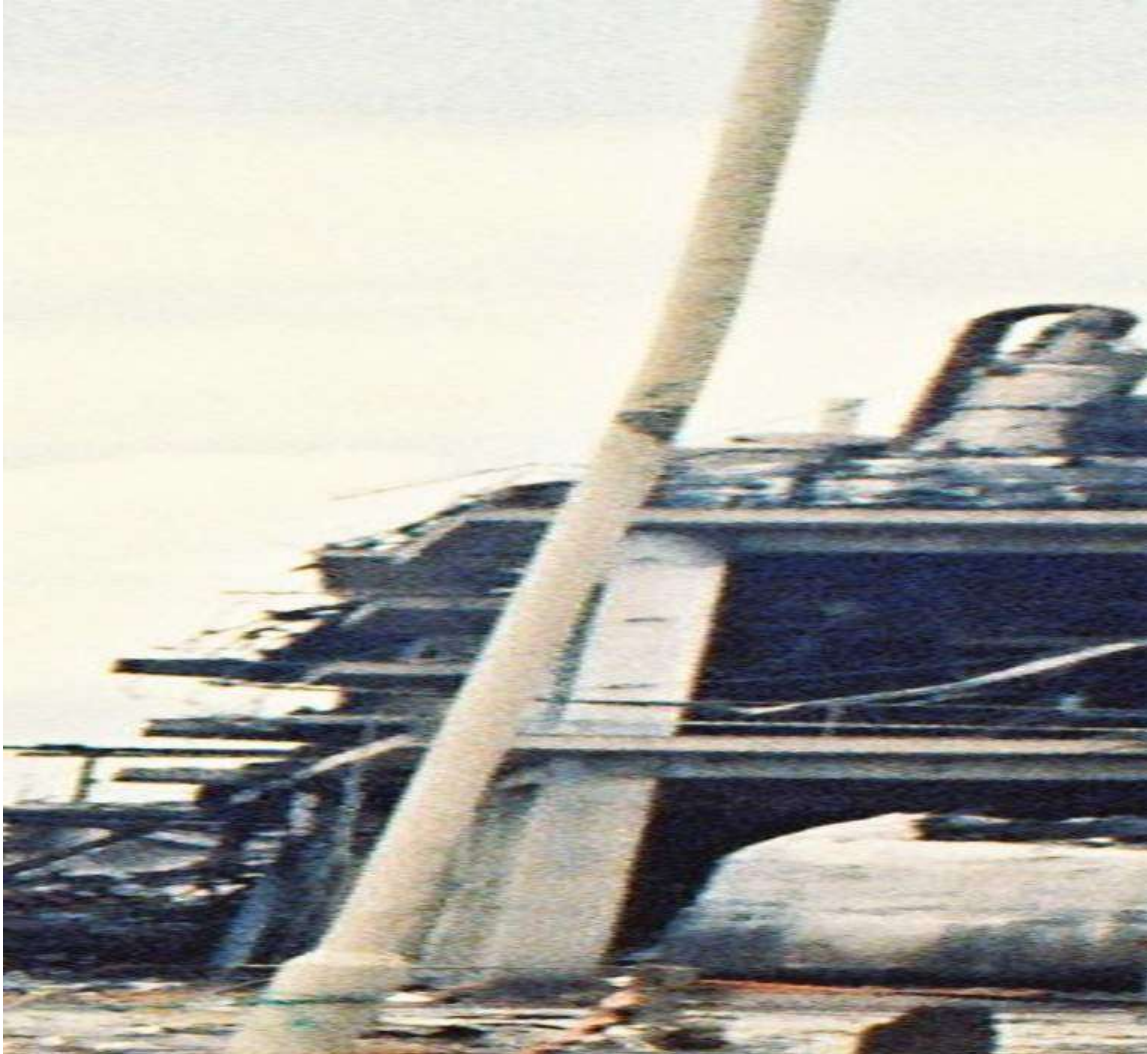
Figure 87: Digitally stretched image of LP9

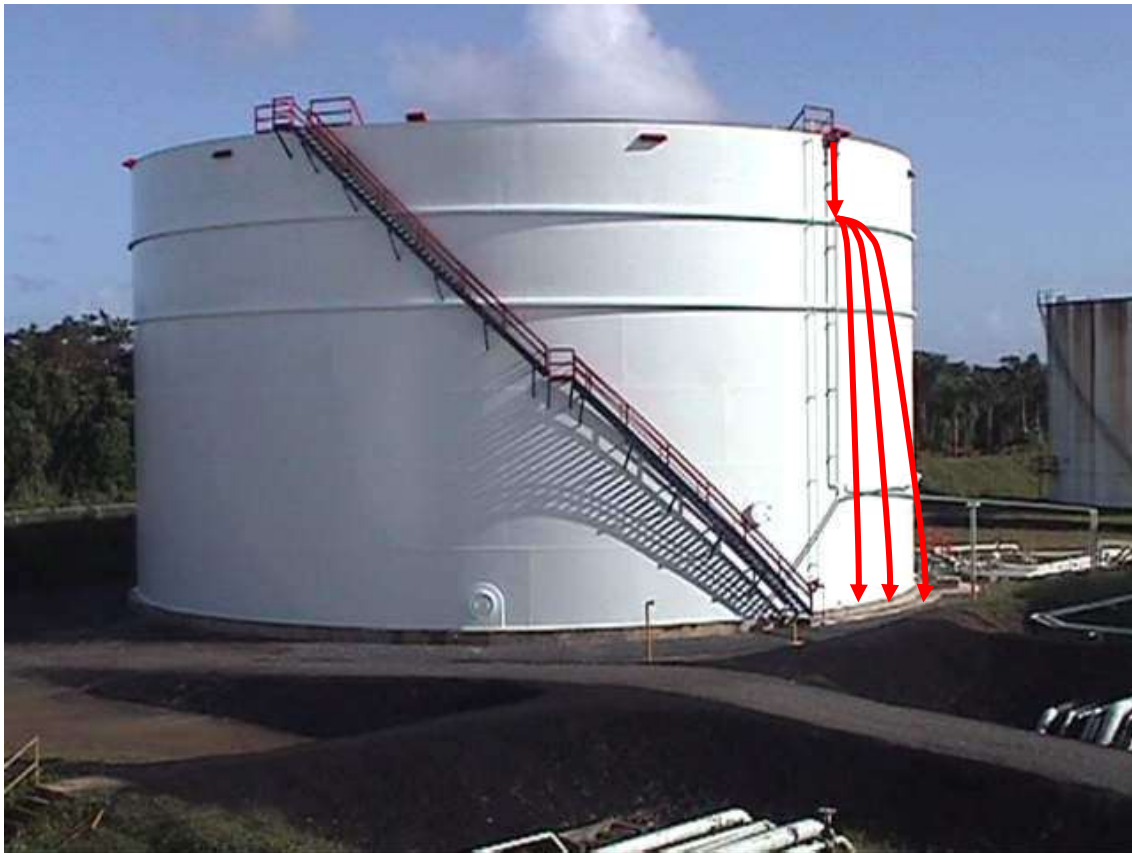
Figure 94: Tank geometry and presumed range of trajectories of over-spilled gasoline

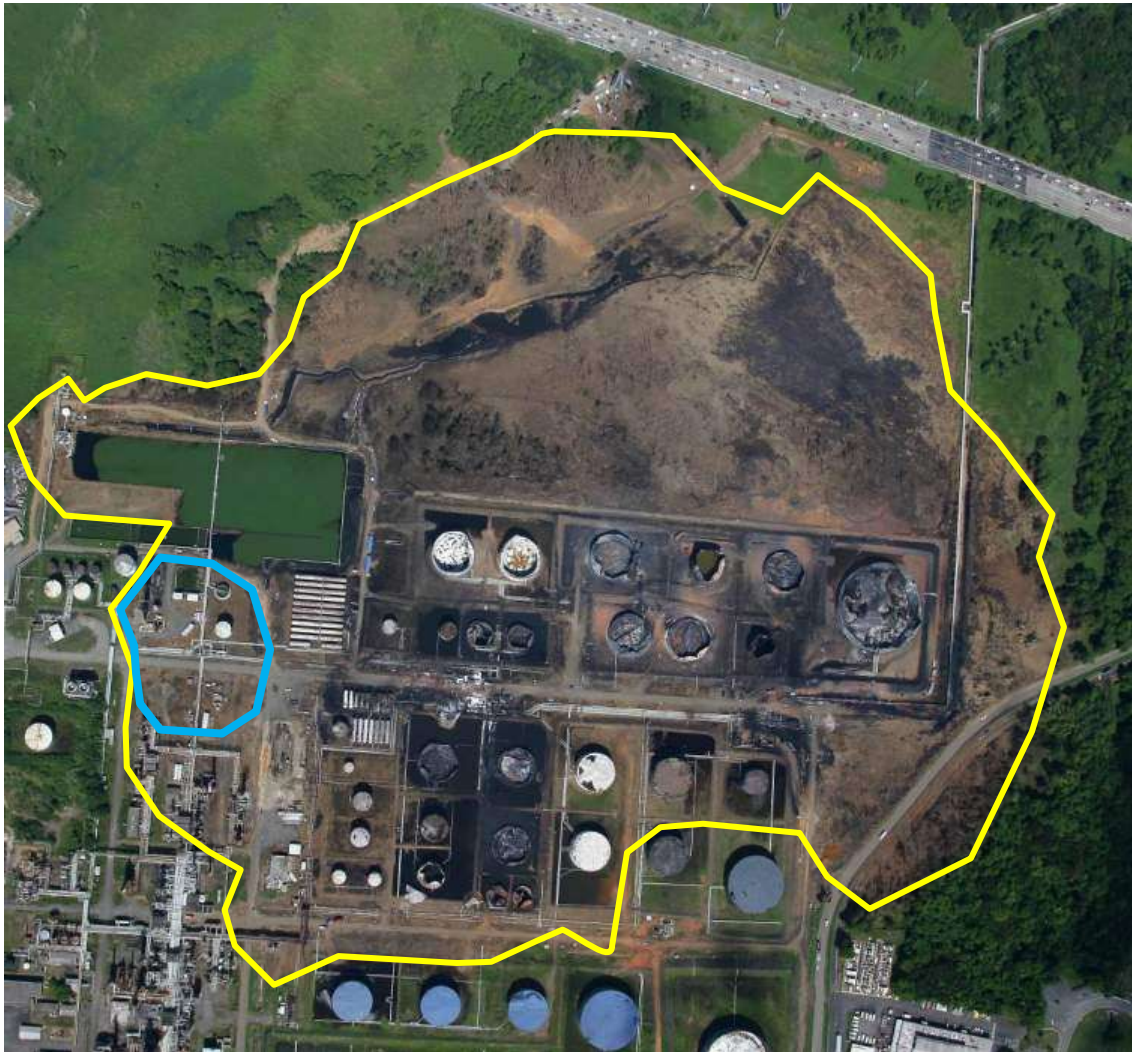
Figure 95: Extent of the burned area (yellow). Area around the point of primary ignition (blue)

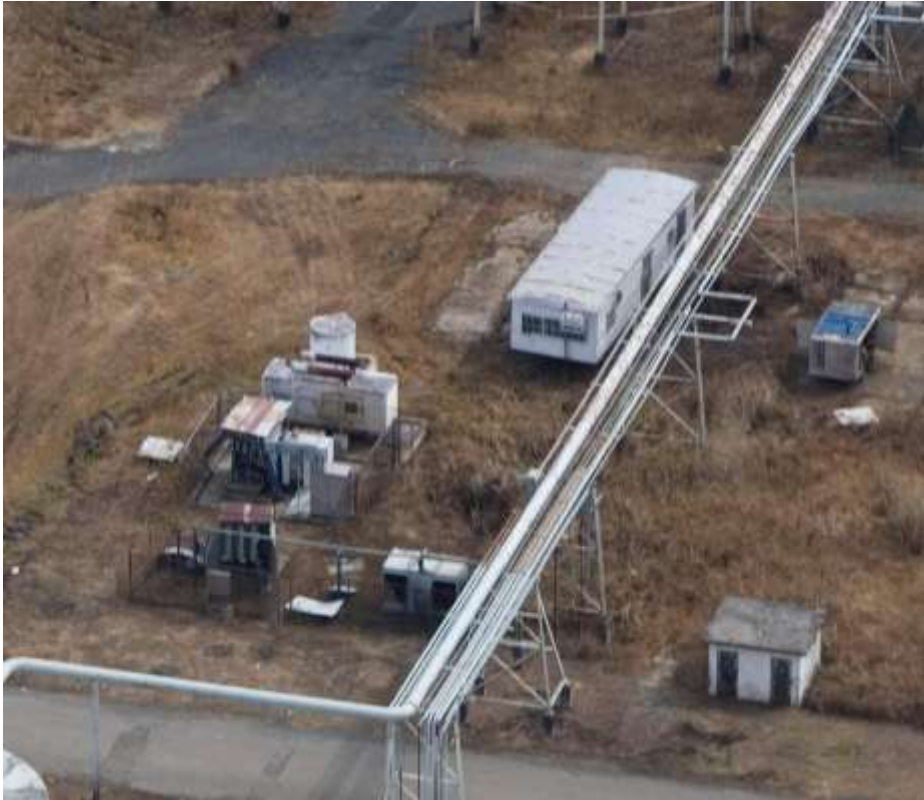
Figure 96: Typical damage around the ignition point
