Harpur Hill, Buxton
Derbyshire, SK17 9JN
T: +44 (0)1298 218000
F: +44 (0)1298 218590
W: www.hsl.gov.uk

Review of Vapor Cloud Explosion Incidents

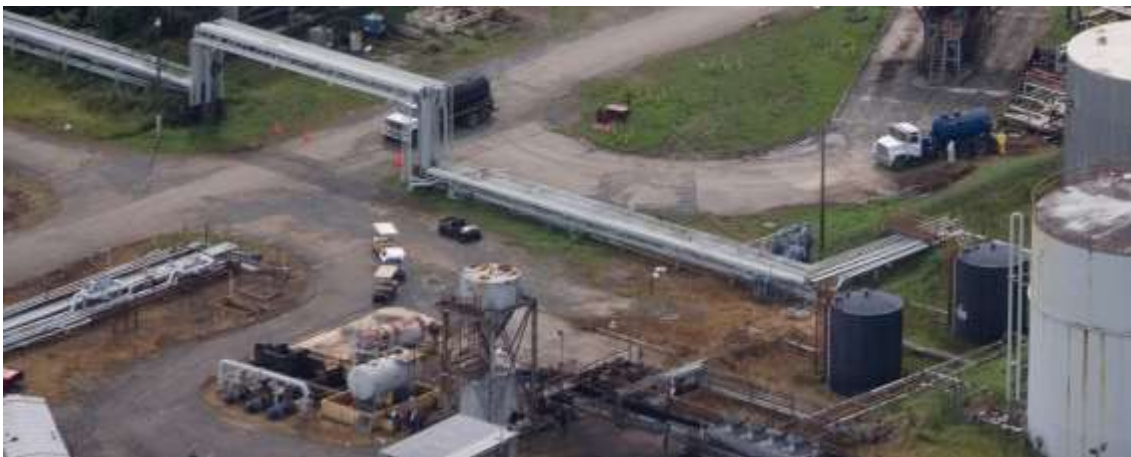
Figure 97: Part of the edge of the cloud – showing character of unburned ground cover

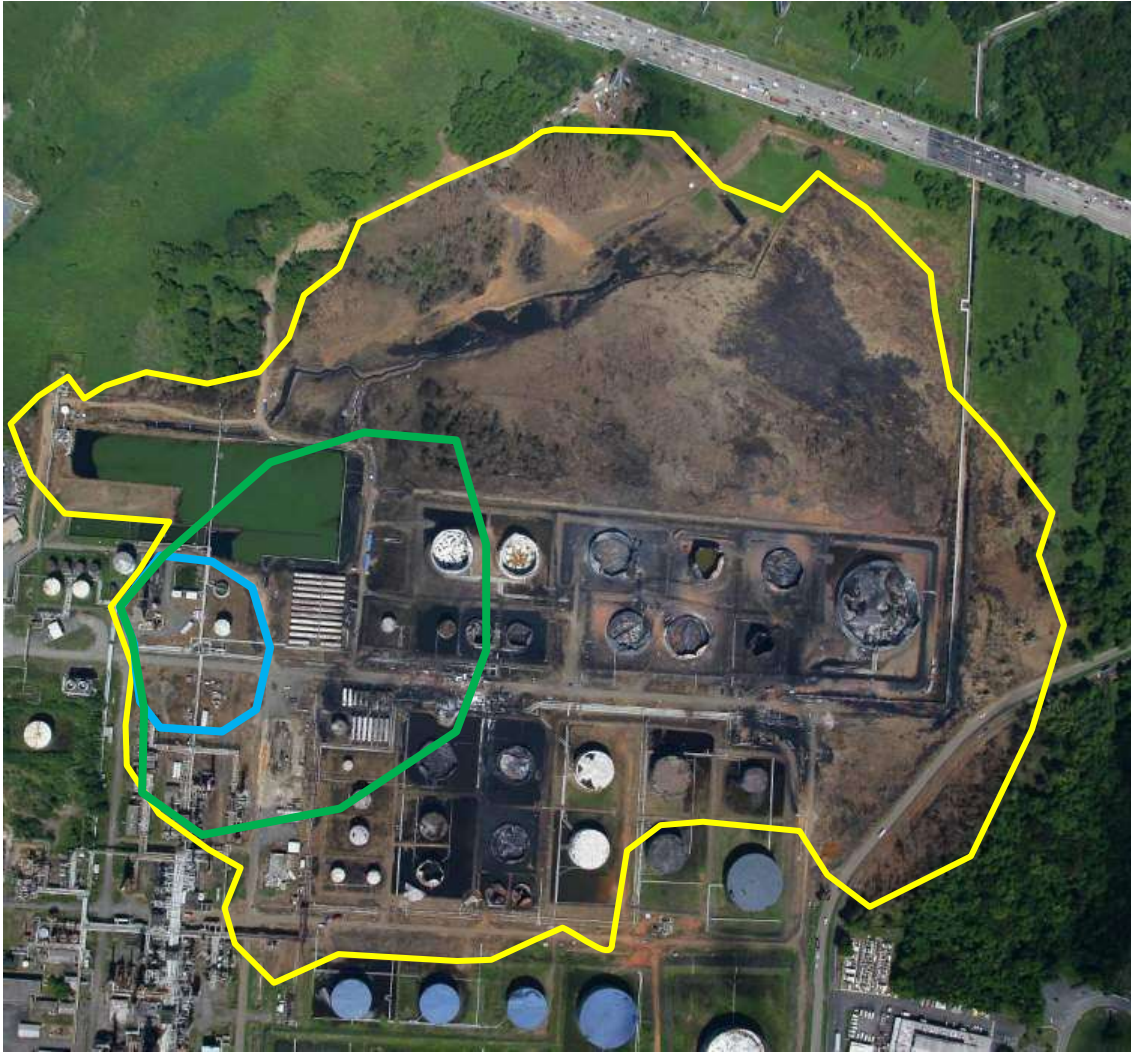
Figure 98: Extent of the burned area (yellow). Approximate extent of flame spread prior to transition to a severe explosion (green).

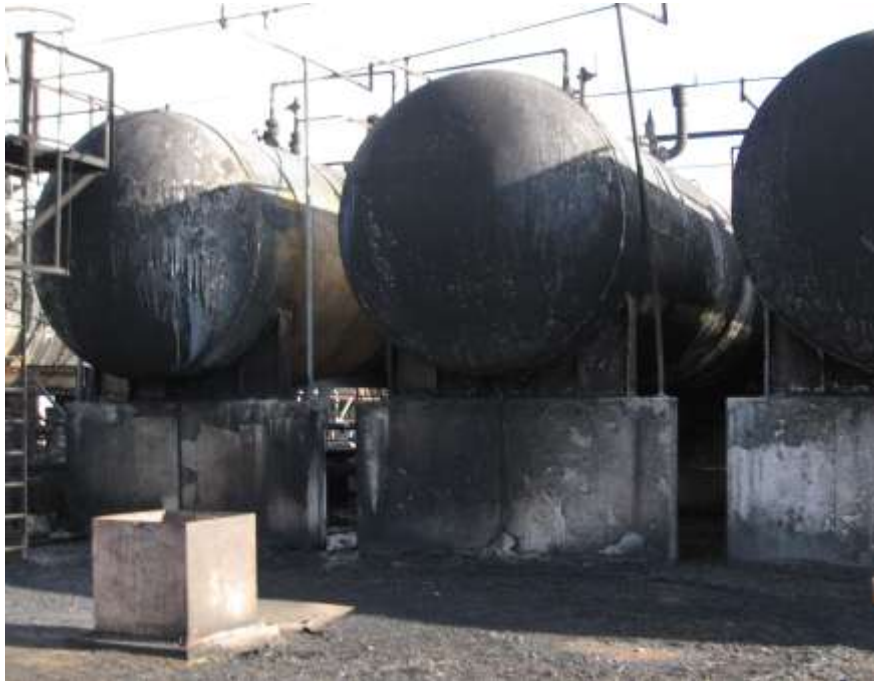
Figure 99: Low level of pressure damage to pipes and steel box

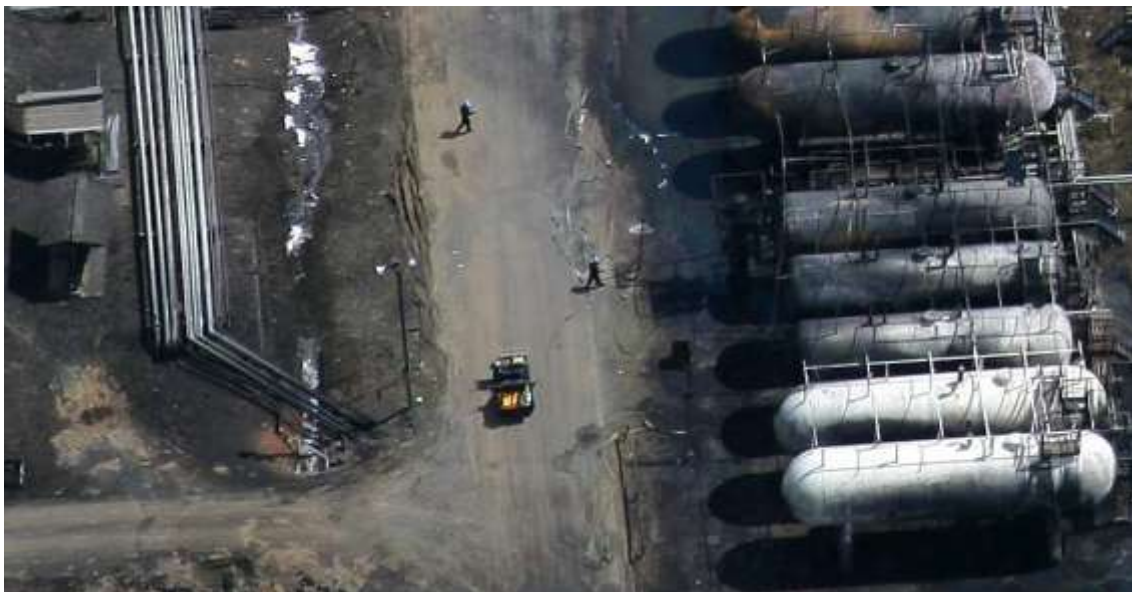
Figure 100: Low level of pressure damage to weather cover sheets (left hand side) and small bore pipe work (right hand side).

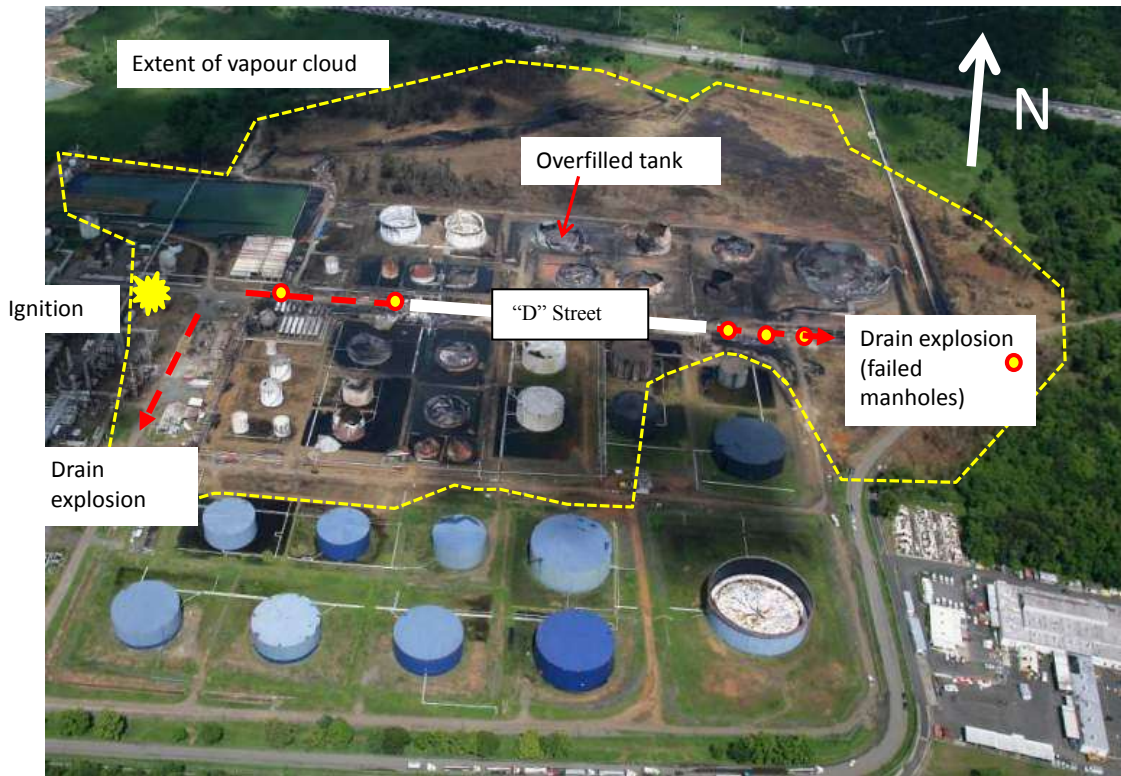
Figure 101: Location of main drain explosions

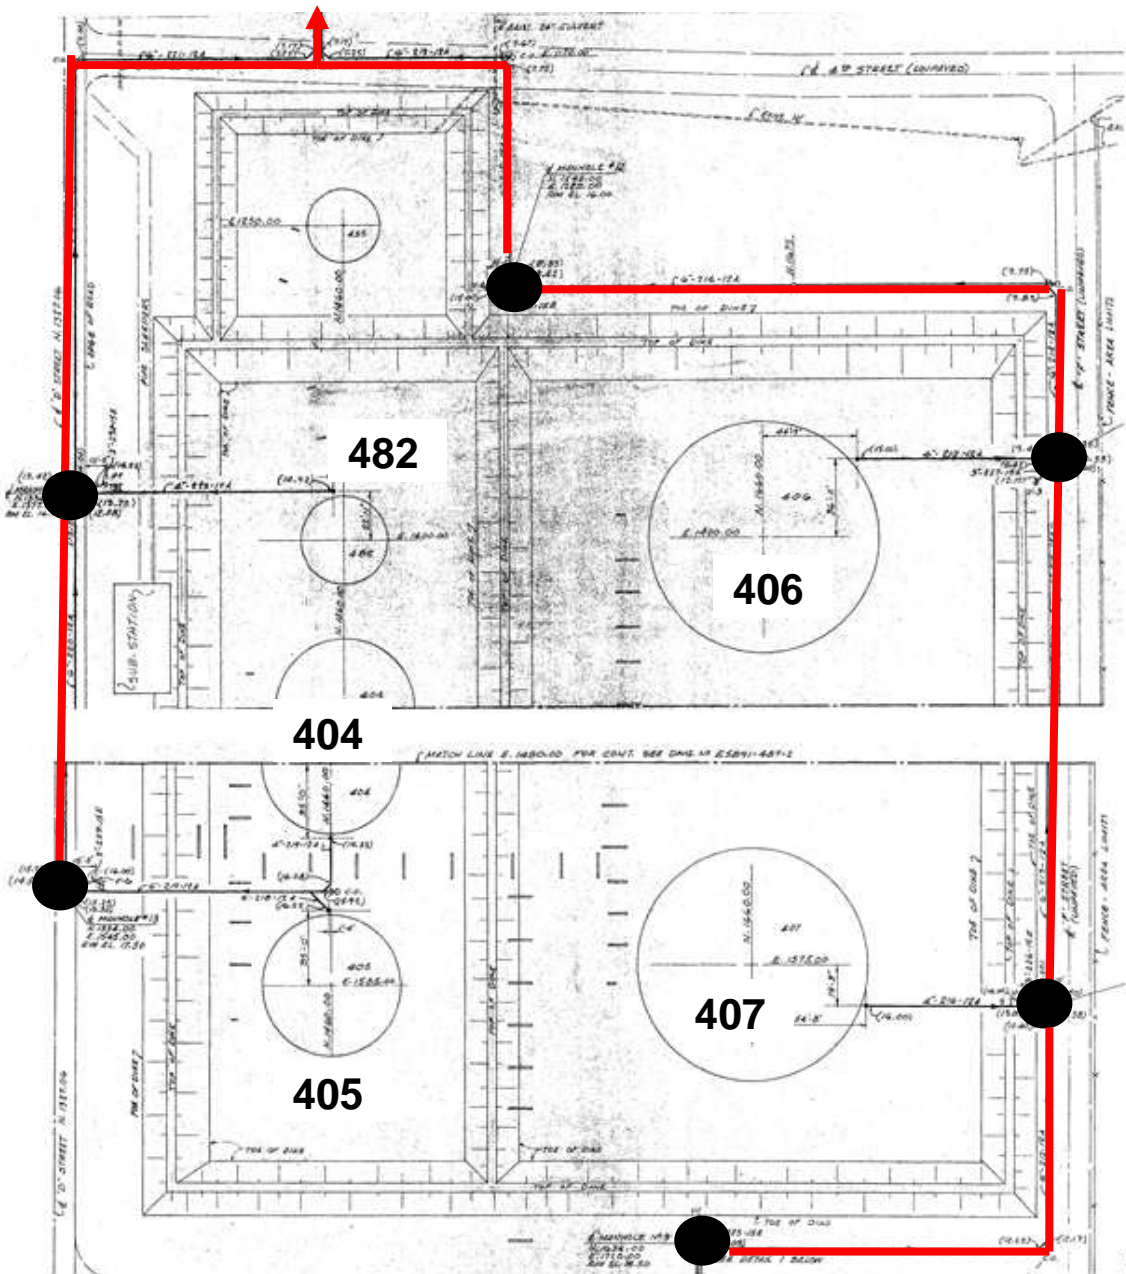
Figure 102: Drain system at the West end of “D” Street. Manholes marked as black circles.

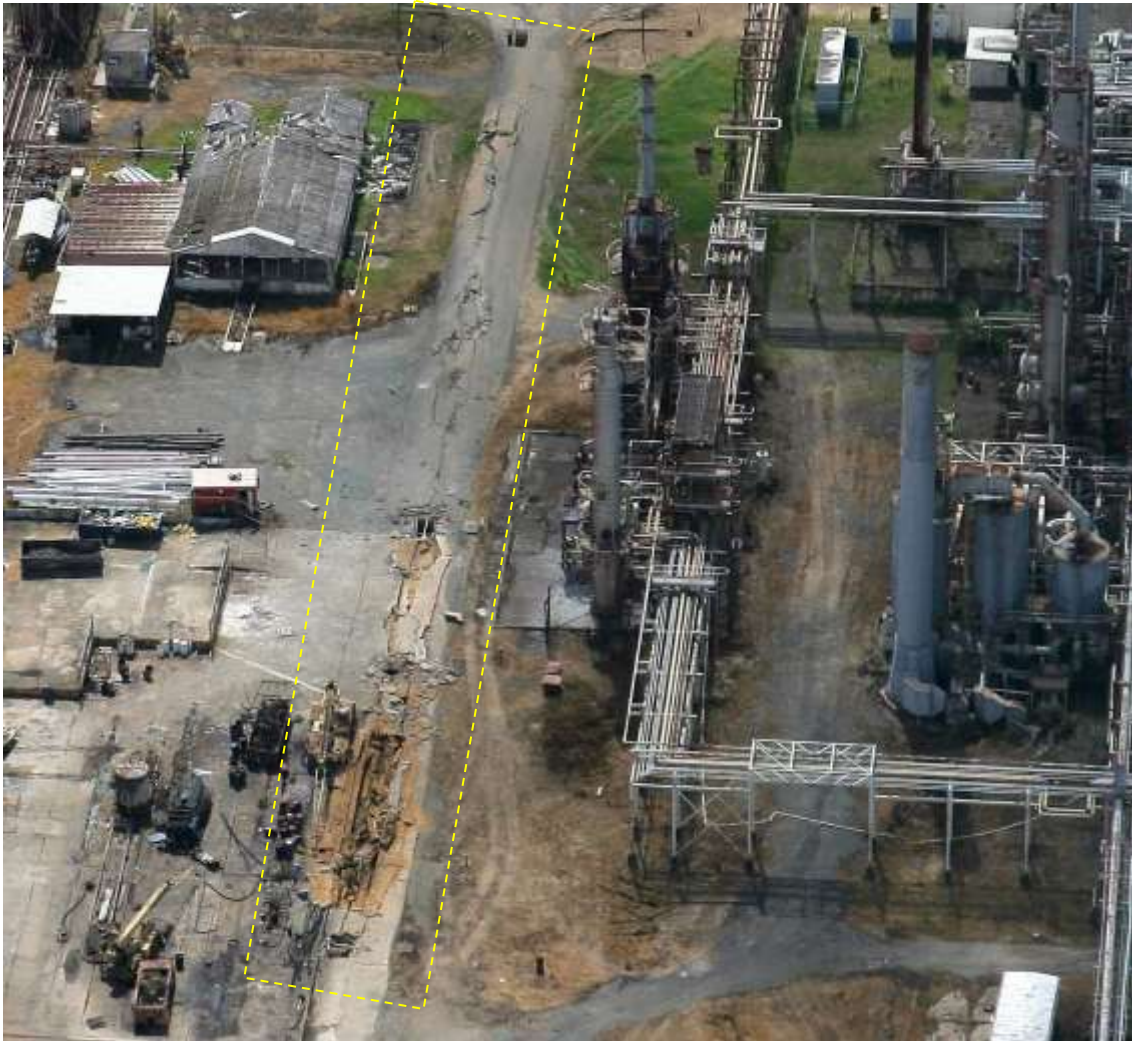
Figure 103: Track of N-S explosion in a drain

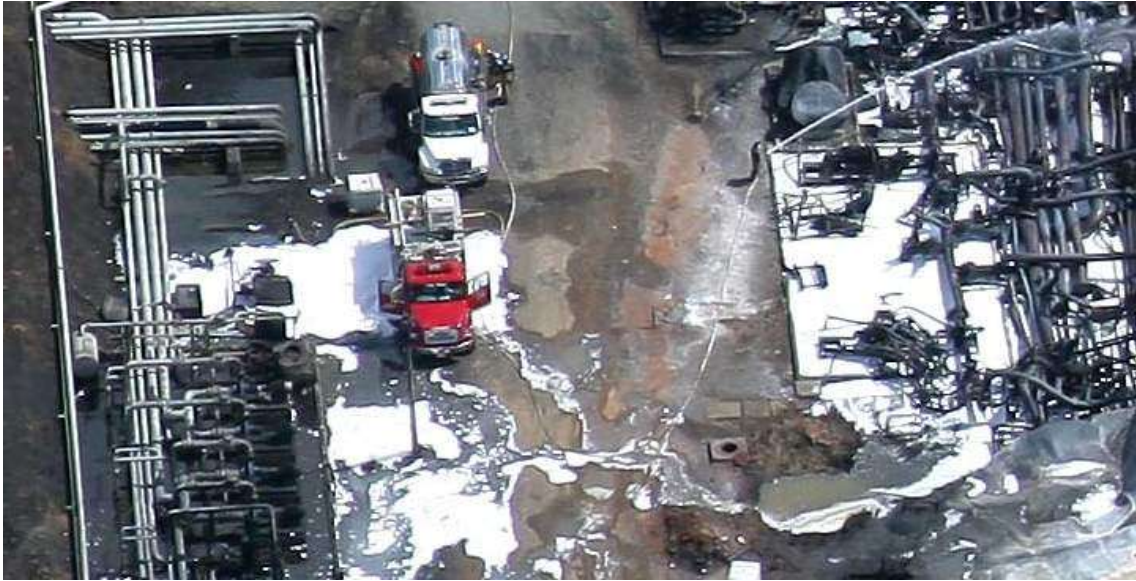
Figure 104: Displaced drain cover half way down “D” Street

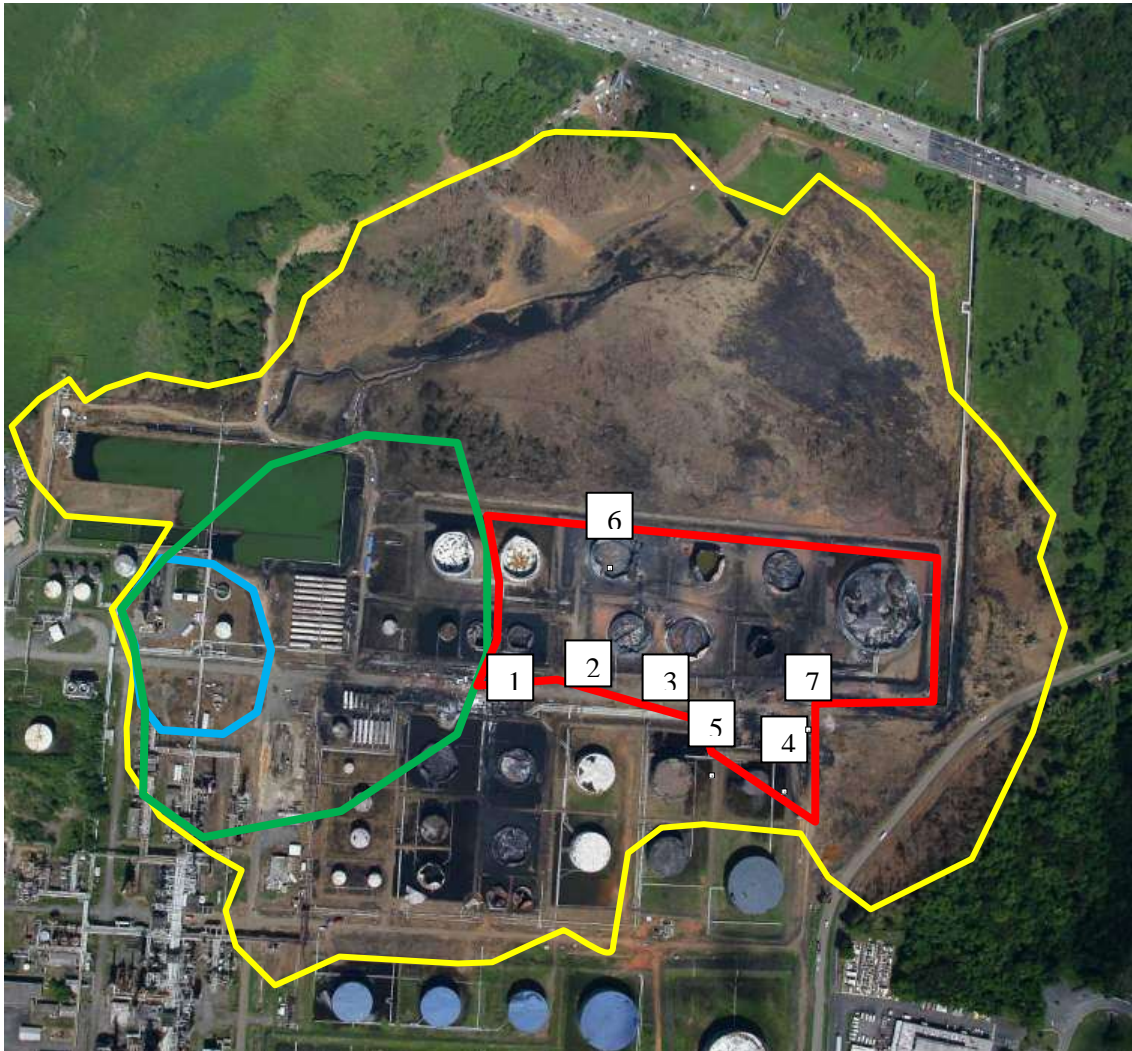
Figure 106: Main on-site area affected by a severe explosion (red line). Approximate locations of seven pressure indicators are shown

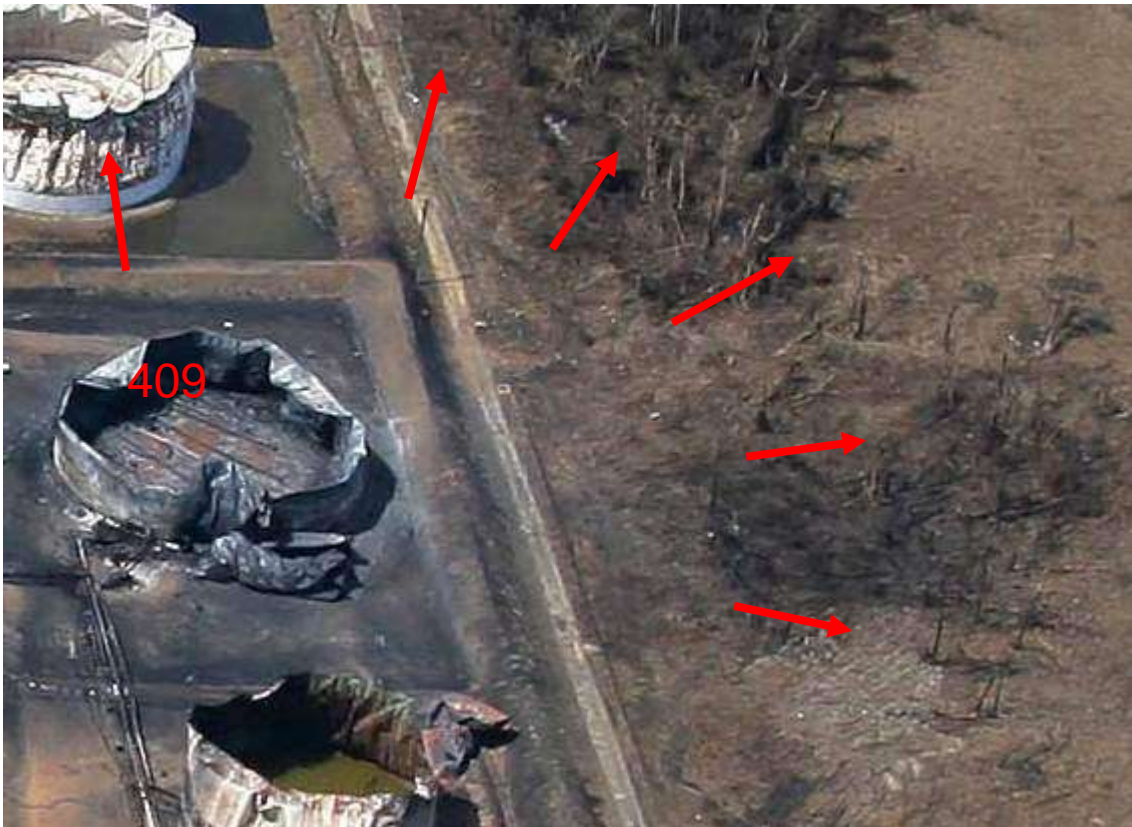
Figure 112: Tree fall and tank damage indicating high overpressures to the north of the overfilled tank (marked as No. 6 in Figure 106)

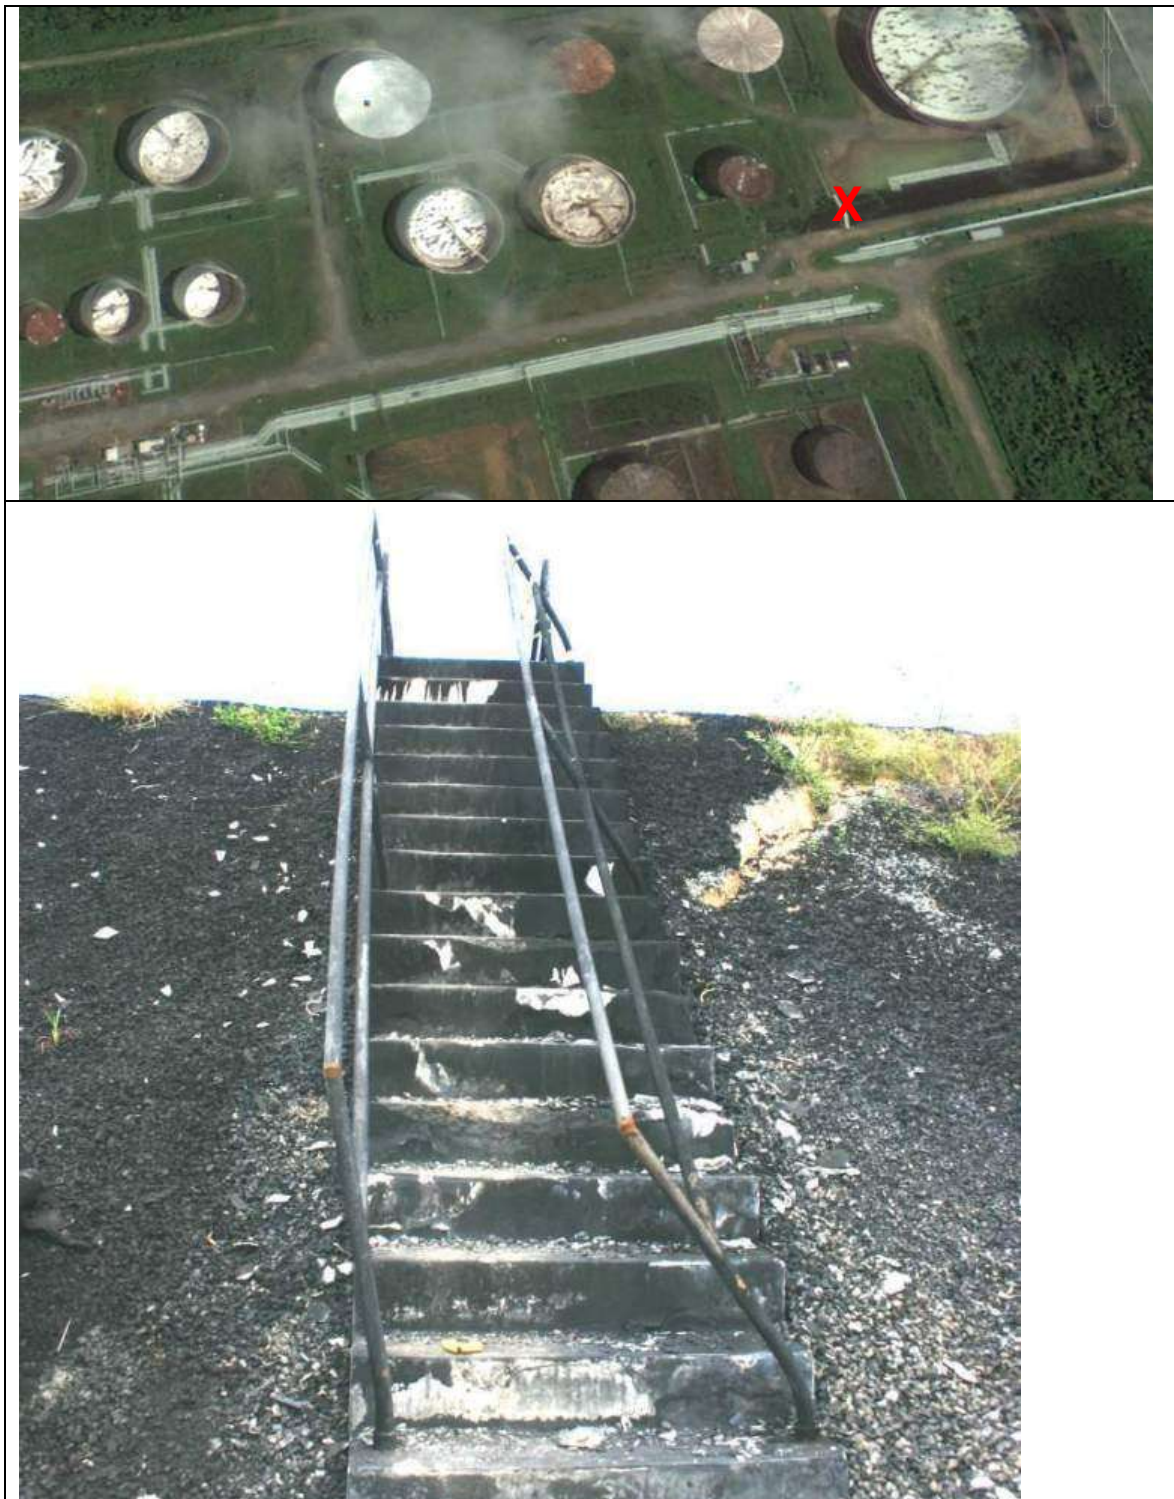
Figure 113: Deformed handrail indicating high overpressures (marked as No. 7 in Figure 106)

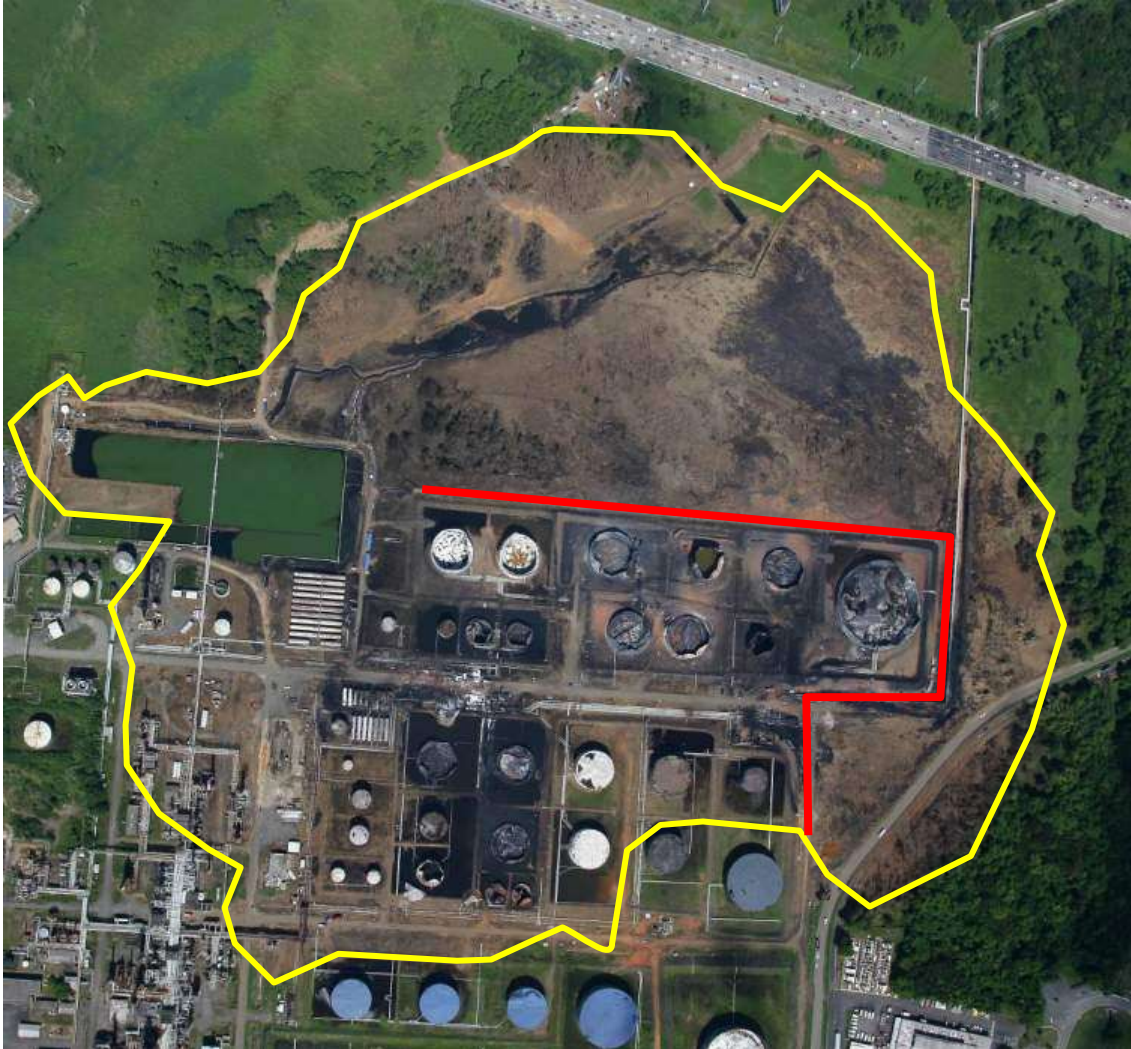
Figure 114: Sections of CAPECO Boundary fence damaged by explosion

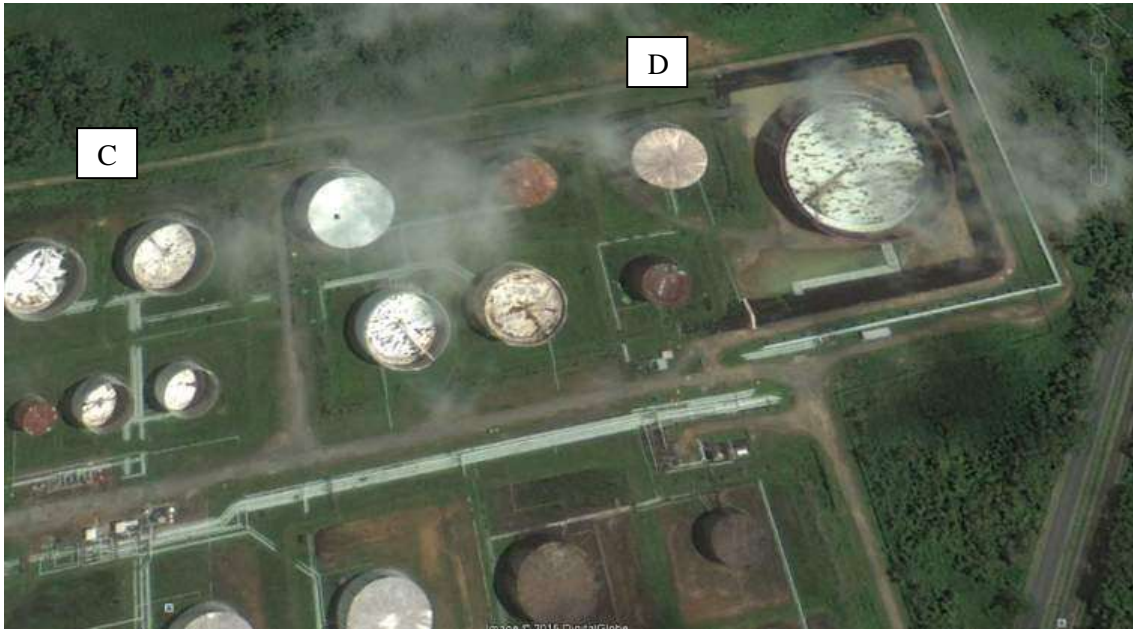
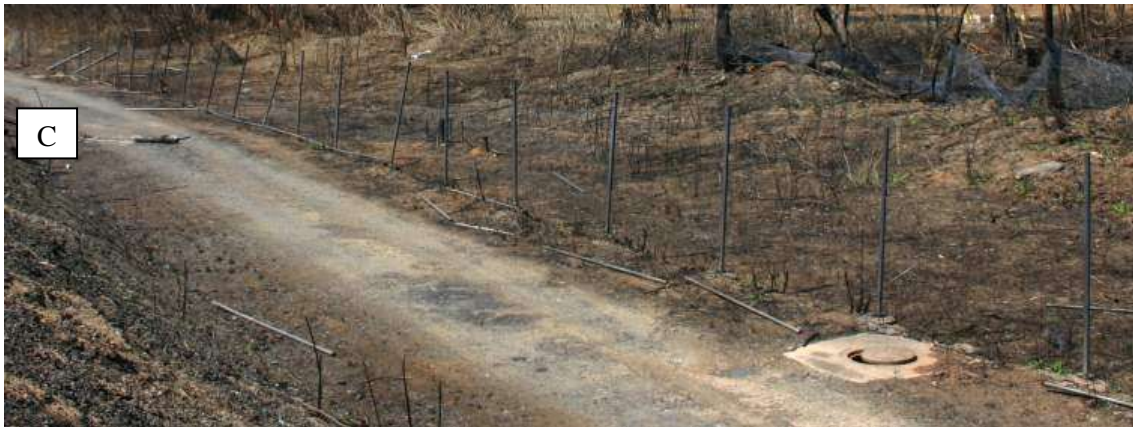
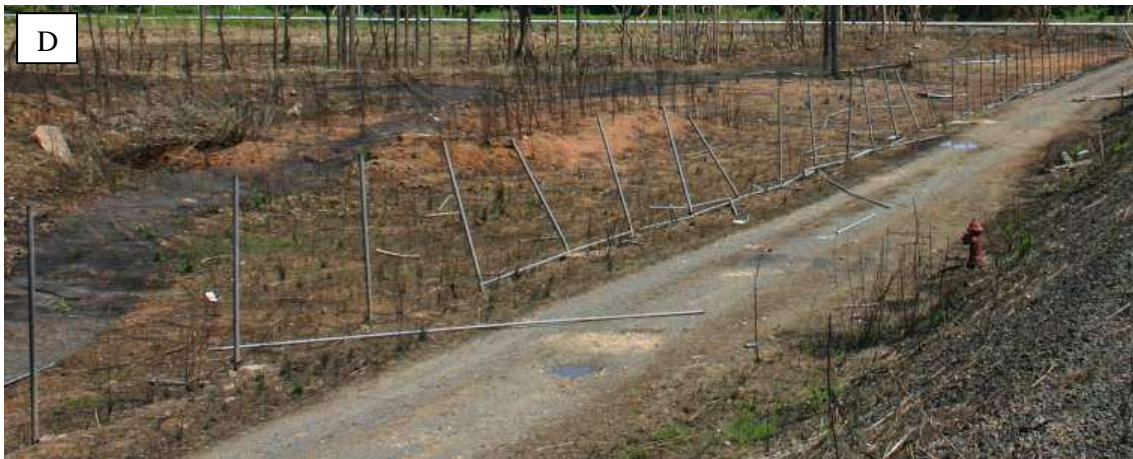
Figure 116: Section of boundary fence

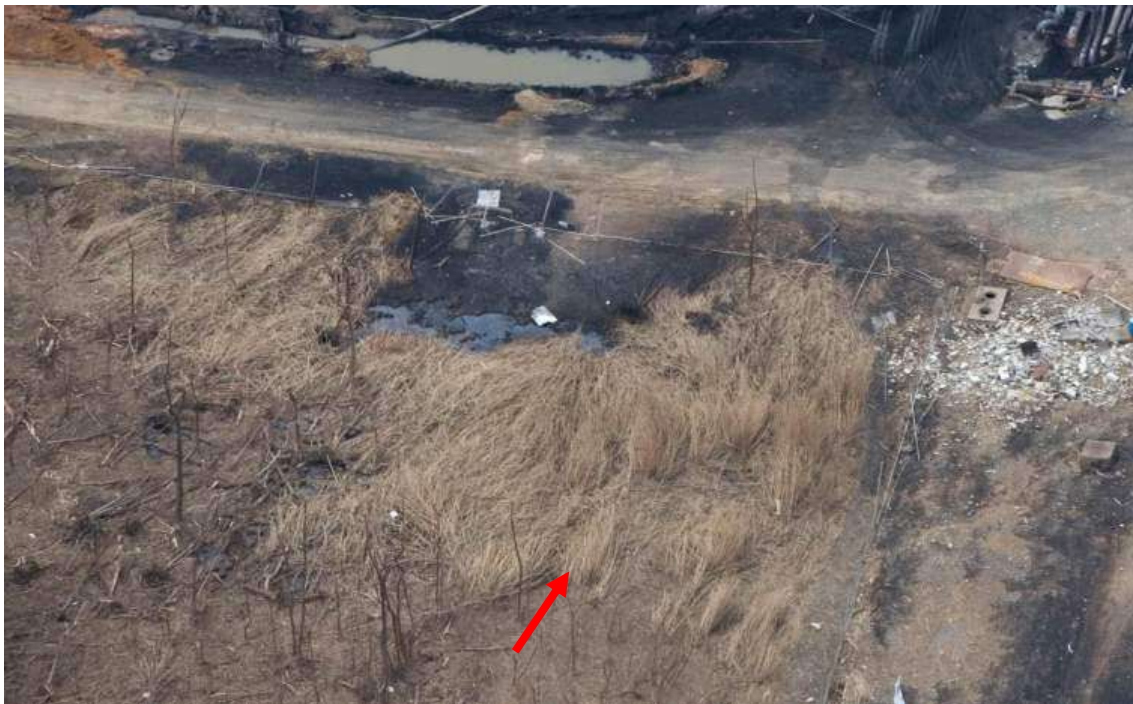
Figure 117: Directional tree and post fall near the E edge of the site

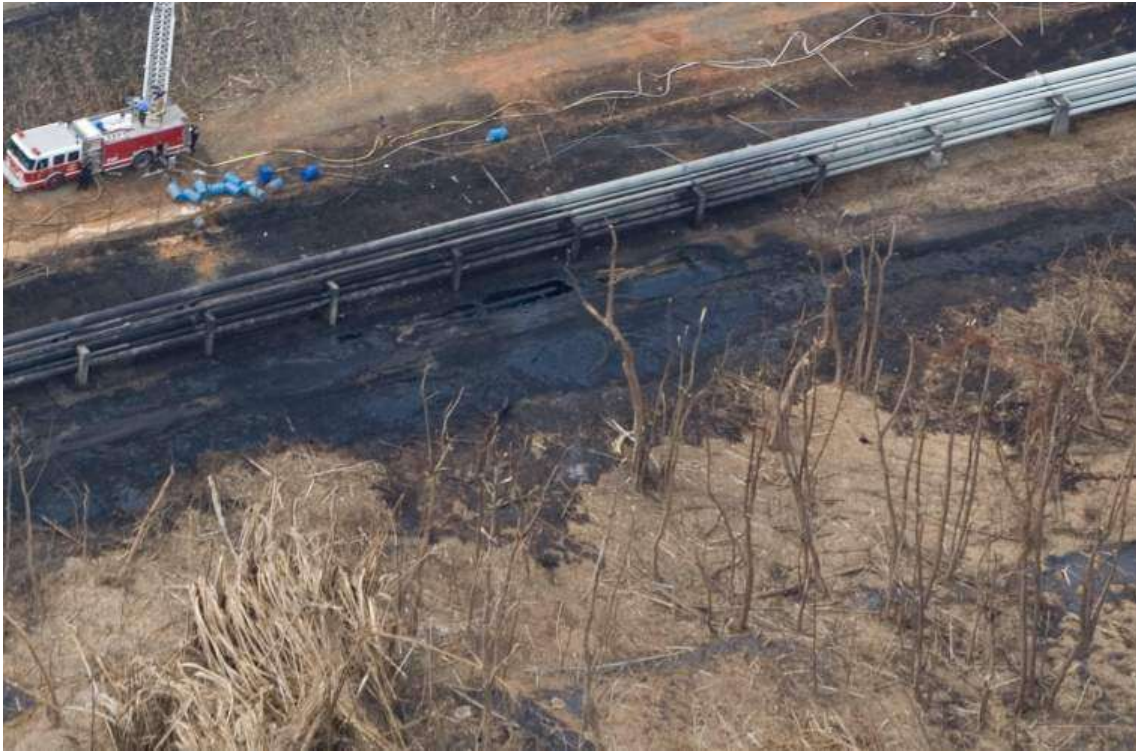
Figure 118: Tree damage close to the NE corner of the site

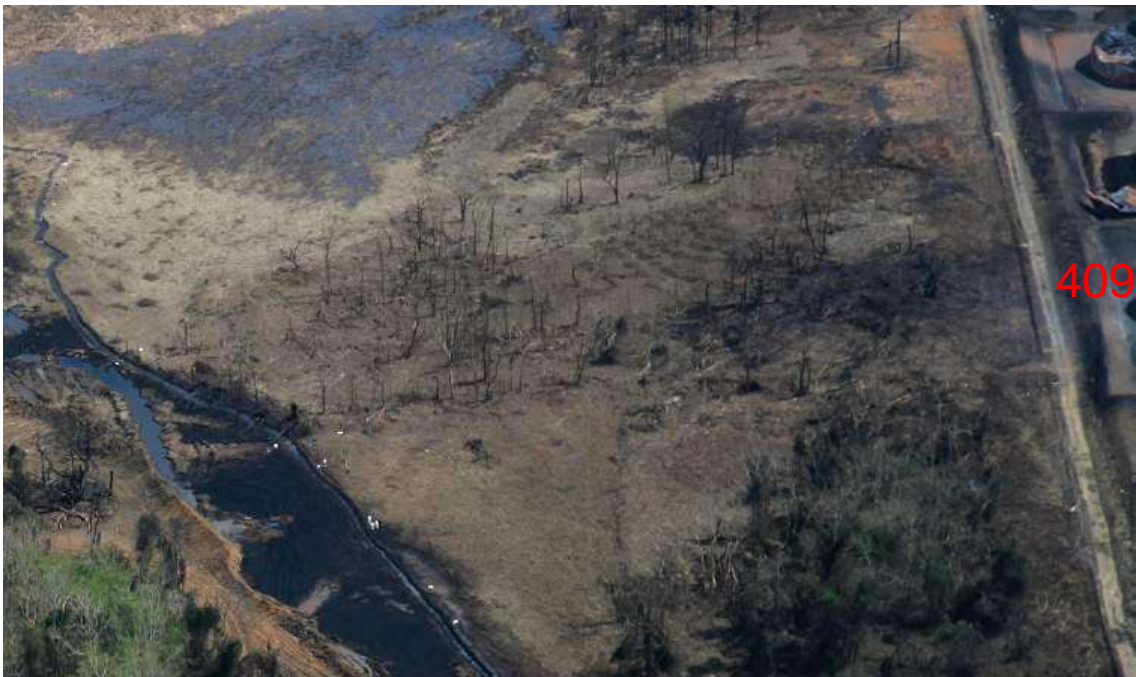
Figure 119: Tree damage in the wetlands to the N of the site – evidence of high pressure damage in burned area, except in the area in the bottom right corner

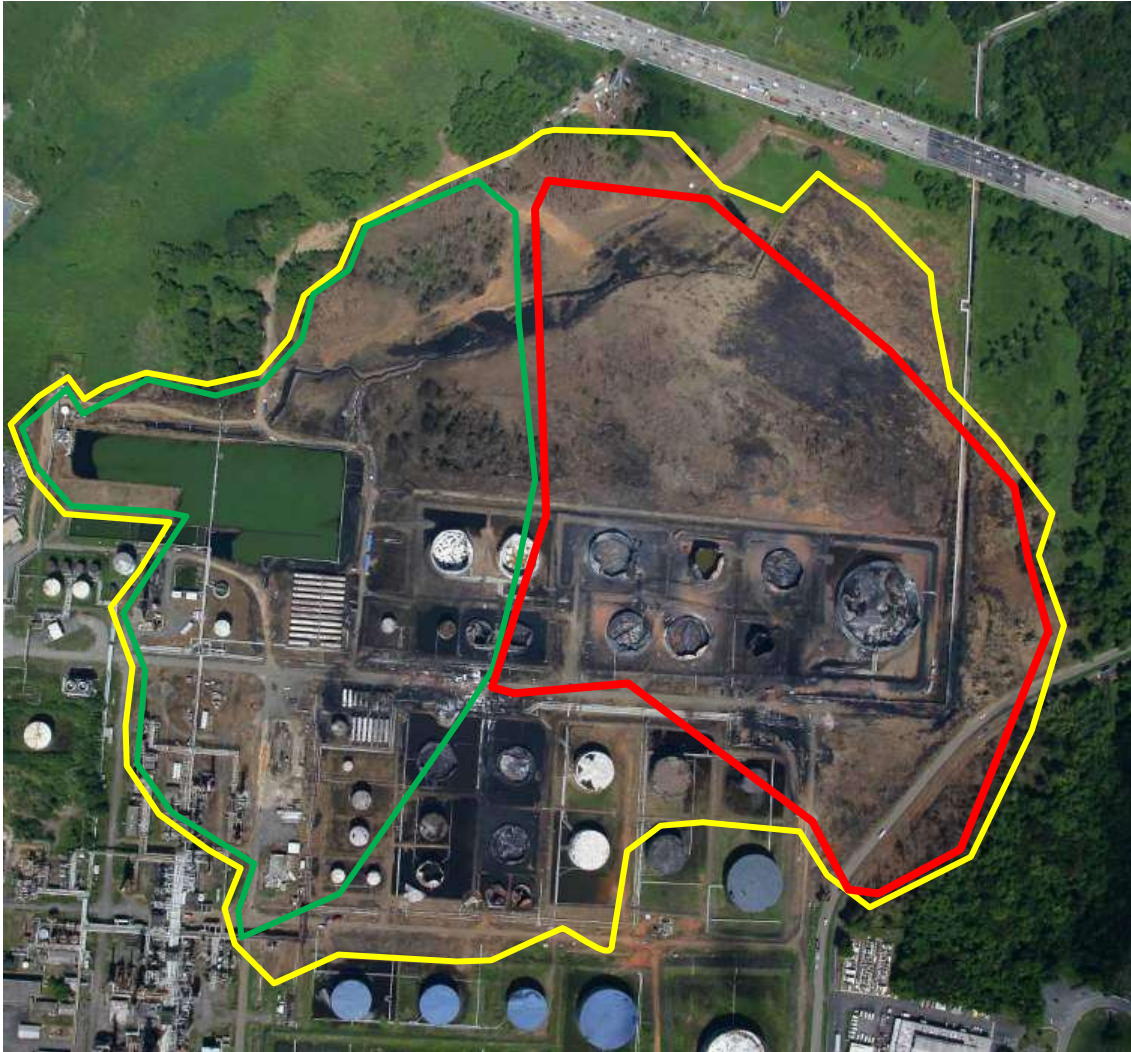
Figure 120: Approximate area apparently affected by low pressure (green) and high pressure (red). The remainder is not known or mixed.

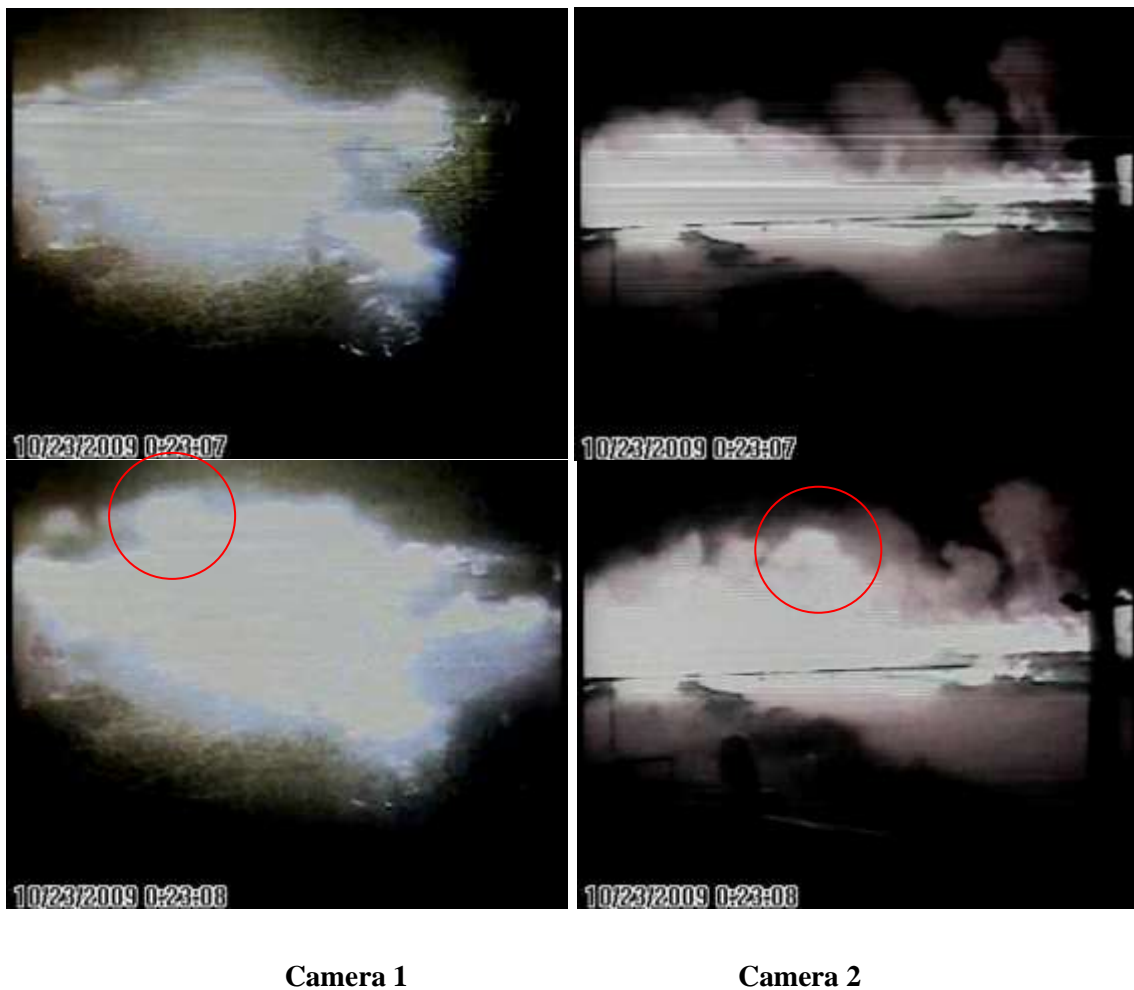
Figure 133: First highly emissive event – as time code changes to 23:08

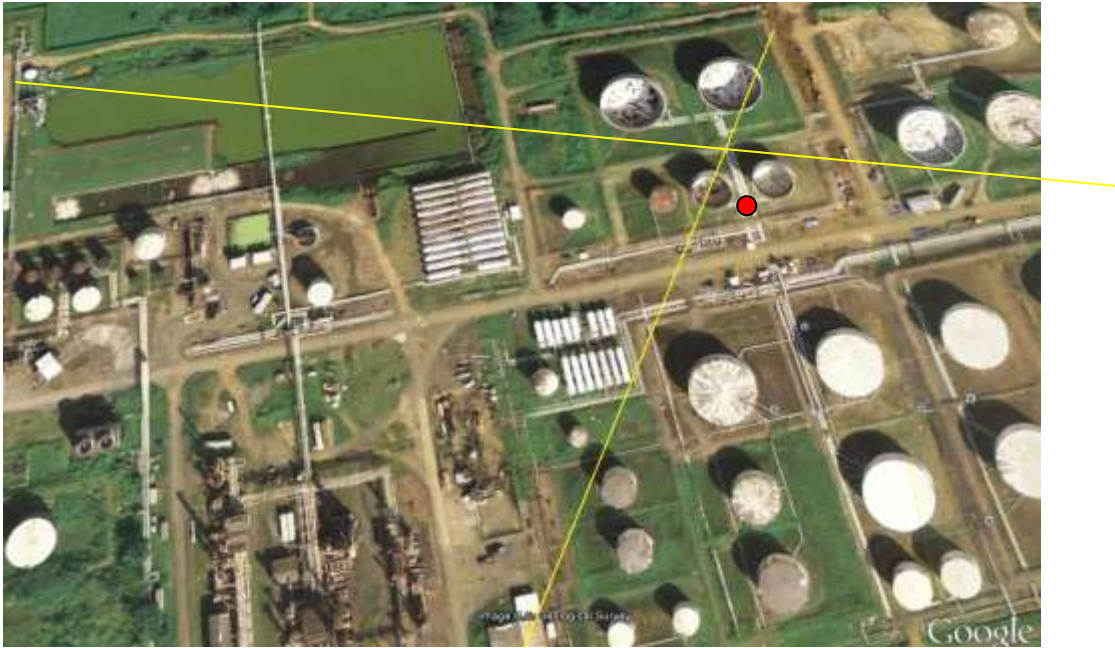
Figure 135: Triangulation for the first emissive event – transition marked with red dot

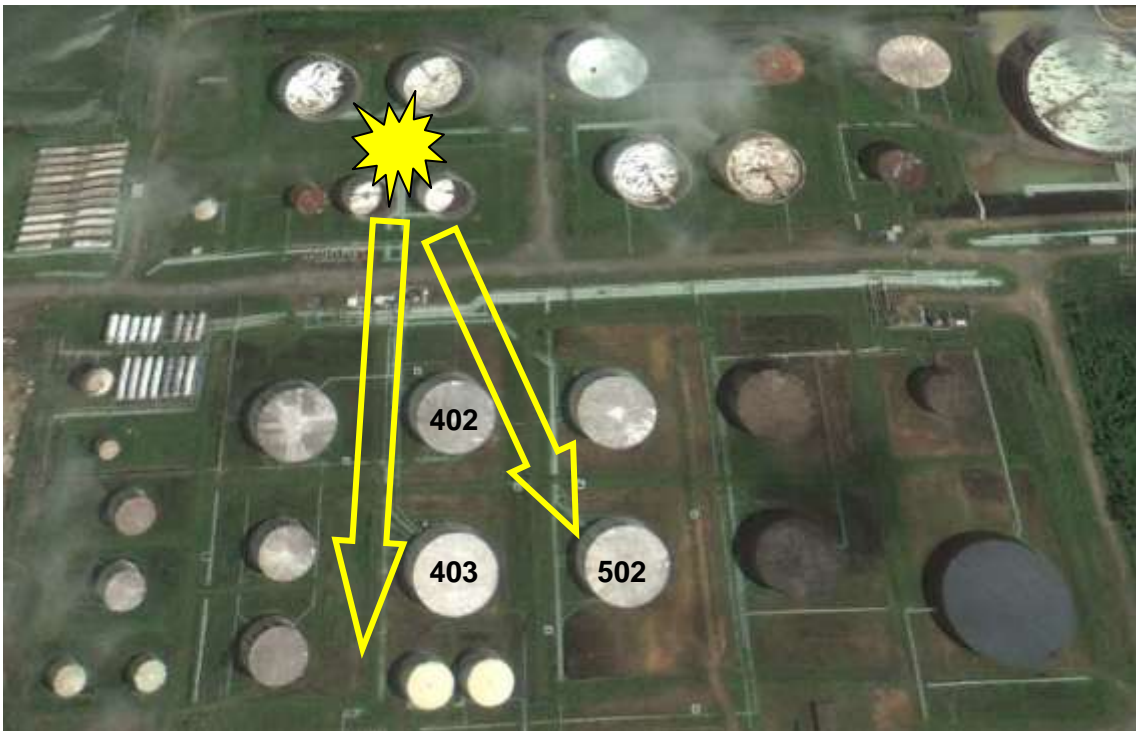
Figure 136: Areas of the cloud that were lit by the first emissive event (compare with Figure 134 - lower image)

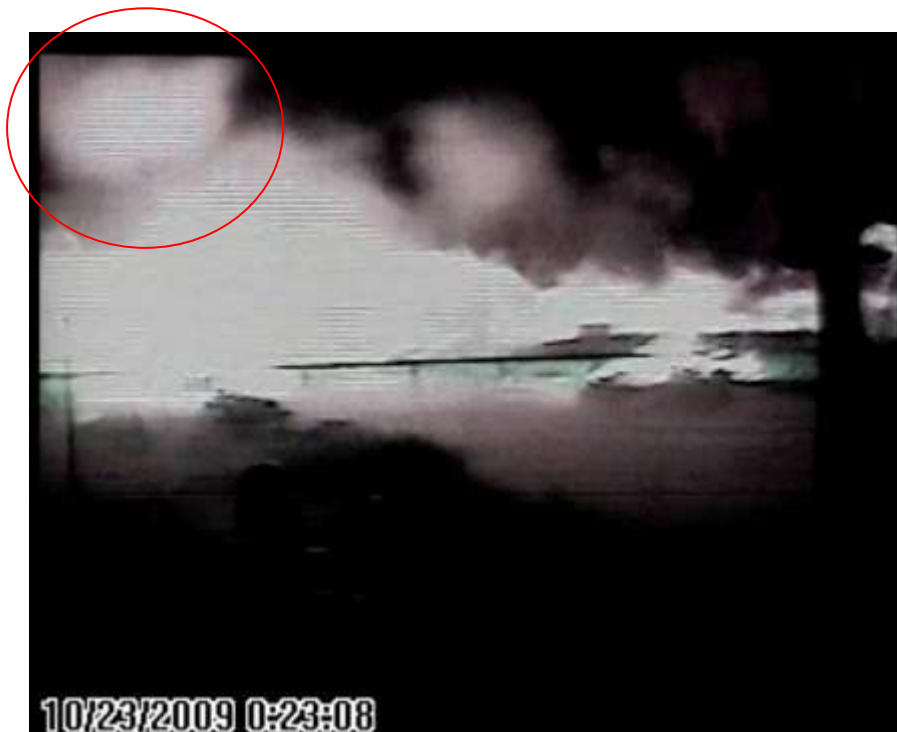
Figure 137: Explosion in the deep part of the cloud to the north of Tank 409

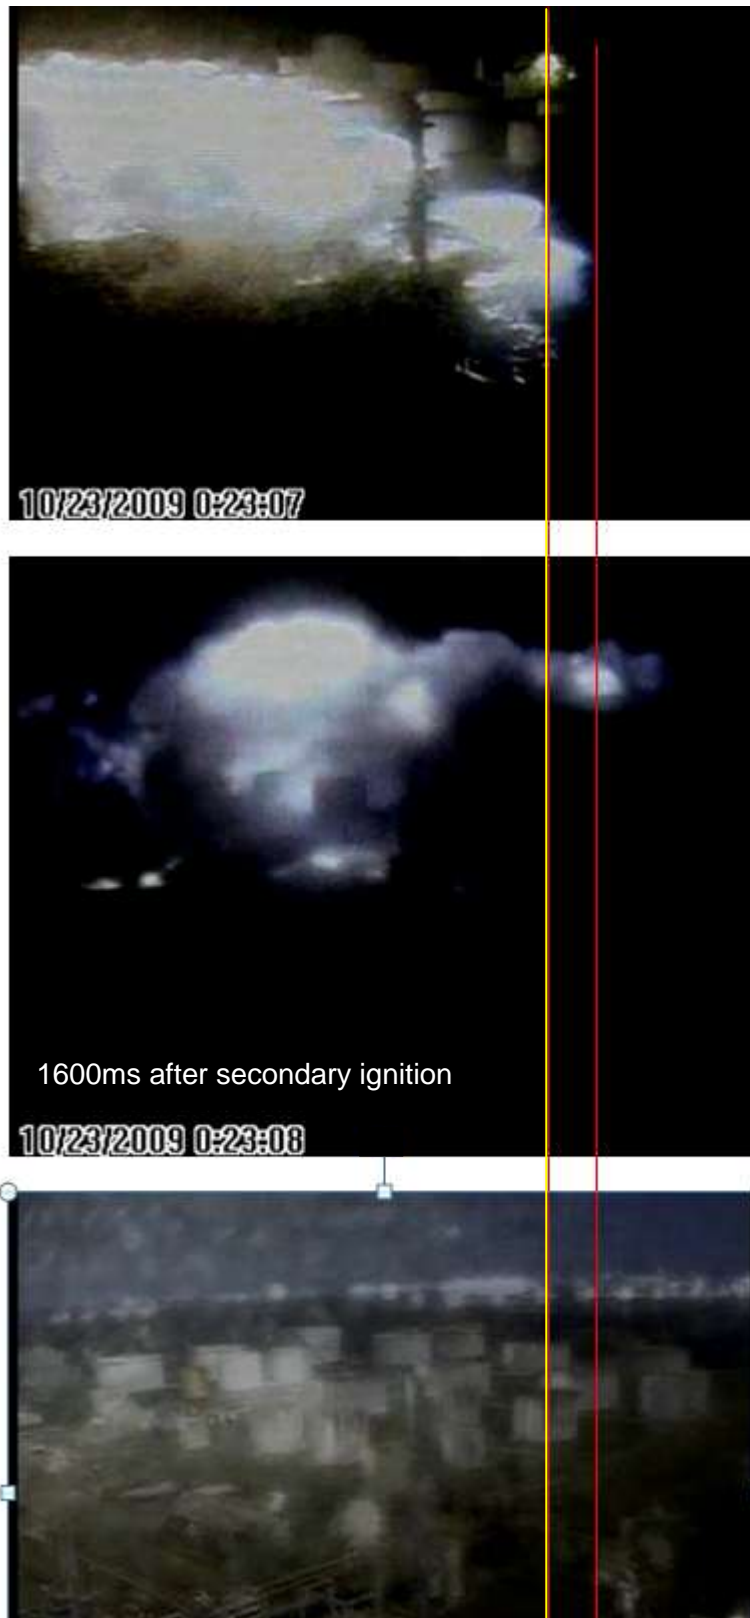
Figure 142: Locations secondary ignition (top) and illuminated debris plume(s) at the East end of “D” Street (centre). Day view (below)
