Harpur Hill, Buxton
Derbyshire, SK17 9JN
T: +44 (0)1298 218000
F: +44 (0)1298 218590
W: www.hsl.gov.uk

Review of Vapor Cloud Explosion Incidents

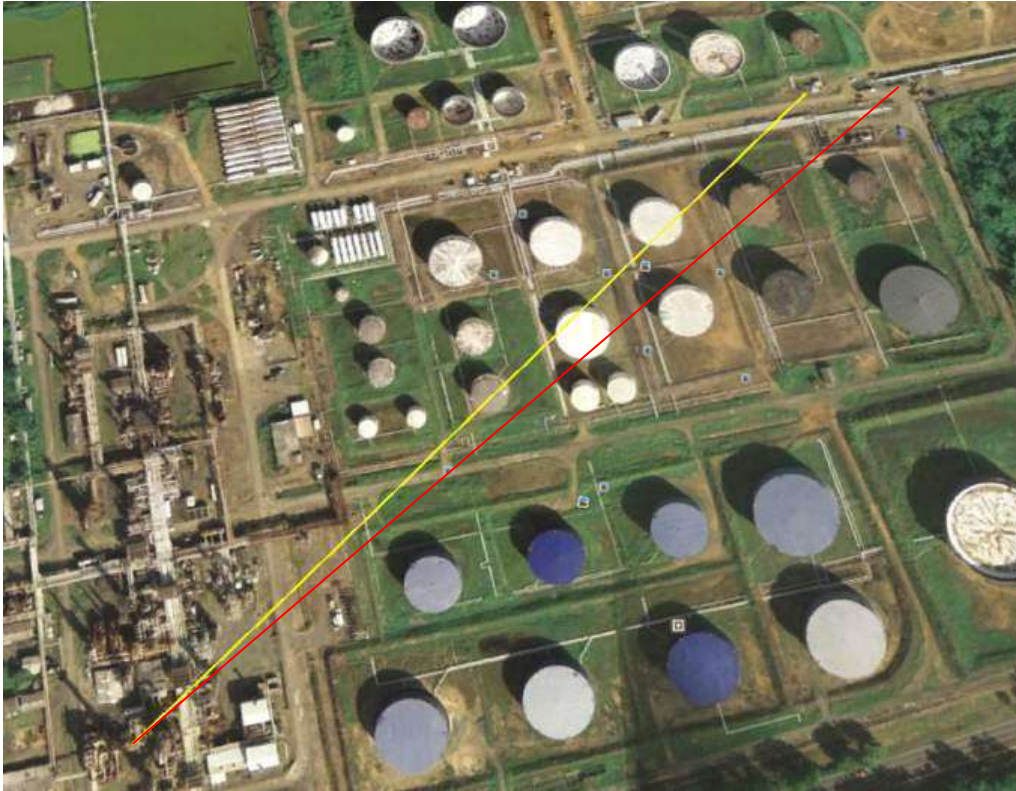
Figure 143: Satellite view showing directions indicated in Figure 142

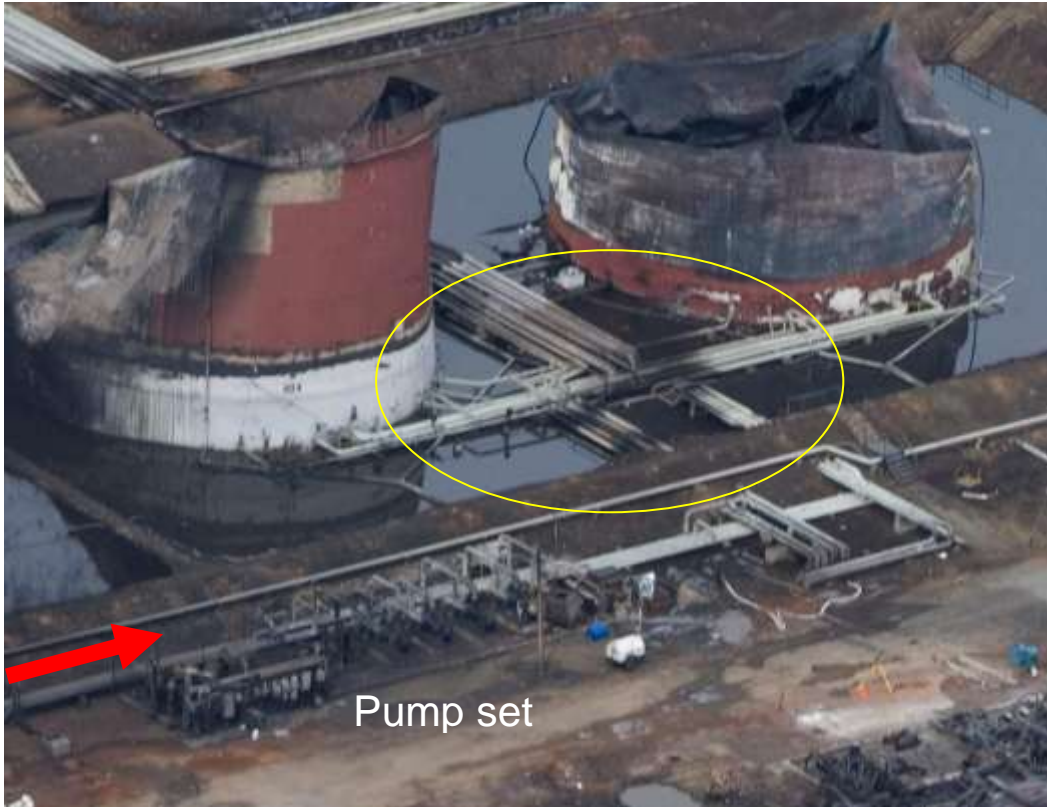
Figure 144: Area where transition to a severe explosion occurred (yellow circle). Arrow indicates direction of explosion approach.

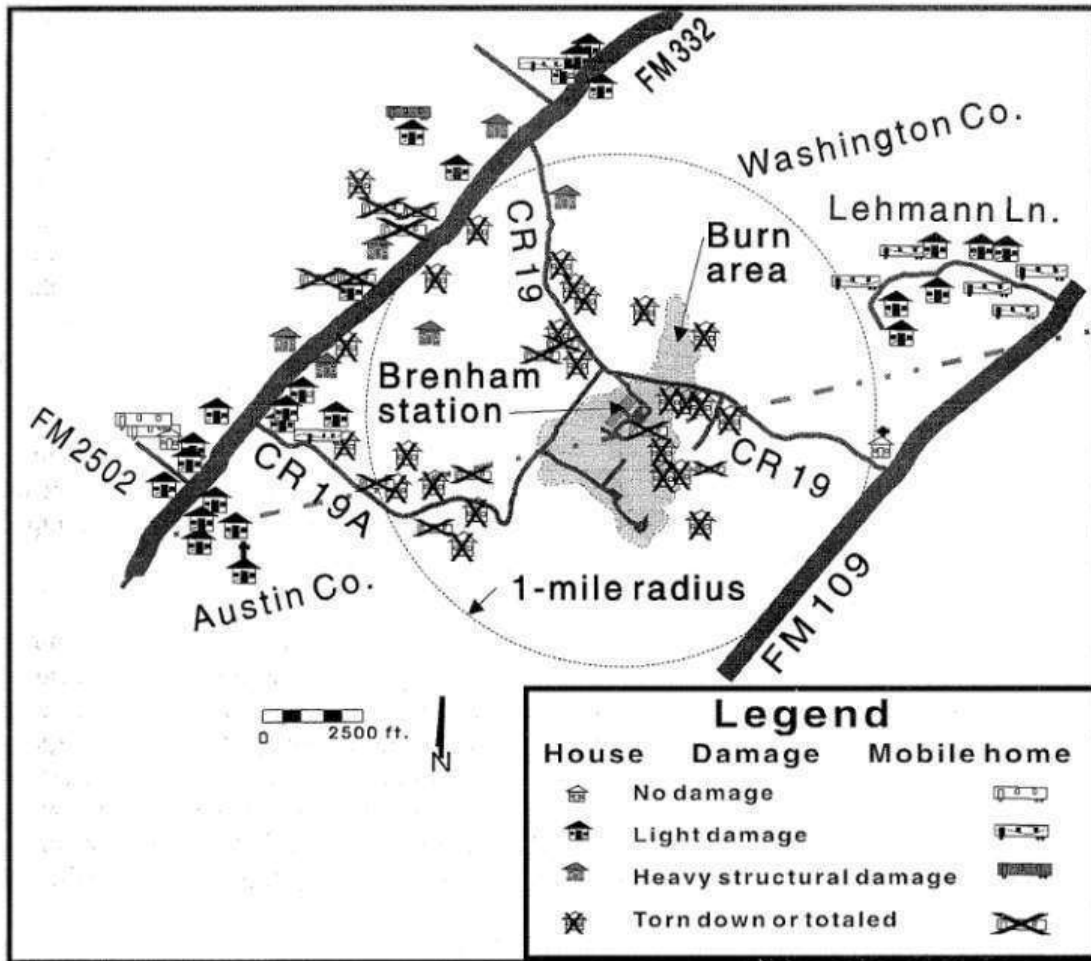
Figure 147: Building damage around the site

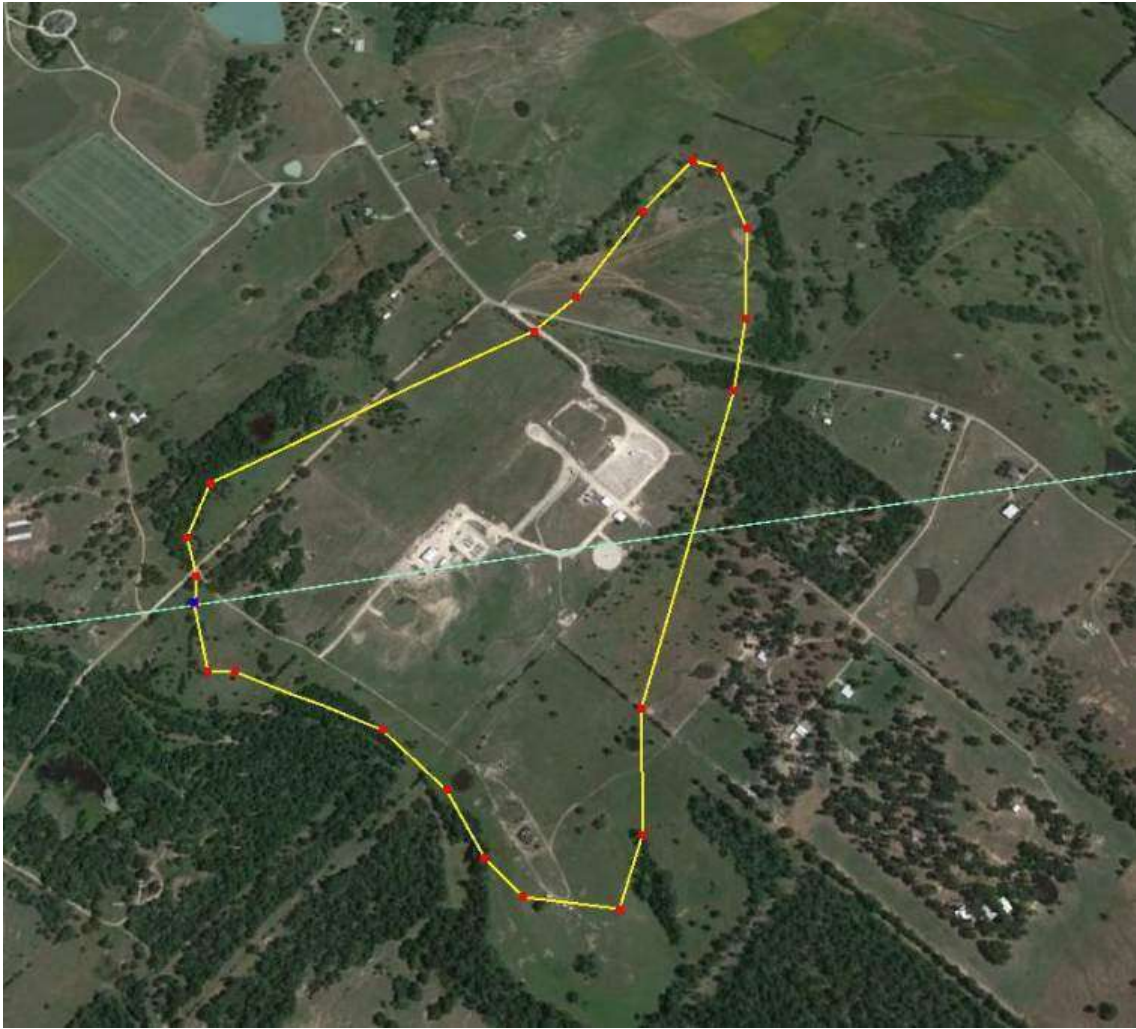
Figure 148: Approximate area covered by cloud (Area shown 625,000 m²)

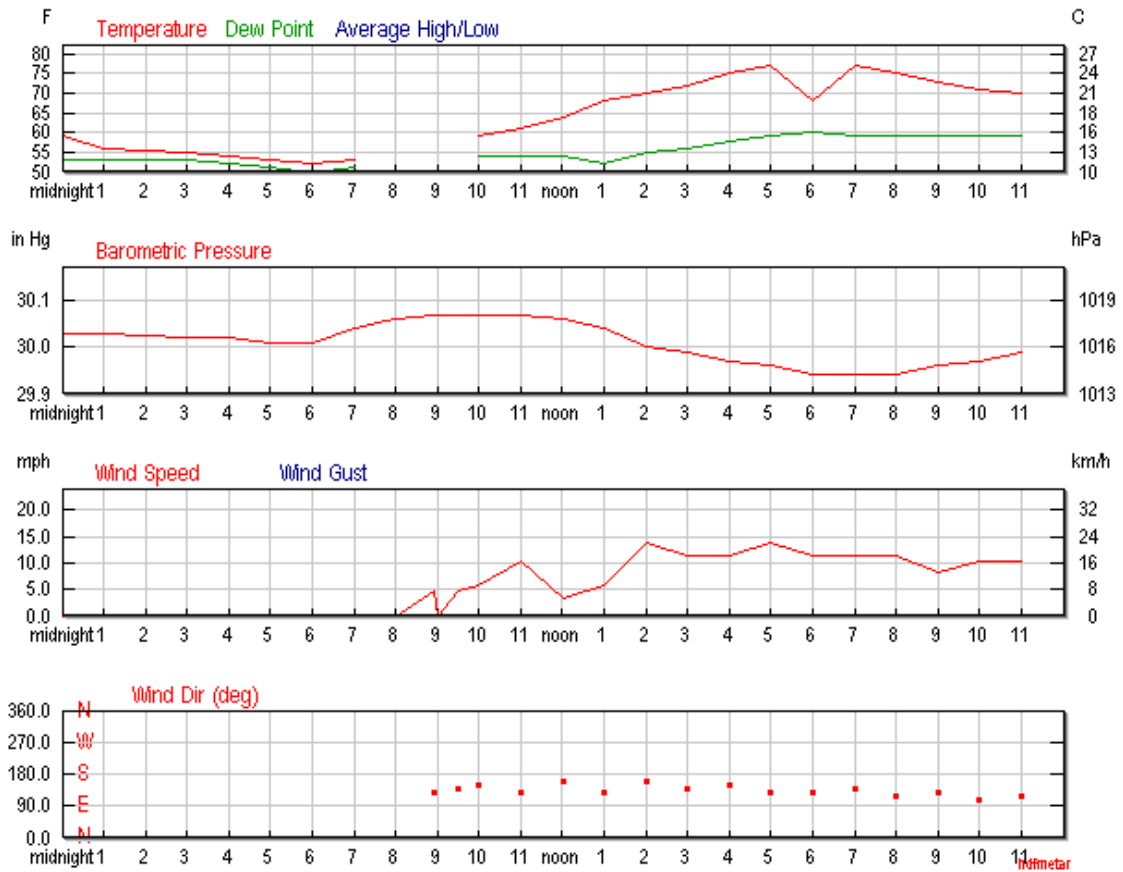
Figure 149: Weather conditions (explosion around 7:00 am)

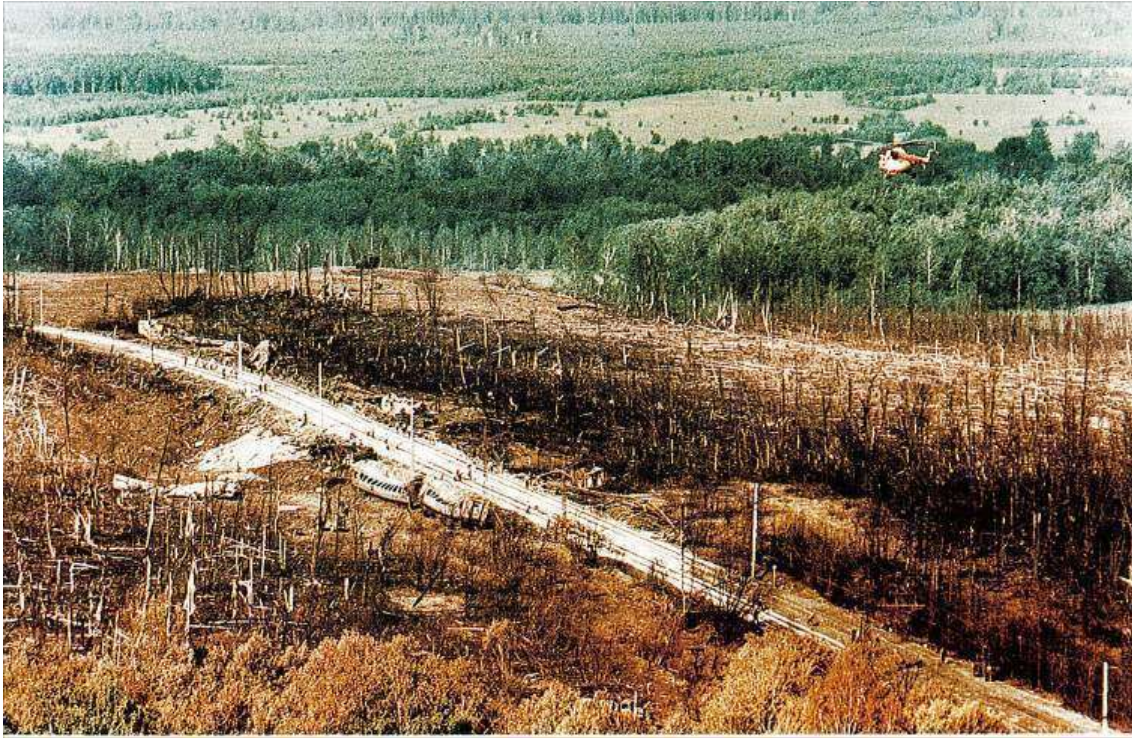
Figure 150: Part of the Ufa blast site

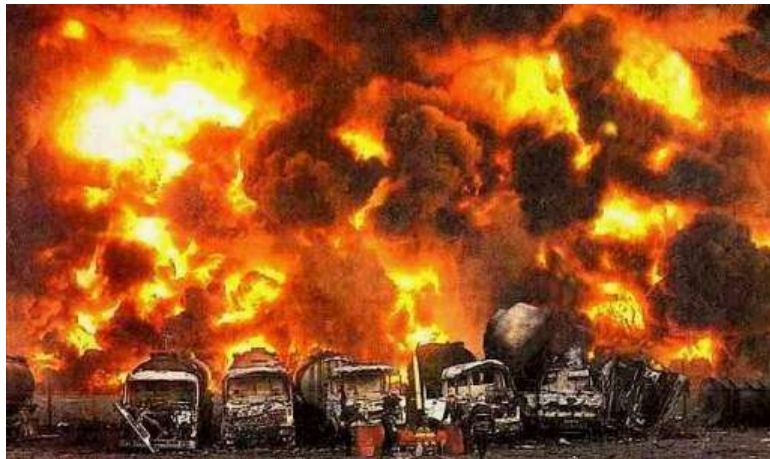
Figure 152: Line of blast damaged tankers within the cloud area

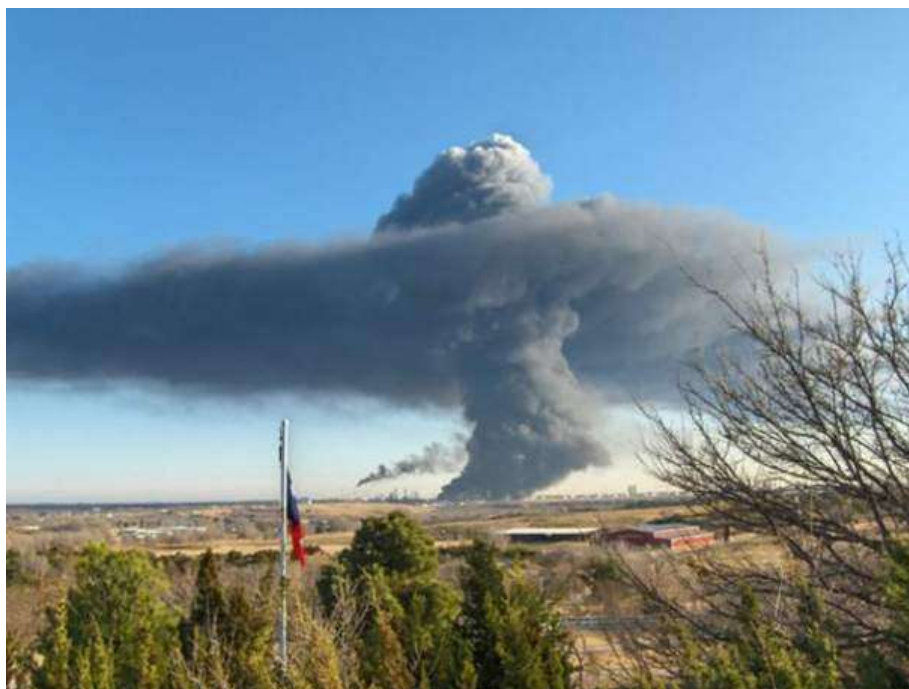
Figure 155: High level inversion. There was also a ground level inversion during the leak

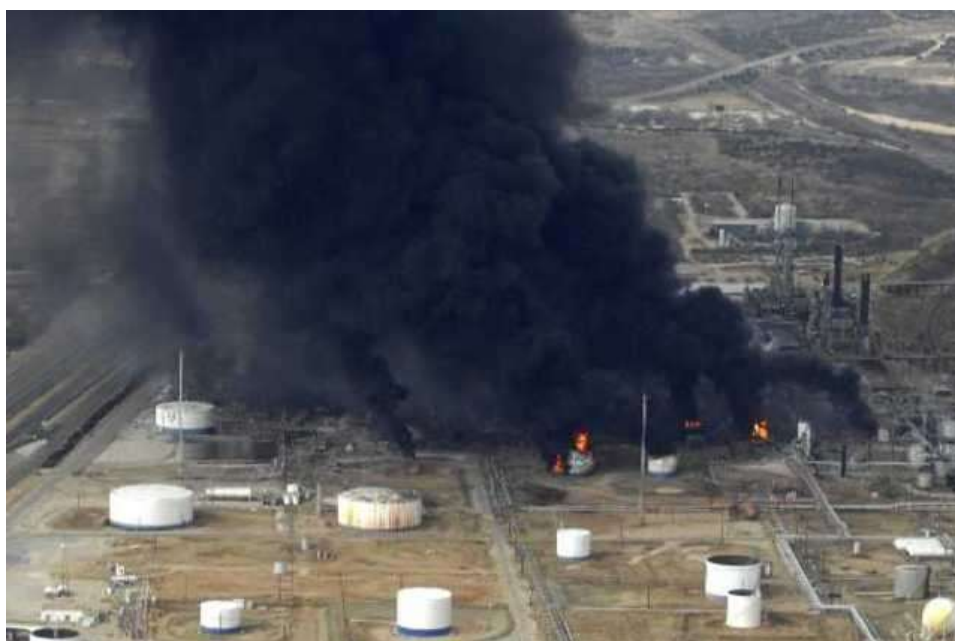
Figure 156: Overview of site giving some idea of the area affected by the cloud

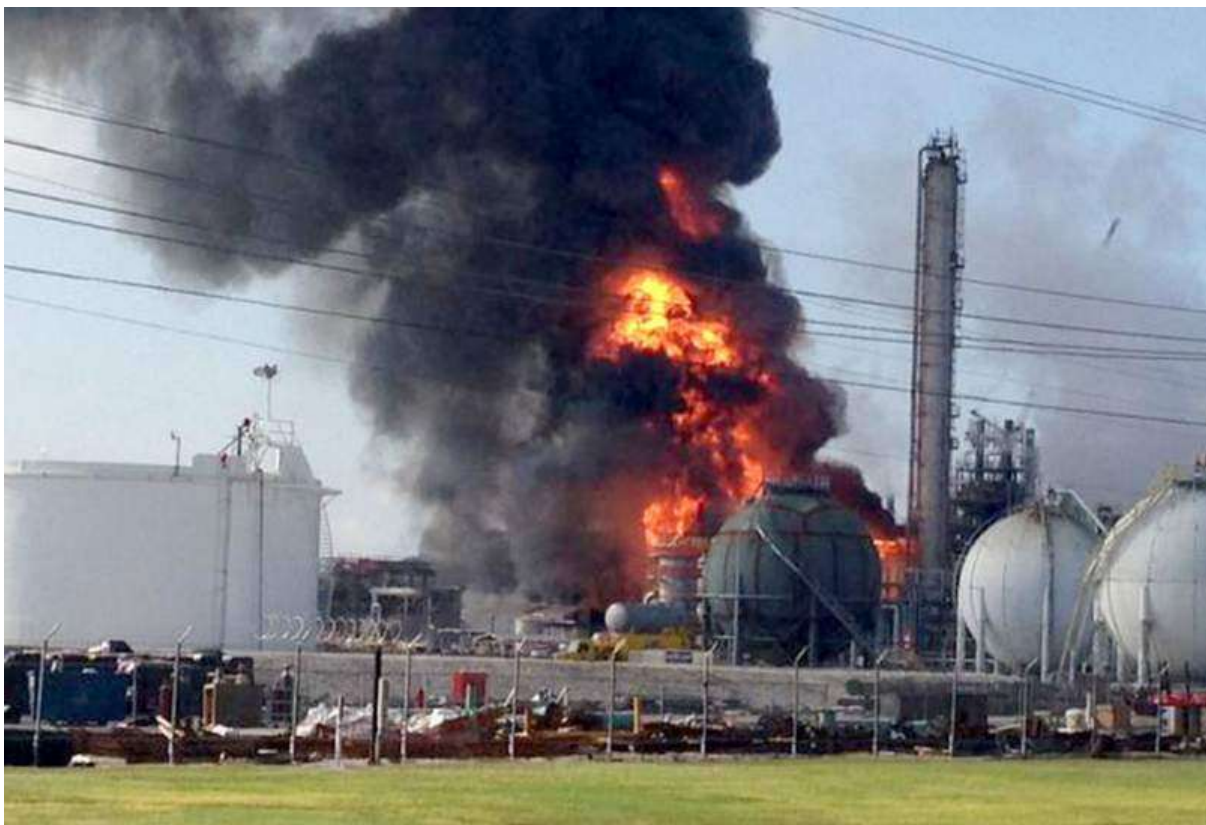
Figure 160: Fire following explosion

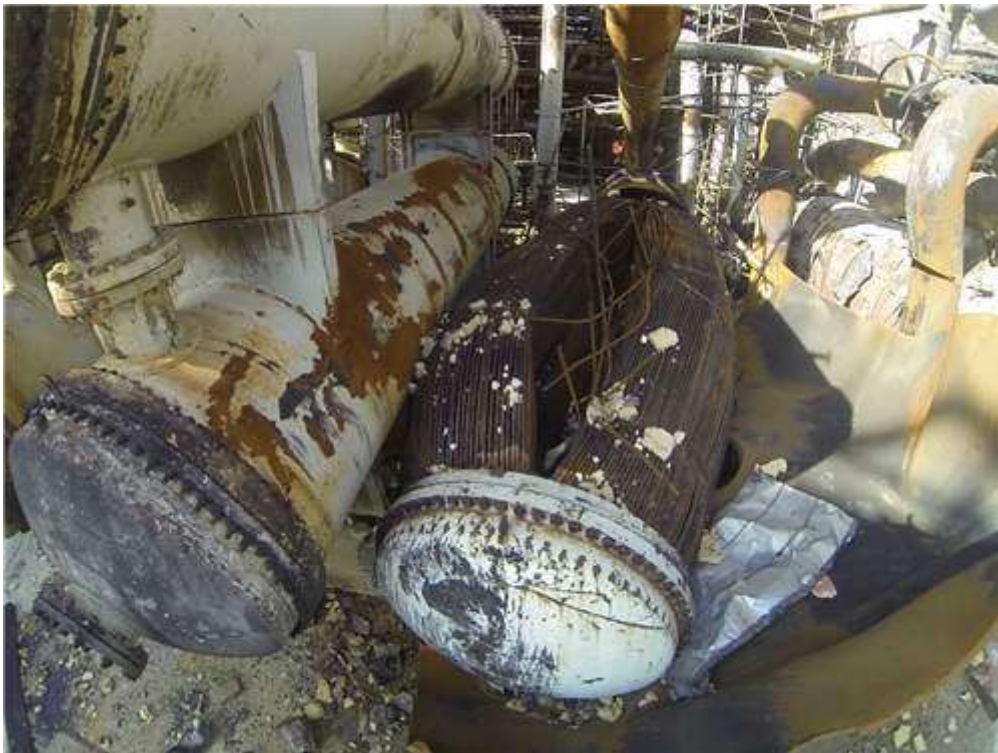
Figure 162: Post blast photo of the heat exchanger which ruptured catastrophically

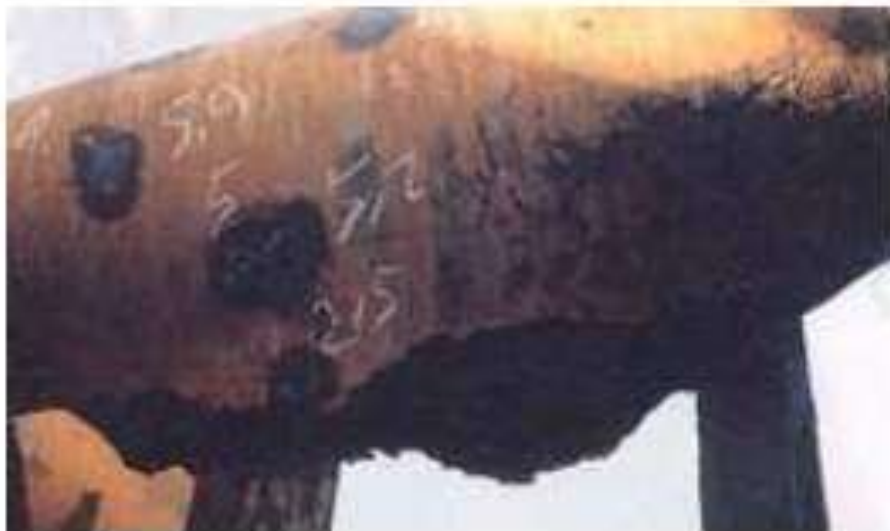
Figure 166: Crack in 8” bypass line

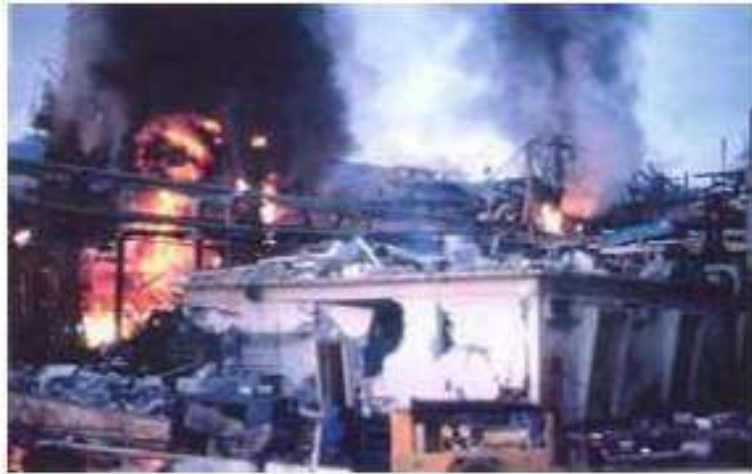
Figure 4 - Vue sur la salle de contrôle à 09h00

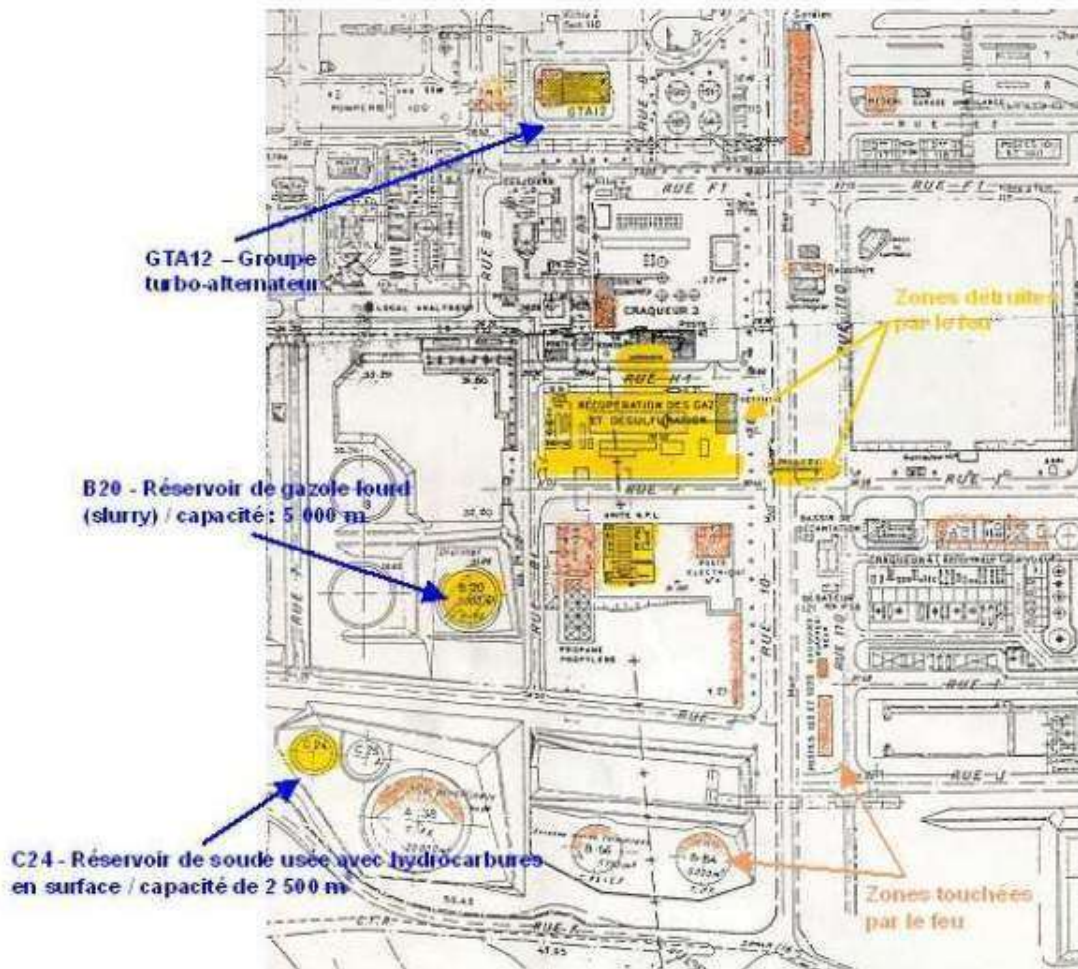
Figure 7 - Illustration des zones sinistrées

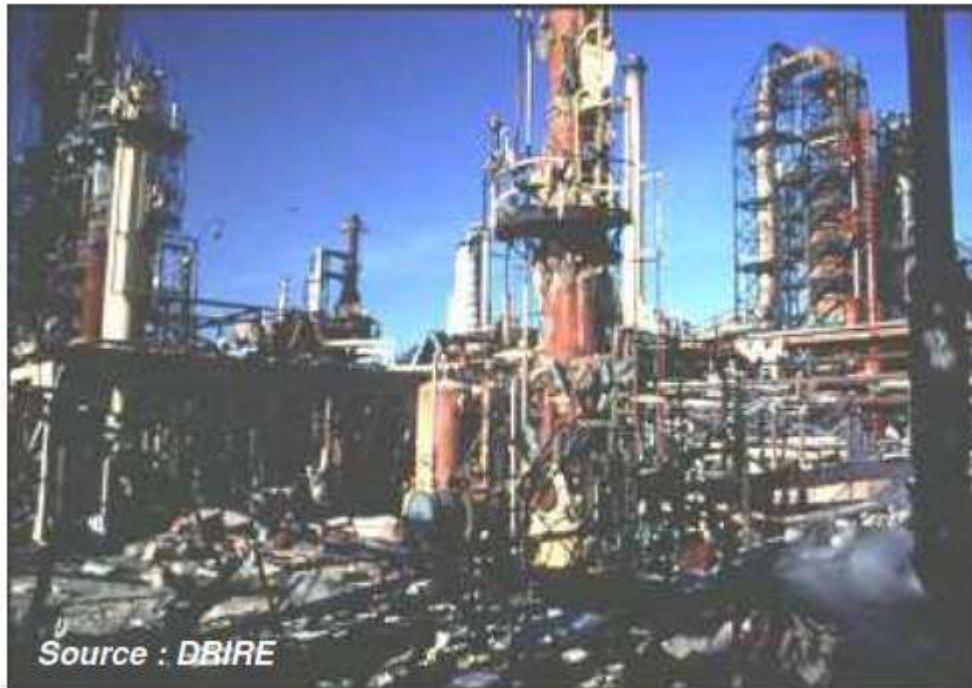
Figure 8 - Installations détruites par l'explosion

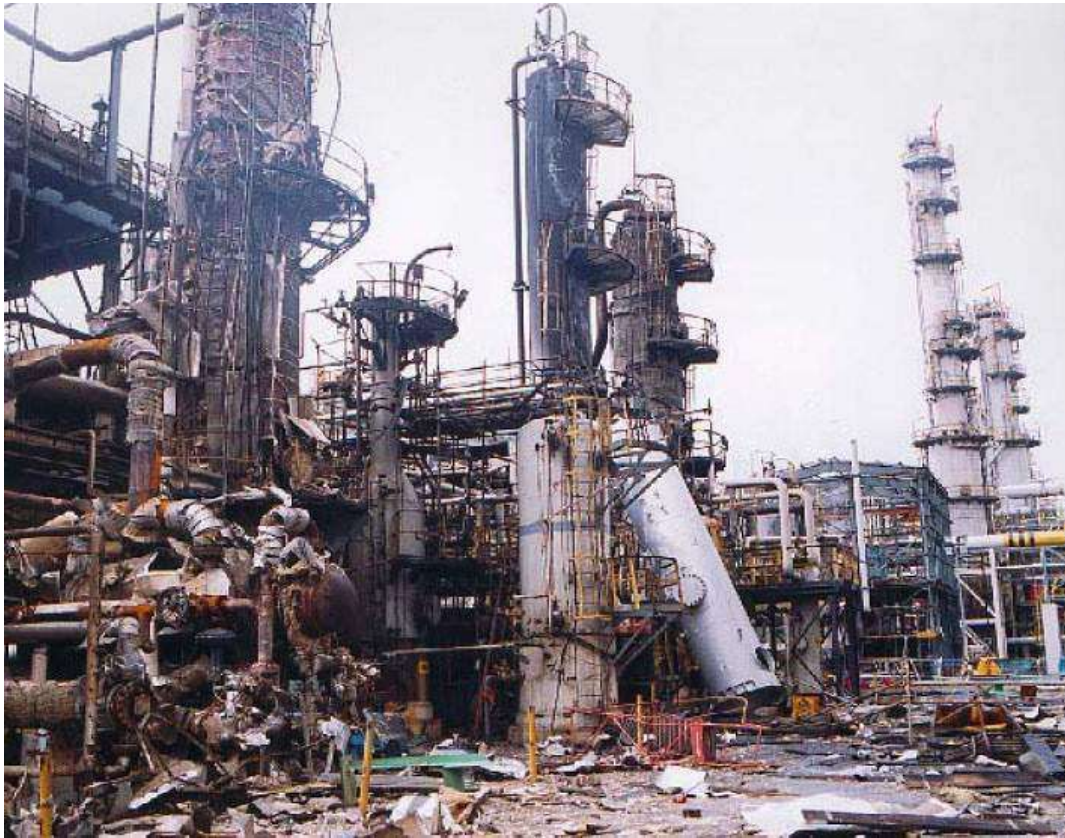
Figure 173: Explosion damage

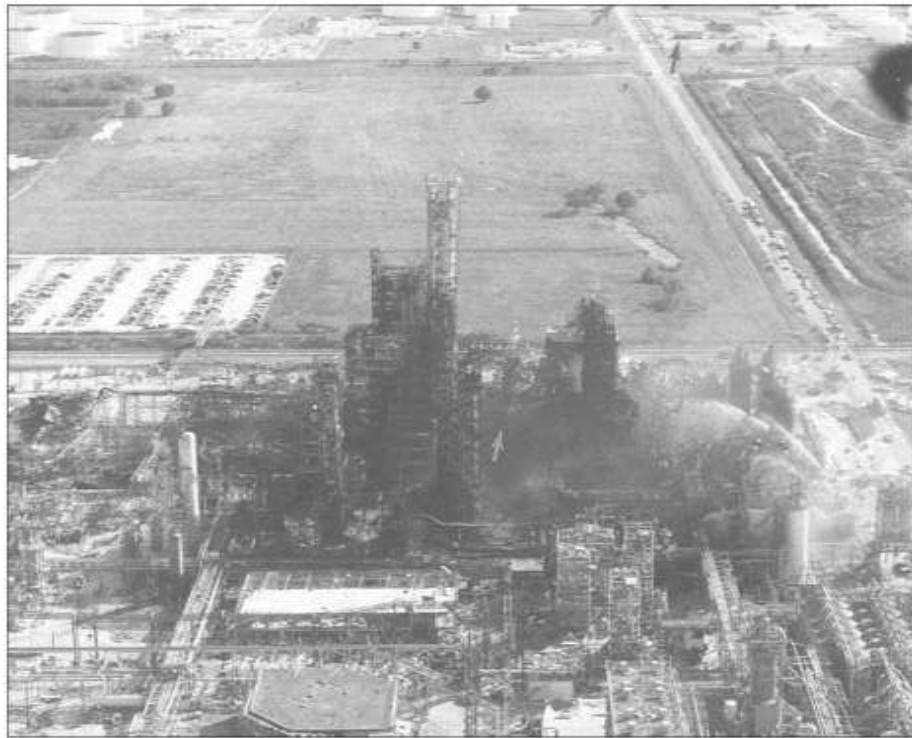
2. Aerial photo of complex as seen from north to south. Arrow at top points to the north edge of the staging area for responding mutual aid equipment. Arrow pointing to building shows where GATX terminal Chief Goyer was located when blast occurred. Area of origin thought to be near center (arrow).

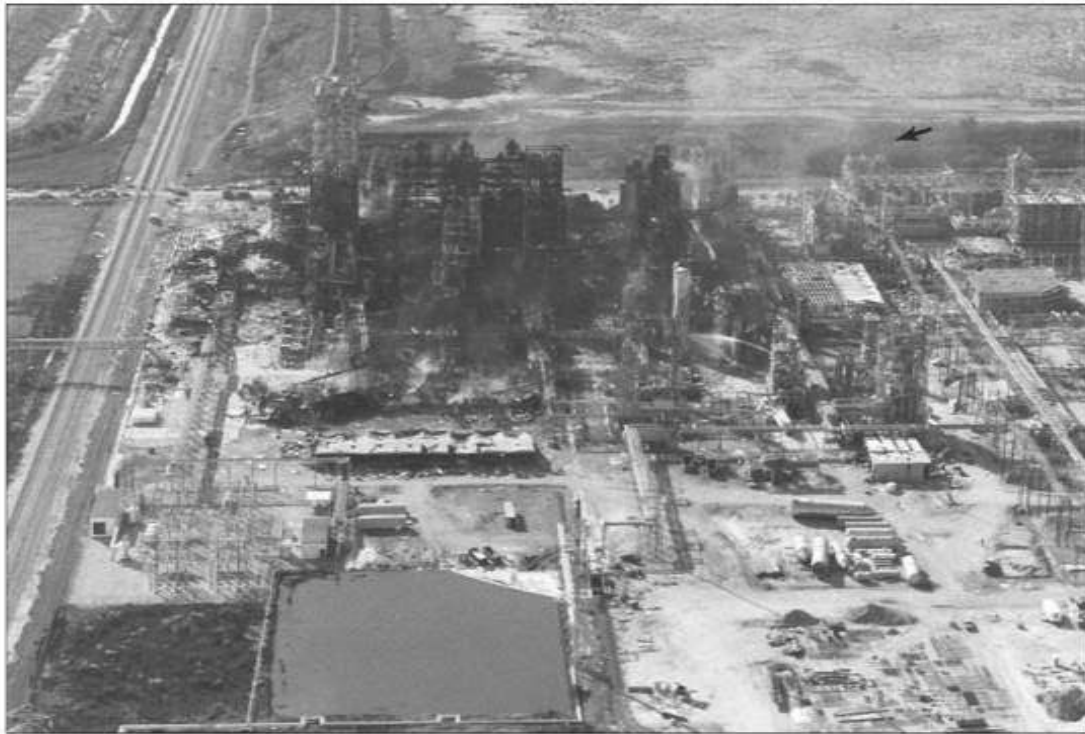
3. Aerial photo of complex as seen from east to west. Arrow points to berm to west of the property. This appears to actually be a bank for a large holding pond but served well as a protective berm.

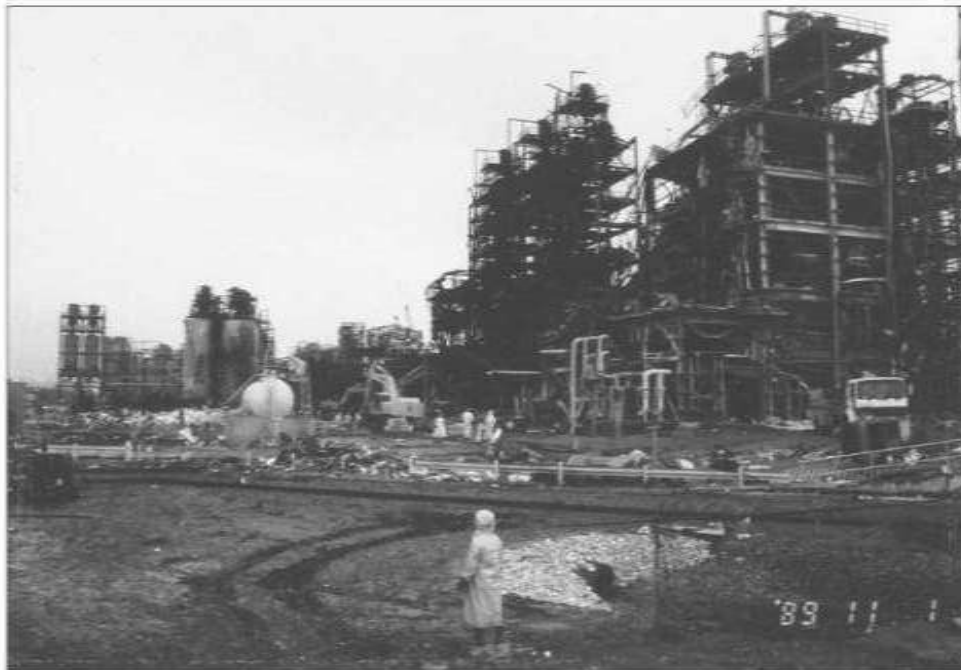
7. View from south to north. Personnel and equipment near structure are working on victim recovery.

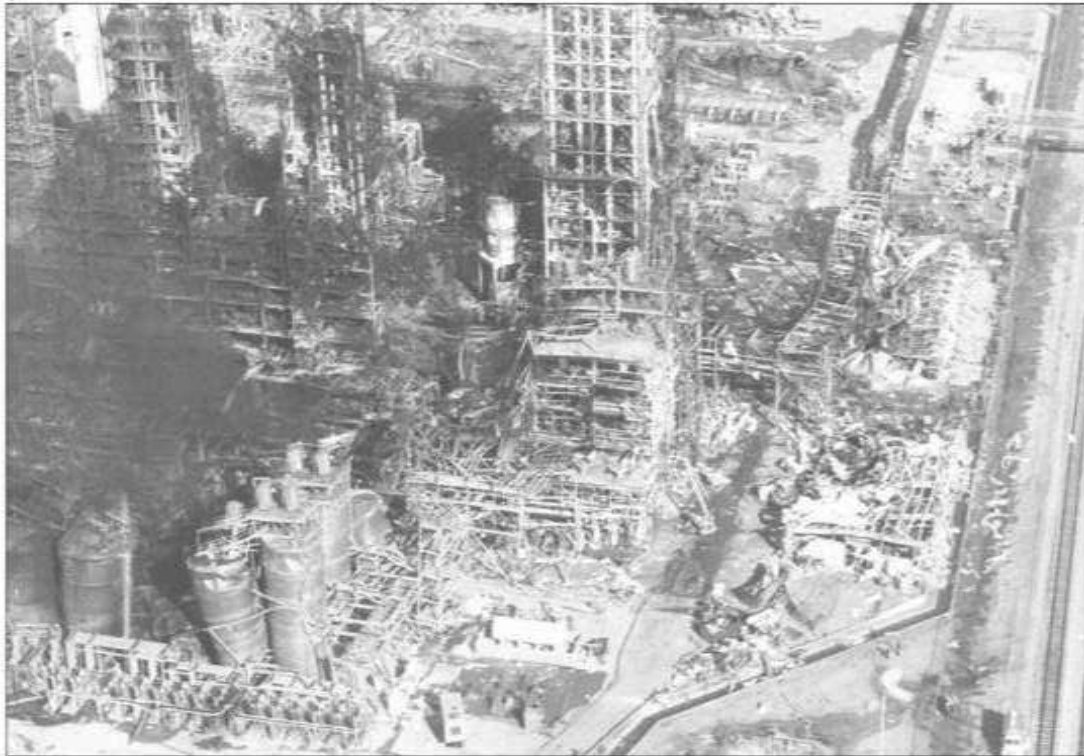
9. View from southwest corner toward north/northeast. Metal fatigue clearly visible in remaining superstructure.

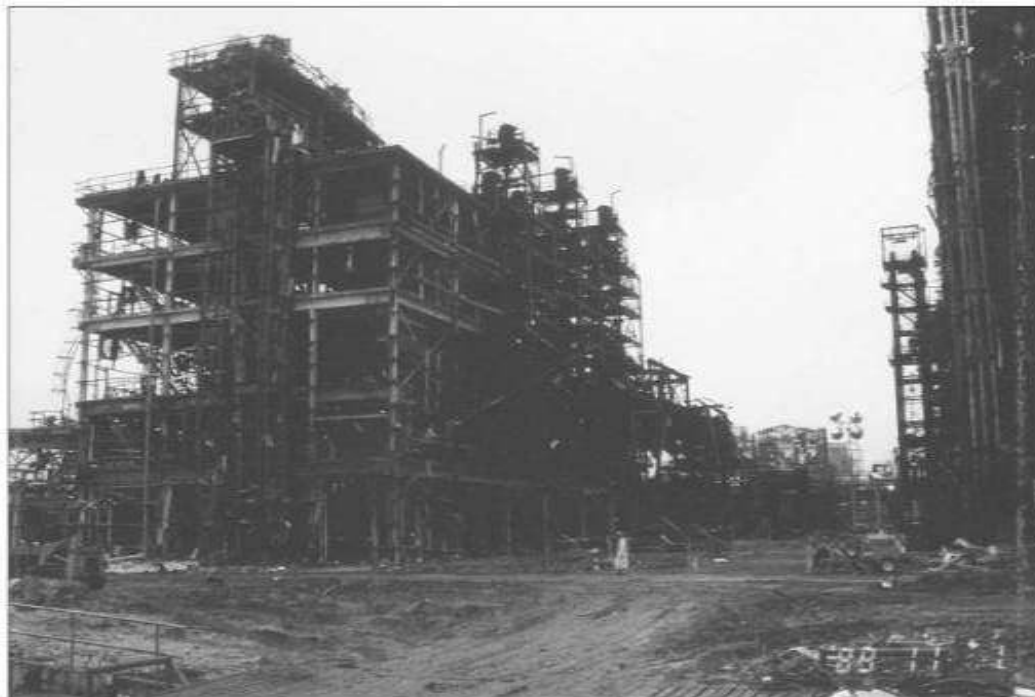
11. View is from south to north. Cleared area is to the west side of the tower. The cleared area in the center was designed in a like manner to the left side of this frame before the explosion.

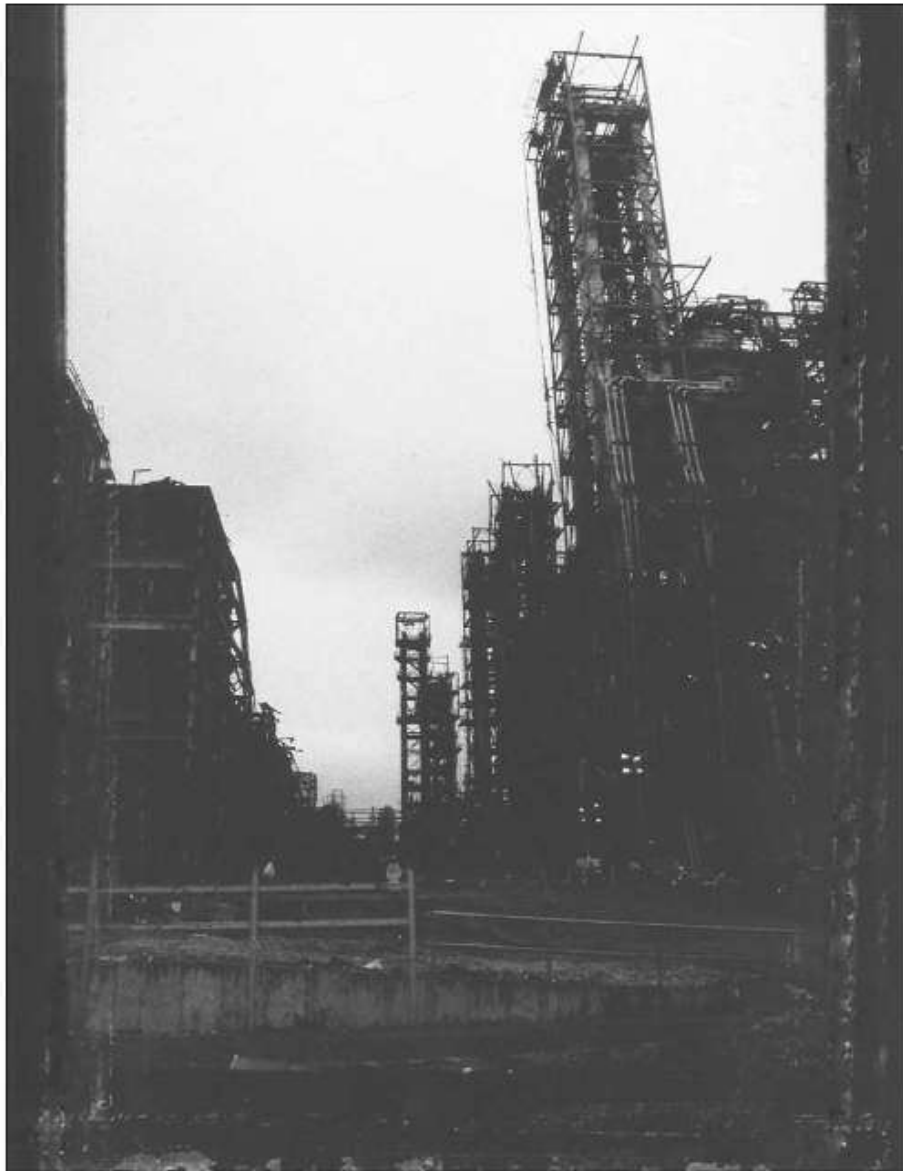
12. View of tower and cleared area from south to north. The tower was listing to the west and north and was reported to be approximately 14 degrees out of plumb.

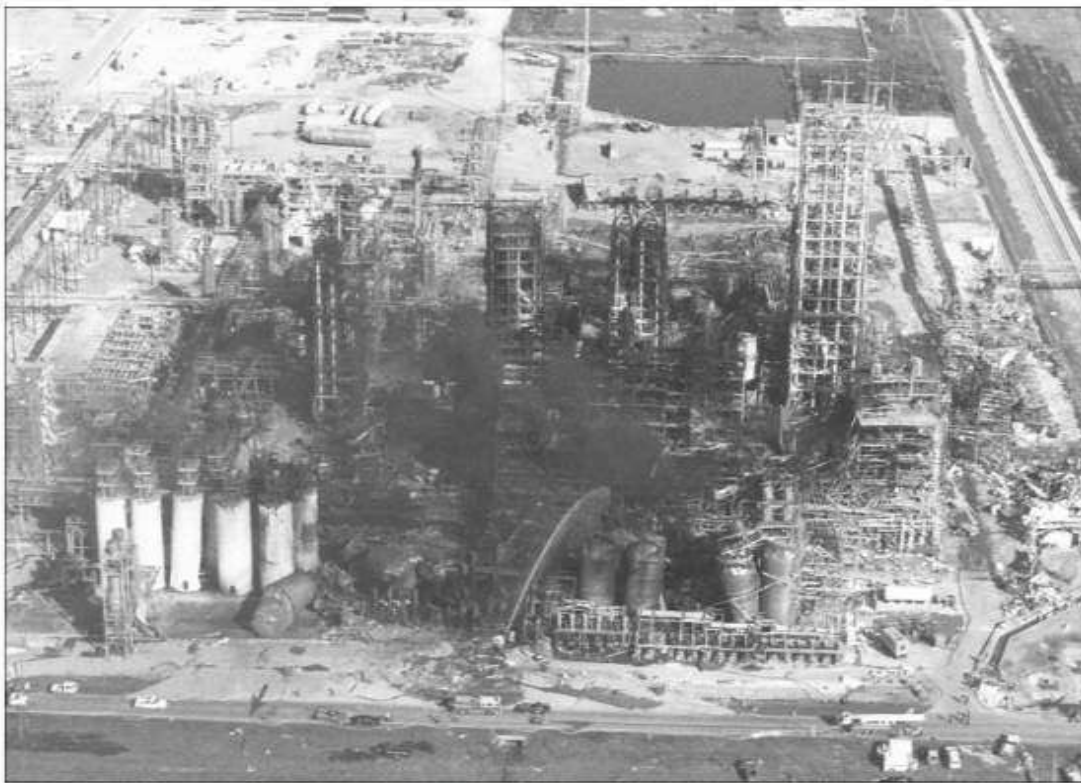
16. View of the plant from west to east. This view has the south side to the right.

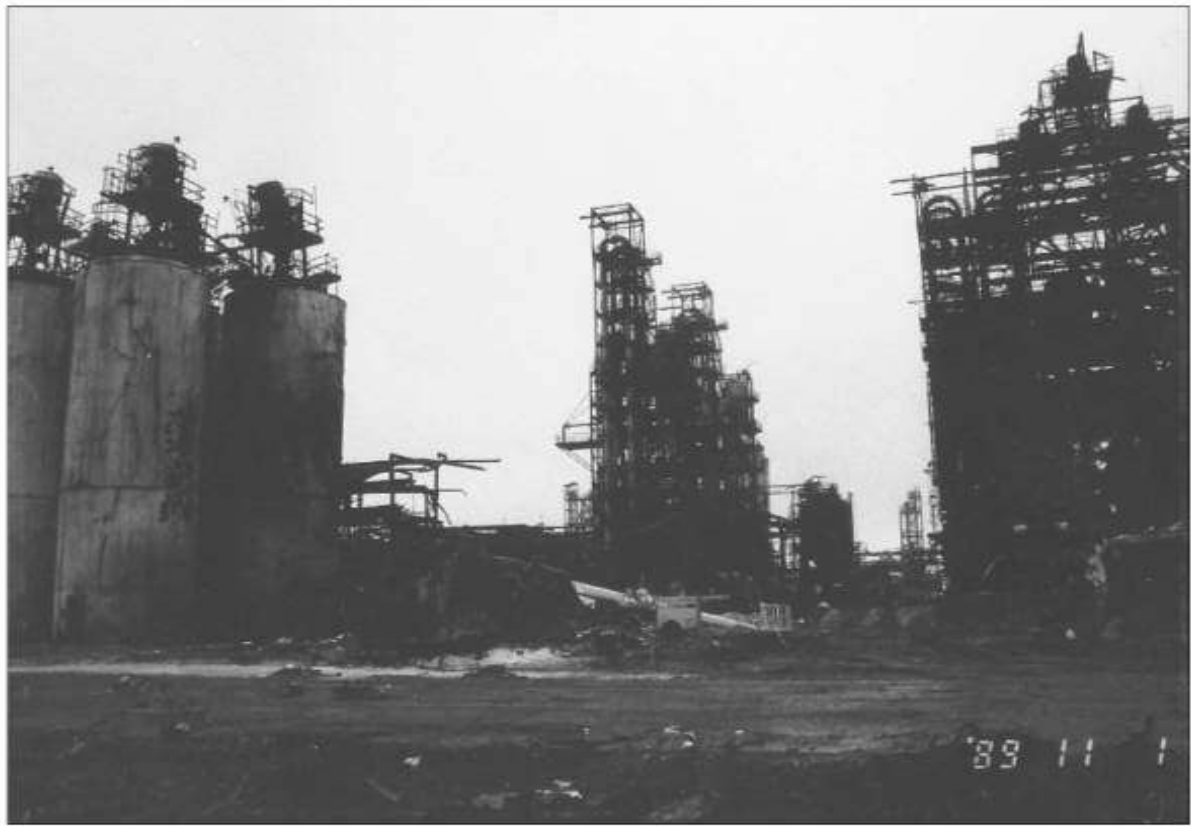
18. Silo holding areas to the northwest of the main blast area. The blast wave partially flattened the silo sides.

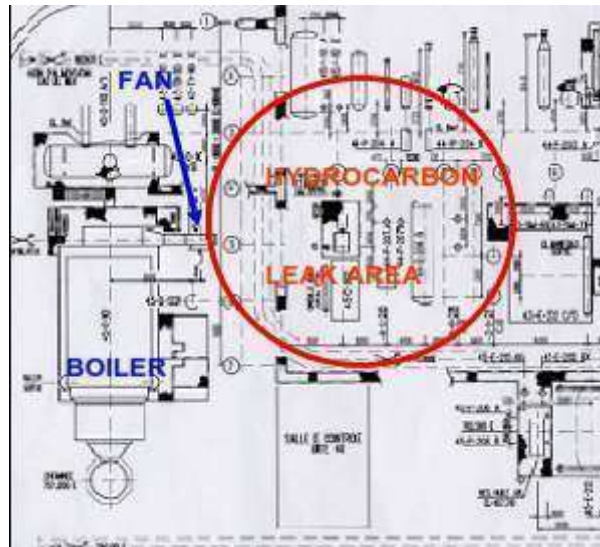
Figure 194: Leak area

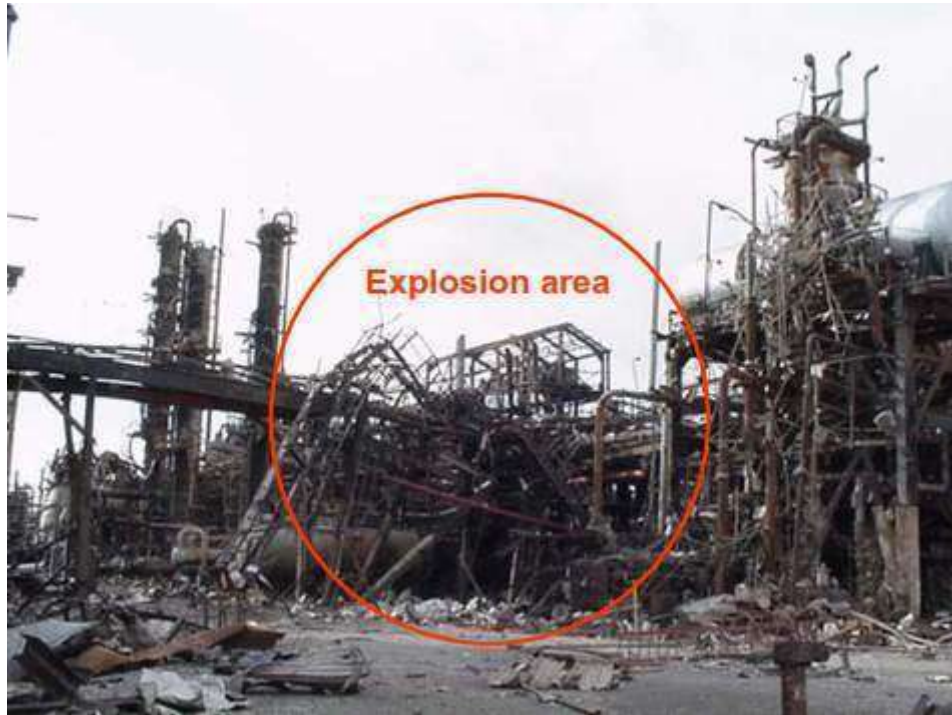
Figure 195: Train 40 after incident

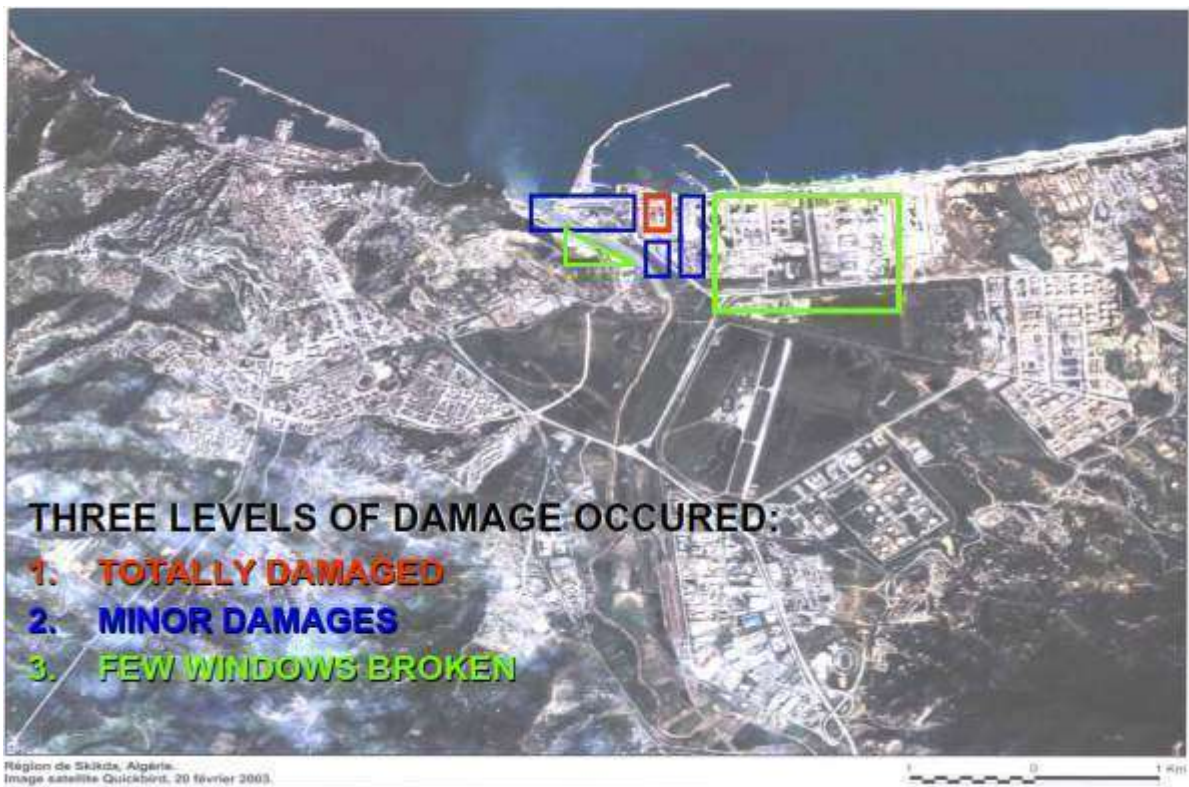
Figure 196: Damage areas off-site

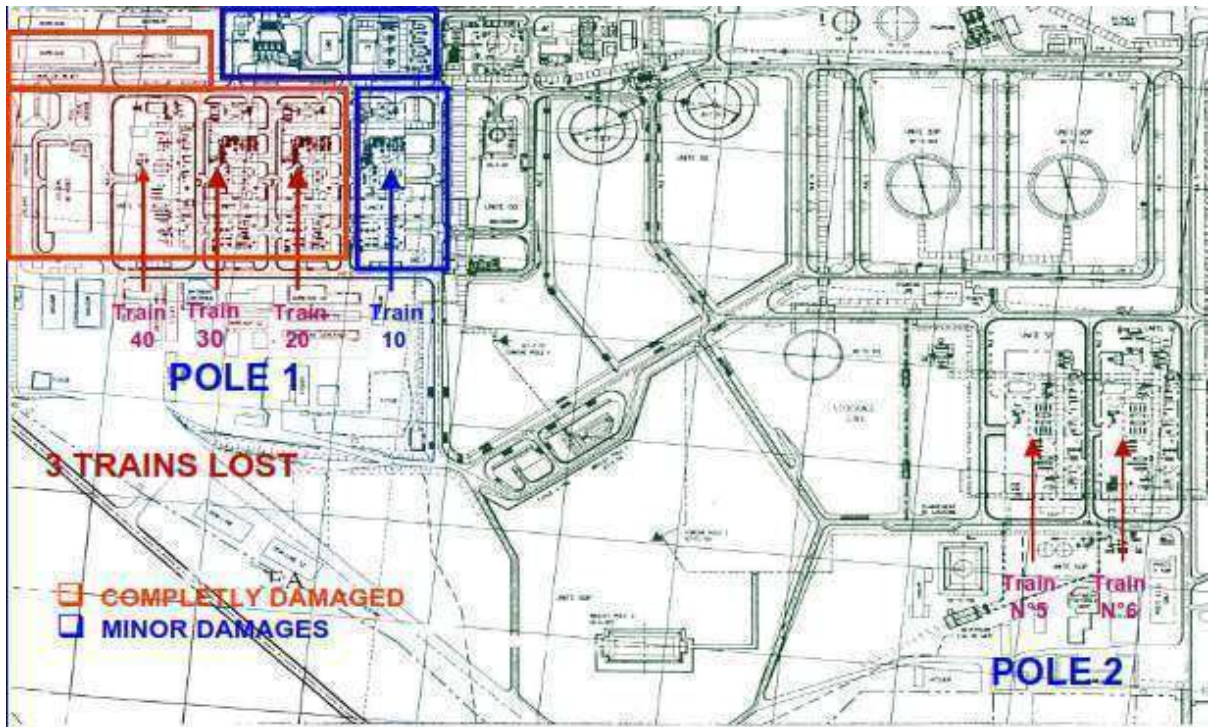
Figure 197: Damage in LNG plant

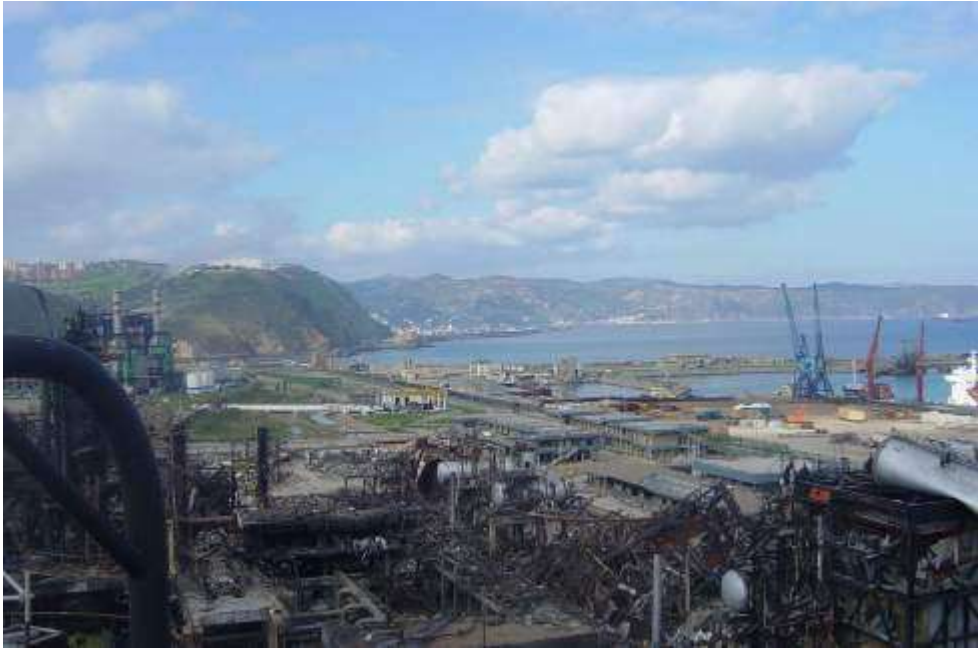
Figure 198: Train 40 and part of Train 30
