Harpur Hill, Buxton
Derbyshire, SK17 9JN
T: +44 (0)1298 218000
F: +44 (0)1298 218590
W: www.hsl.gov.uk

Review of Vapor Cloud Explosion Incidents

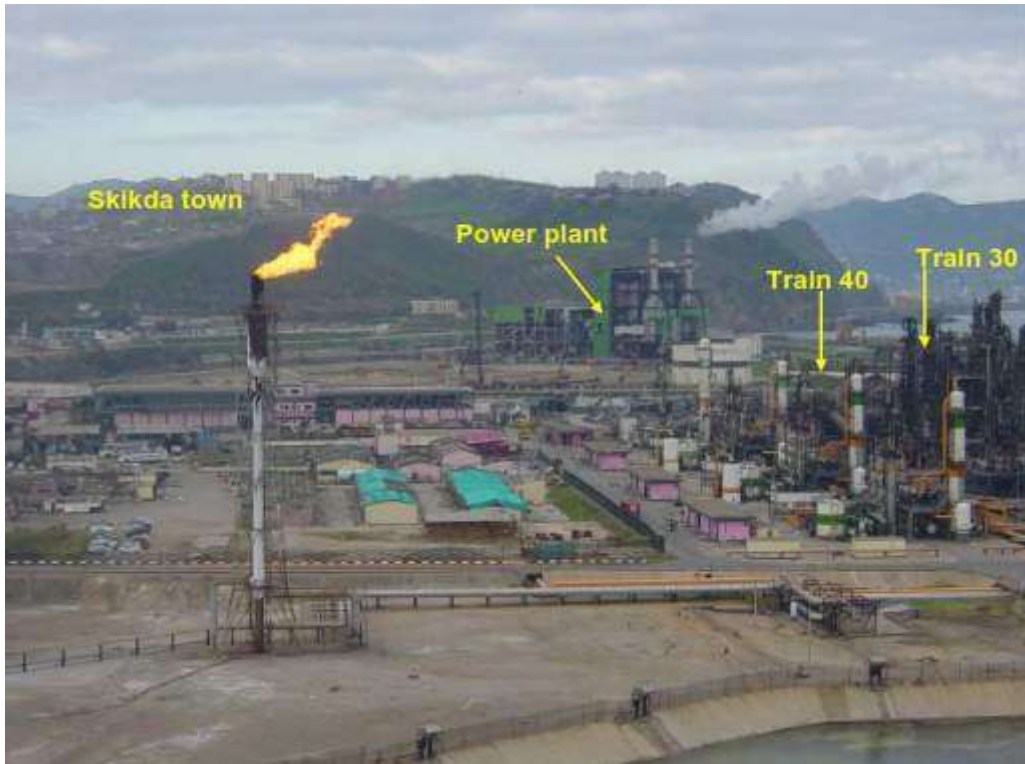
Figure 201: Damage to plant

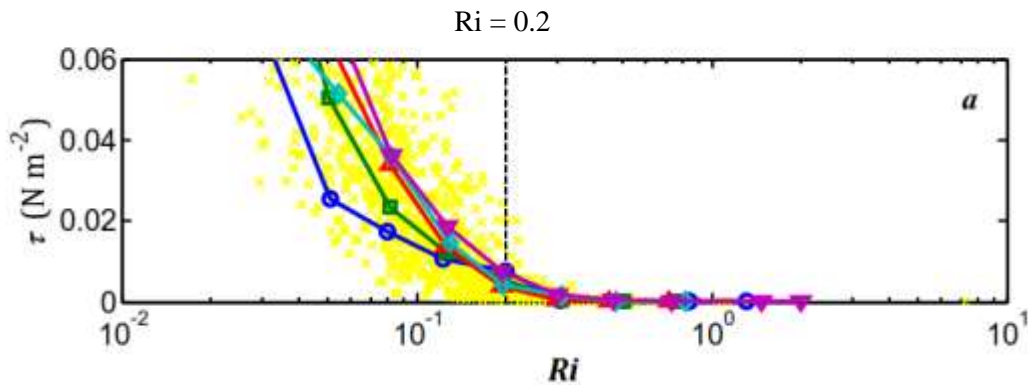
Figure 202: Momentum flux ($\rho \langle u'w' \rangle$) as a function of Richardson number over a period of 11 months. Coloured lines are average values at different elevations between 2.2m (blue) and 18.2m (magenta).

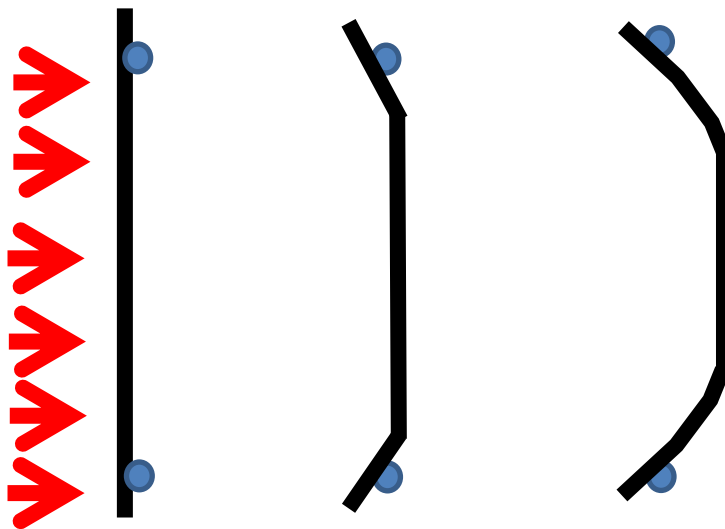
Figure 206: Progress of a zone of plastic formation away from the points of restraint.

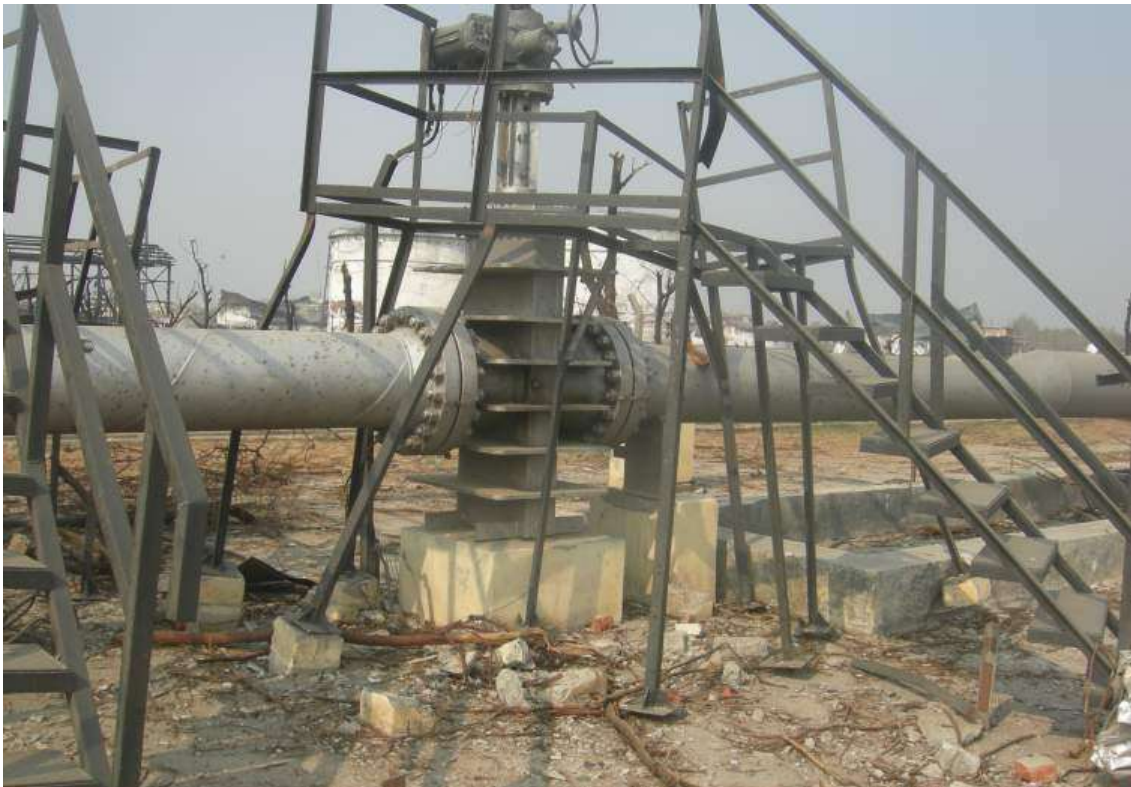
Figure 207: Lightweight open steel structures in the centre of the Jaipur explosion – there no evidence of continuously curved steels that were observed in detonation testing.

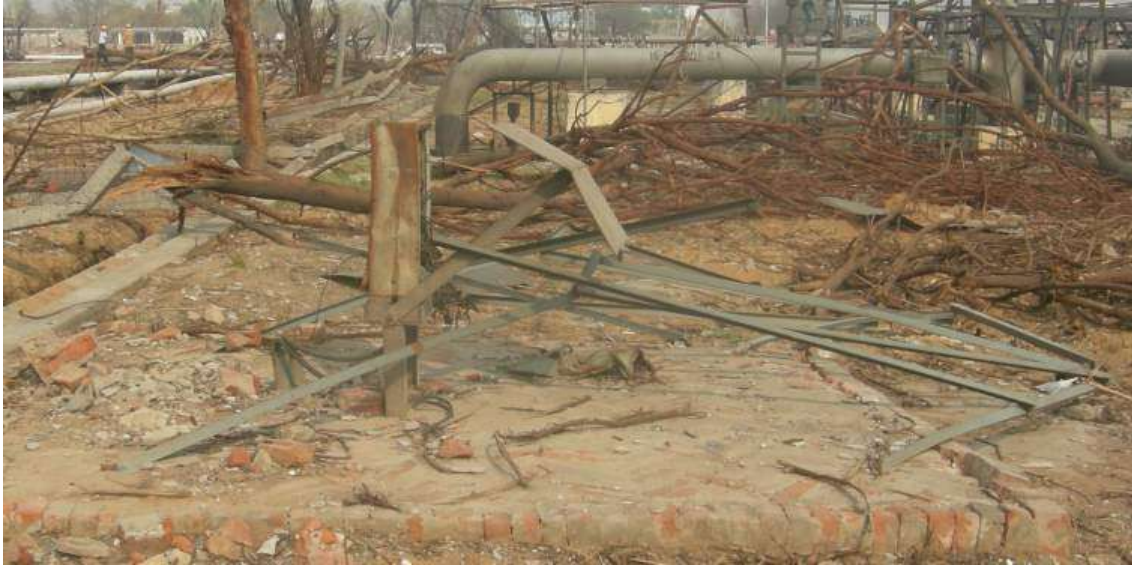
Figure 208: Lightweight open steel structures in the centre of the Jaipur explosion – there was no evidence of continuously curved steels that were observed in detonation testing. Figure 208 does however show evidence of a severe explosion: the observed crush damage to an electrical connection box would require a pressure of at least 2 bar (29 psi).

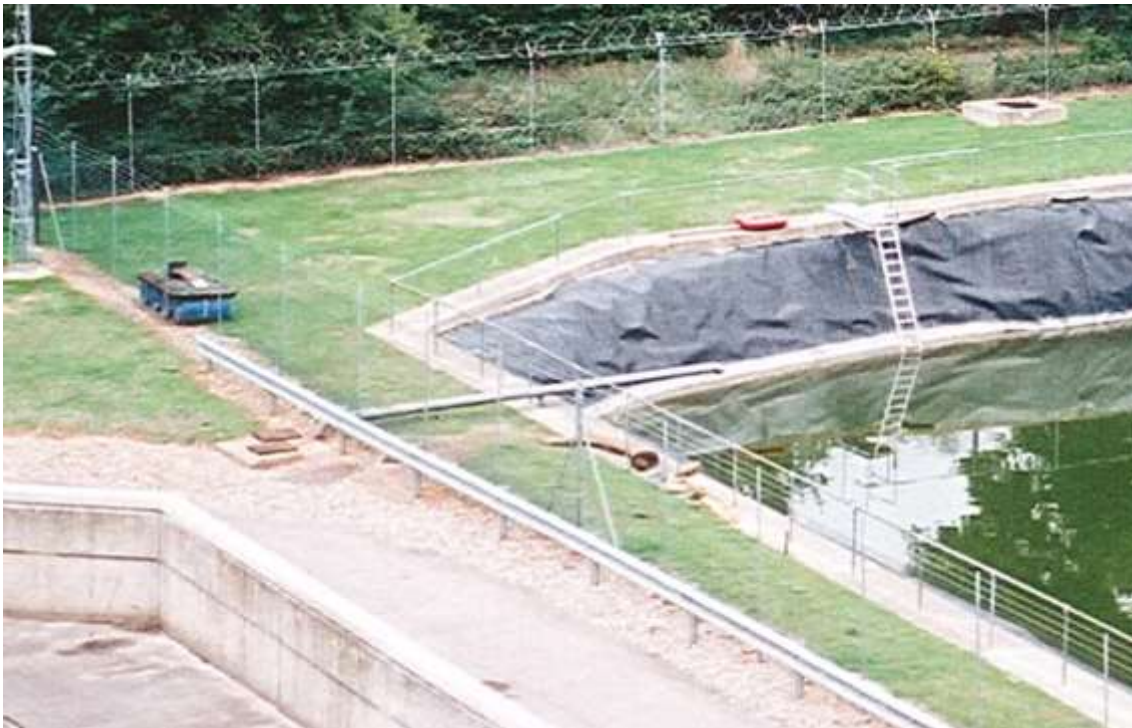
Figure 209: Lagoon area prior to incident - cloud depth at the level of the site road in the foreground was 4 - 4.5 m (13.1 – 14.7ft) – from CCTV records.

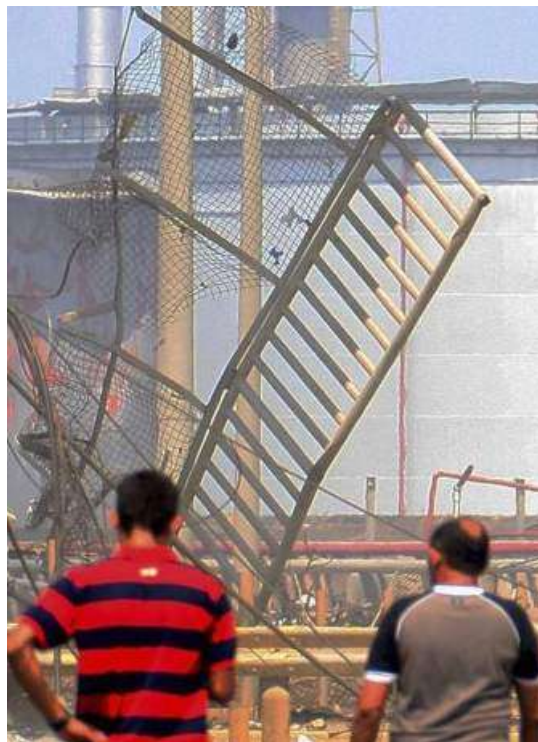
Figure 215: Mono-modal failure of hand rail on a bridge above the cloud at Amuay.

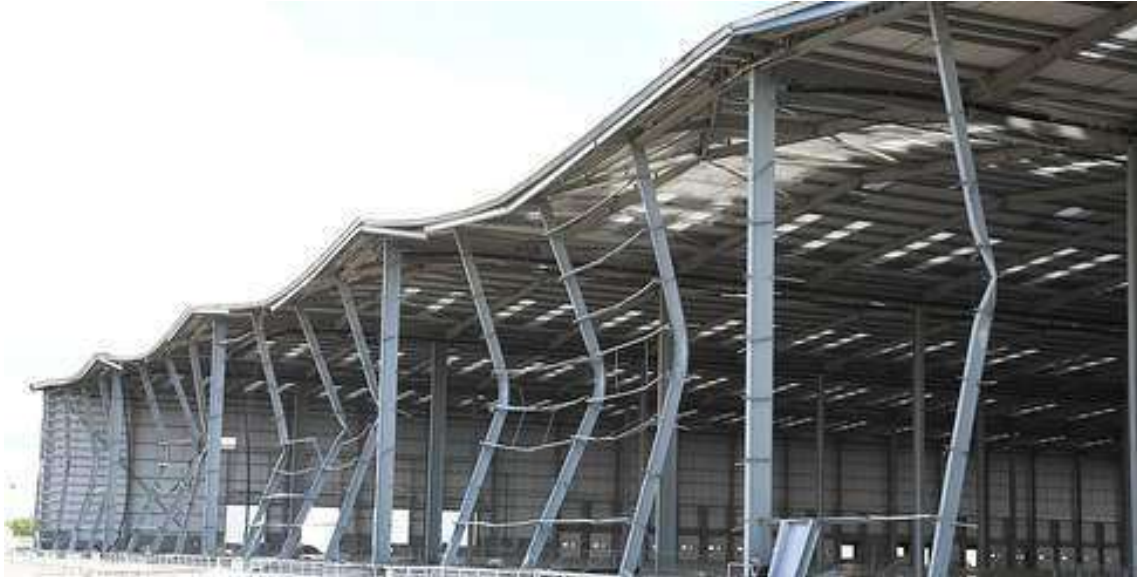
Figure 216: Pressure damage to a large warehouse 300 m (984 ft) from the edge of the Buncefield cloud.

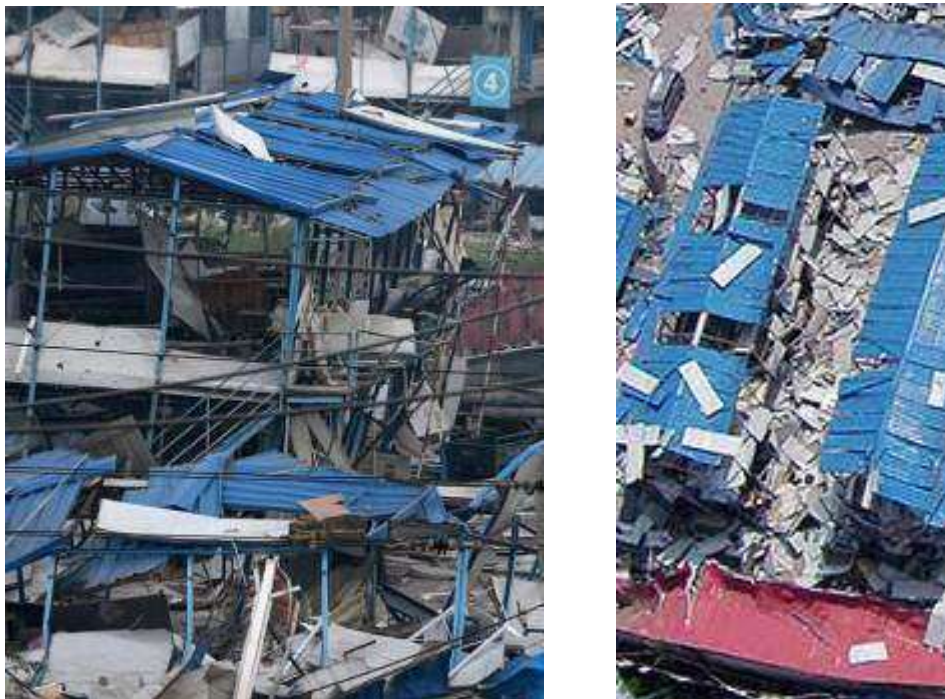
Figure 217: Side and top views of a warehouse 640 m (2100 ft) from the Tianjin explosion

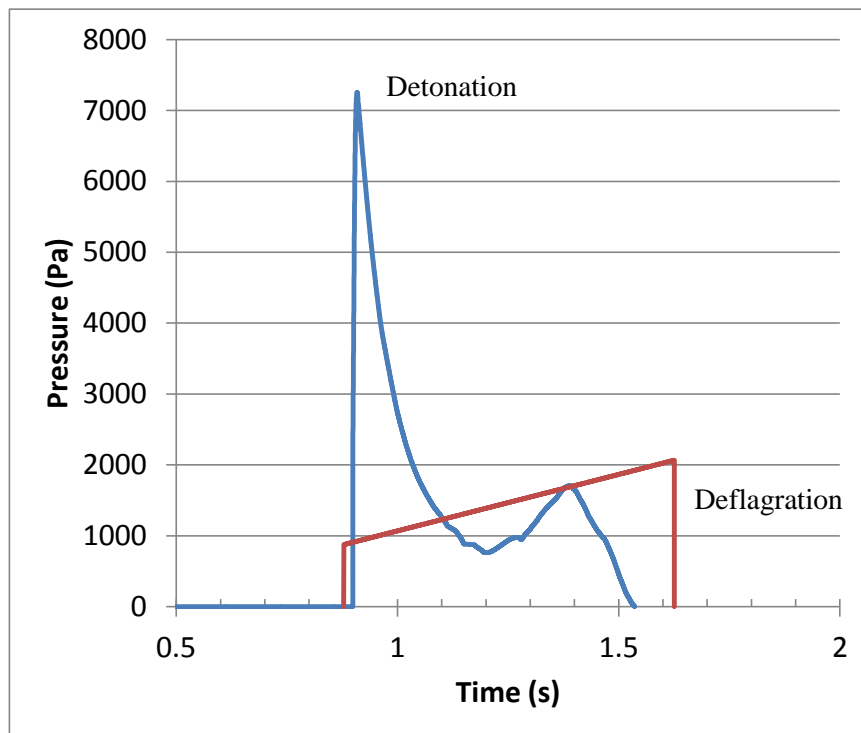
Figure 218: Incident pressure profiles with positive impulses sufficient to cause observed deflection of wall.

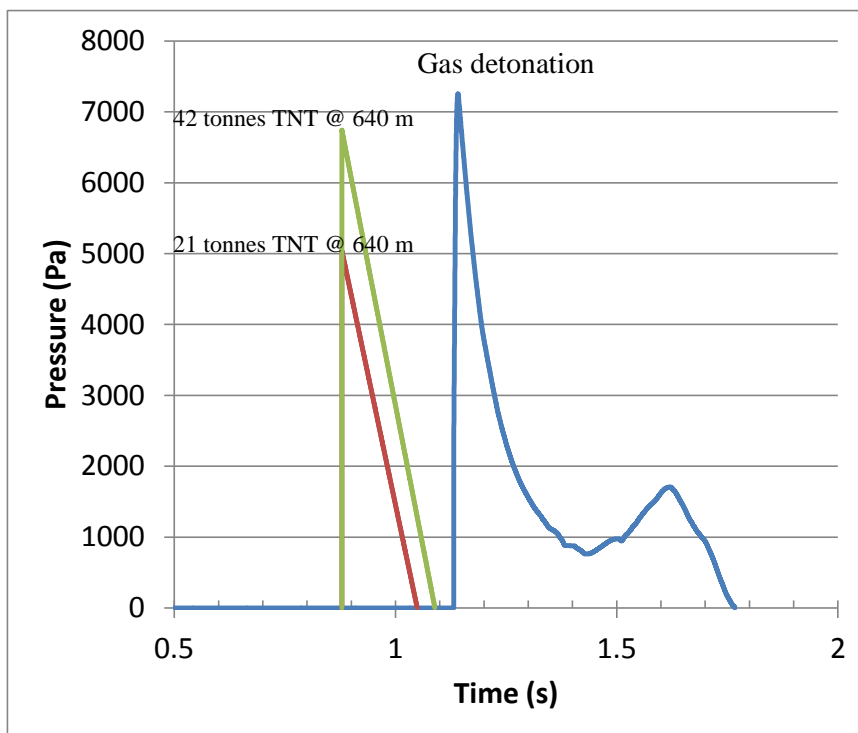
Figure 219: Detonation pressure pulse compared with TNT blasts from 21 and 42 tonnes TNT (46,300 and 92,600 lb)

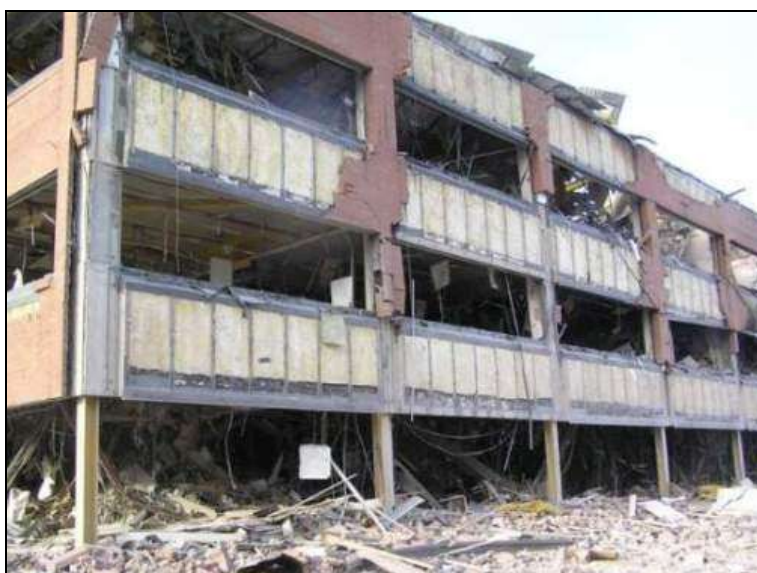
Figure 220: Northgate building after the blast

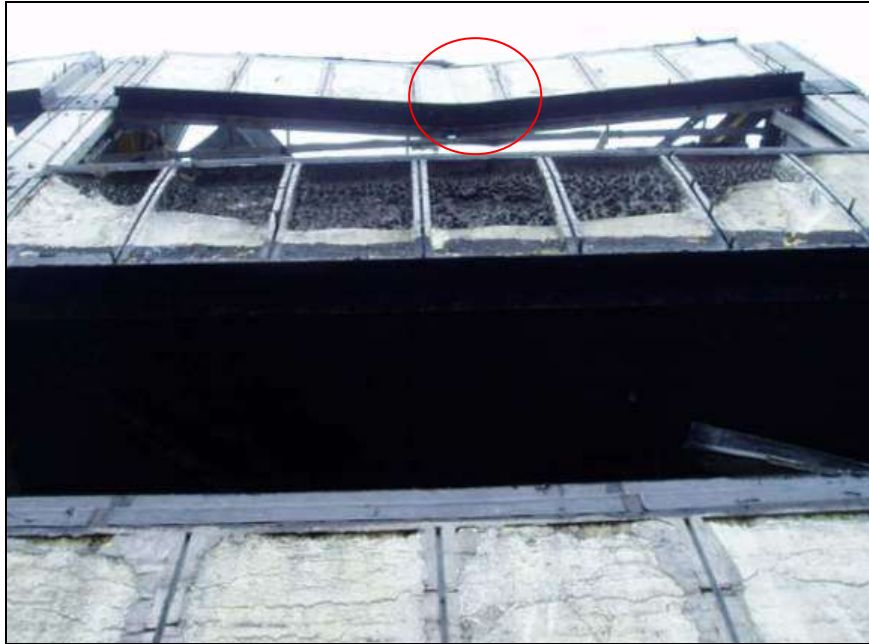
Figure 221: Failure of top level cladding panels – single central crack (circled) as a result of mono-modal failure

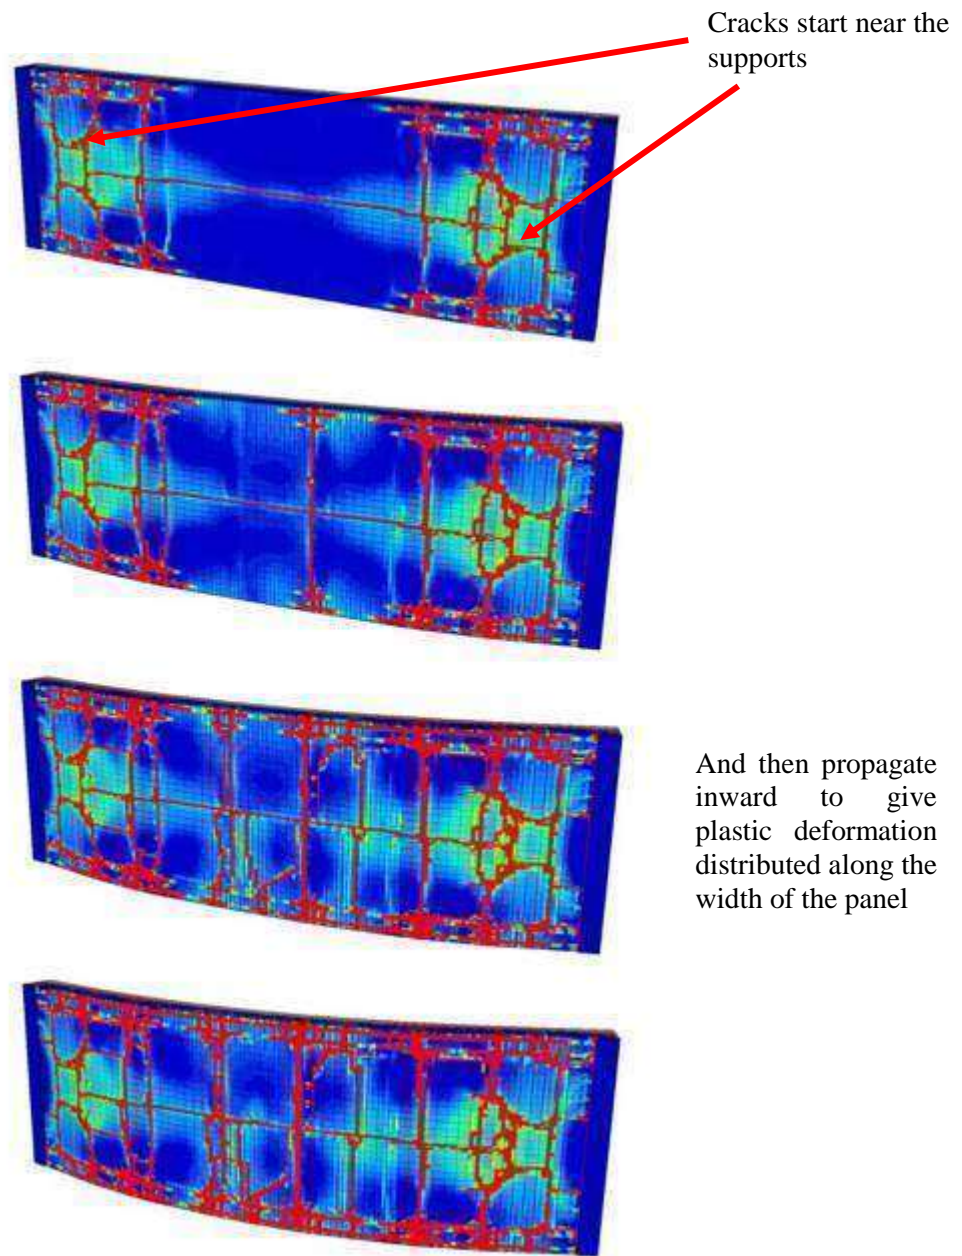
Figure 222: Multi-modal cracking predicted in the cladding panel if subjected to detonation loading (snapshots at 20 ms intervals).

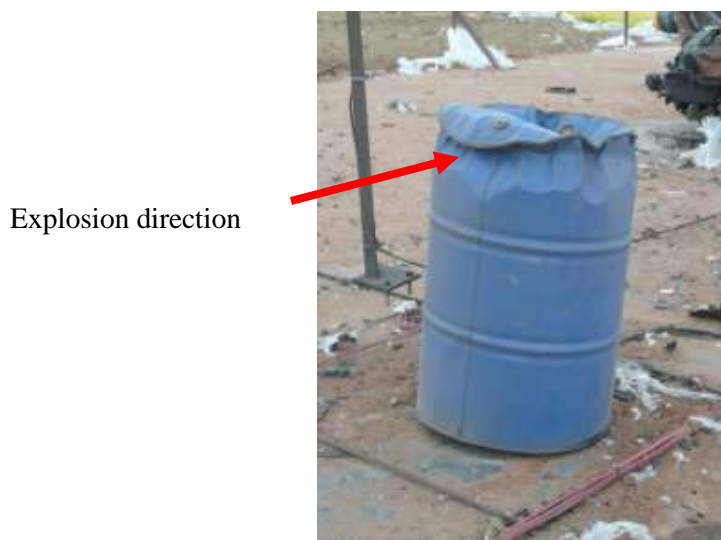
Figure 223: Near full drum in a detonation test

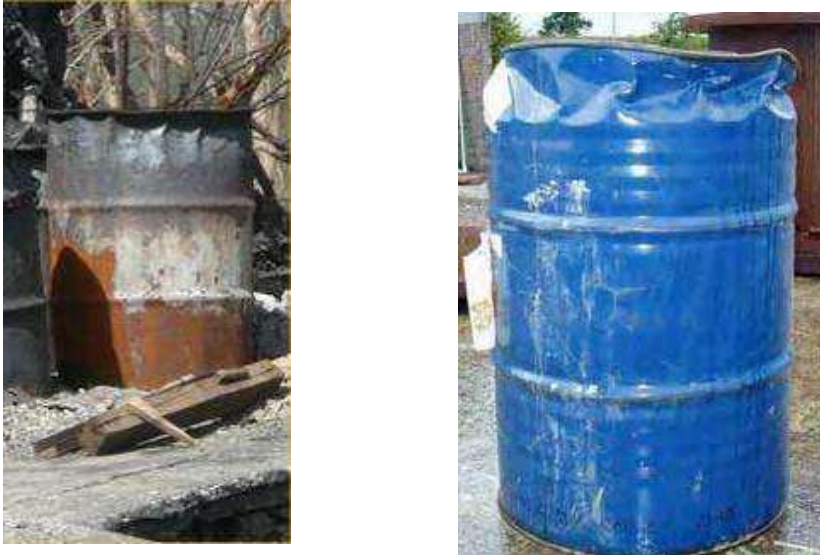
Figure 224: Drum damage

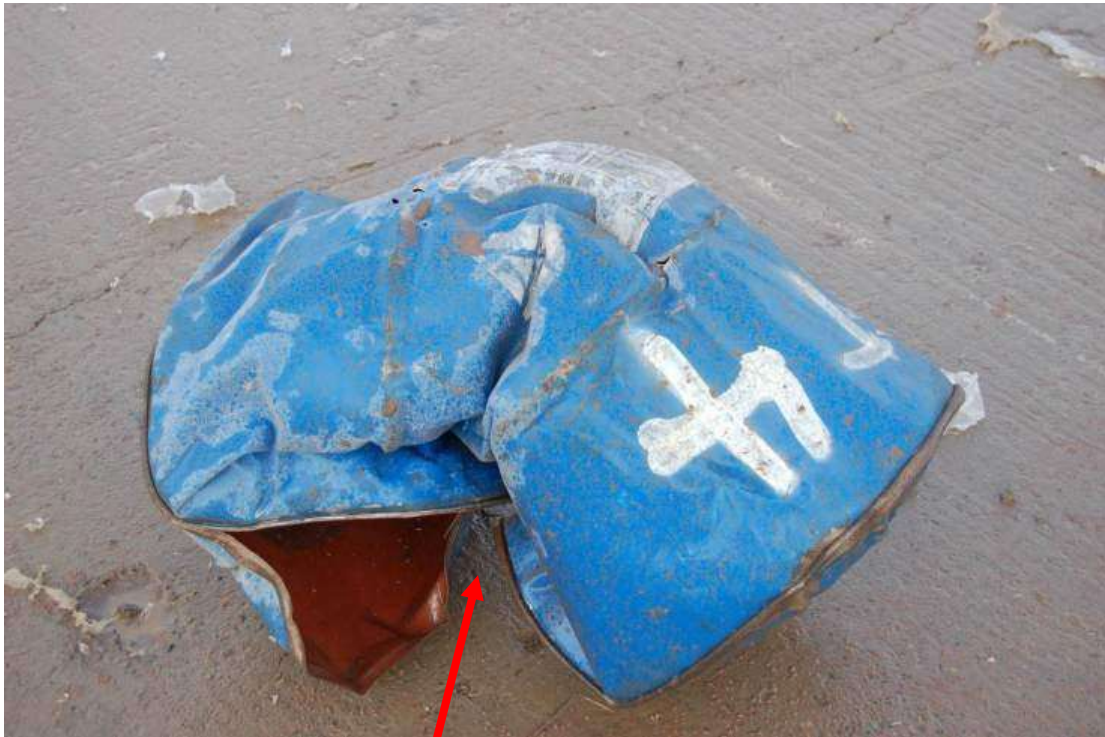
Damage to the drum is grossly asymmetric and it is immediately obvious from what direction the detonation struck the drum.

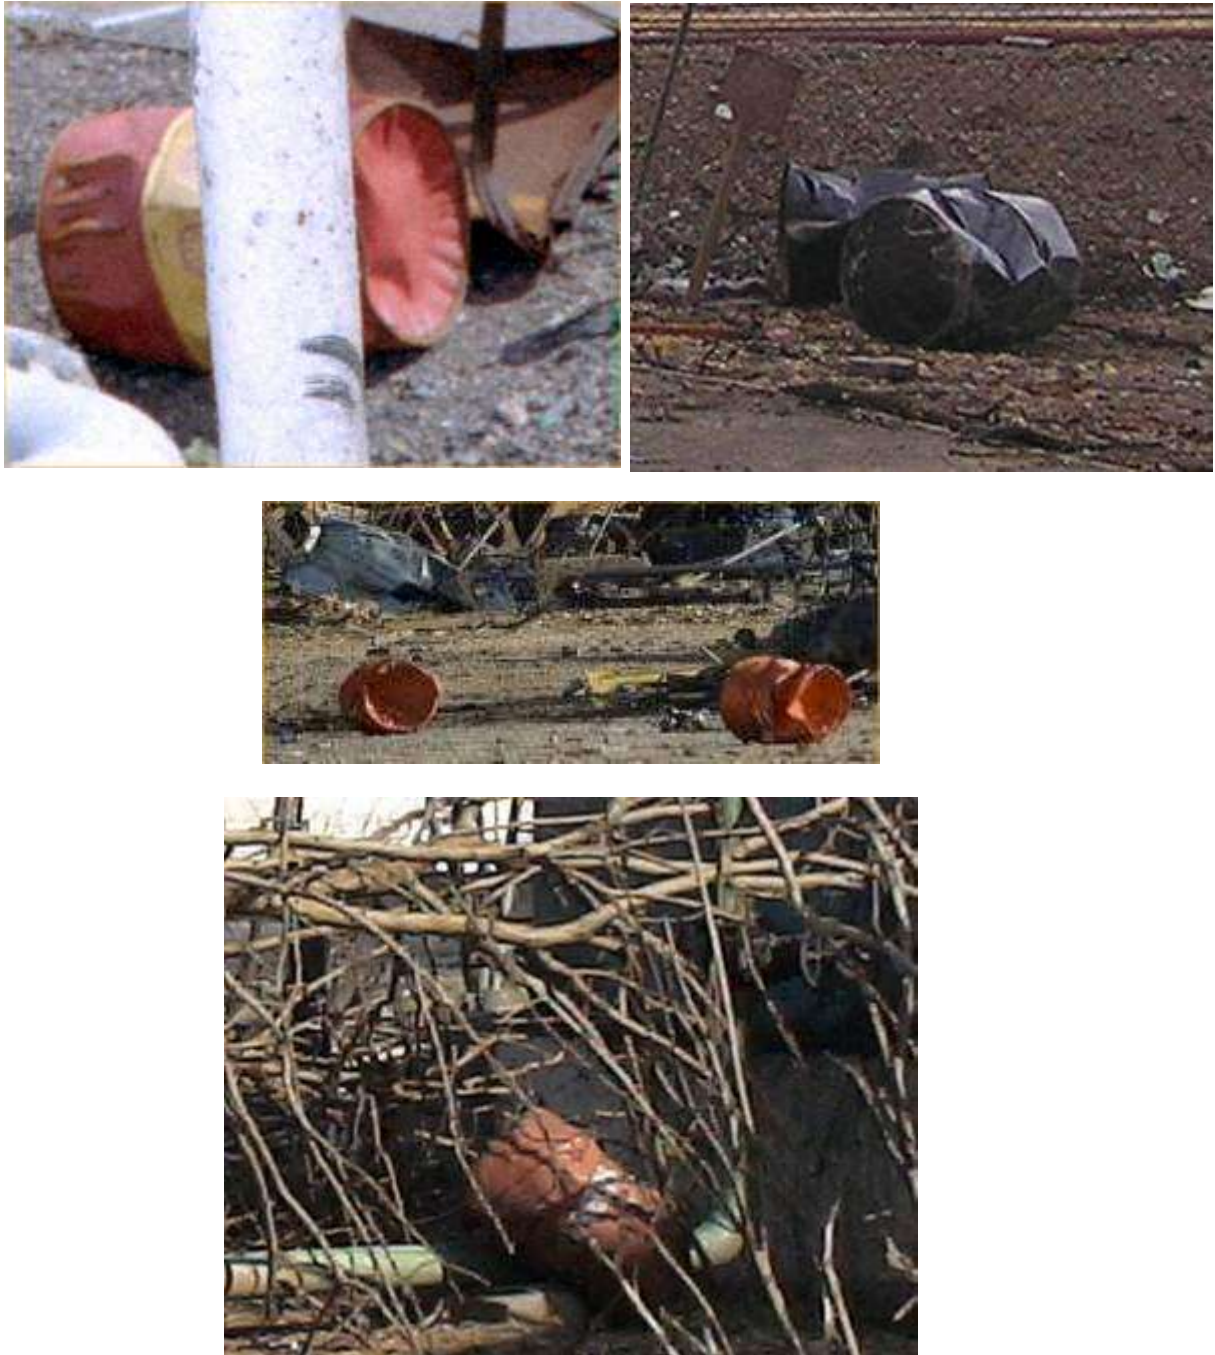
Figure 226: Remains of empty drums involved in incidents

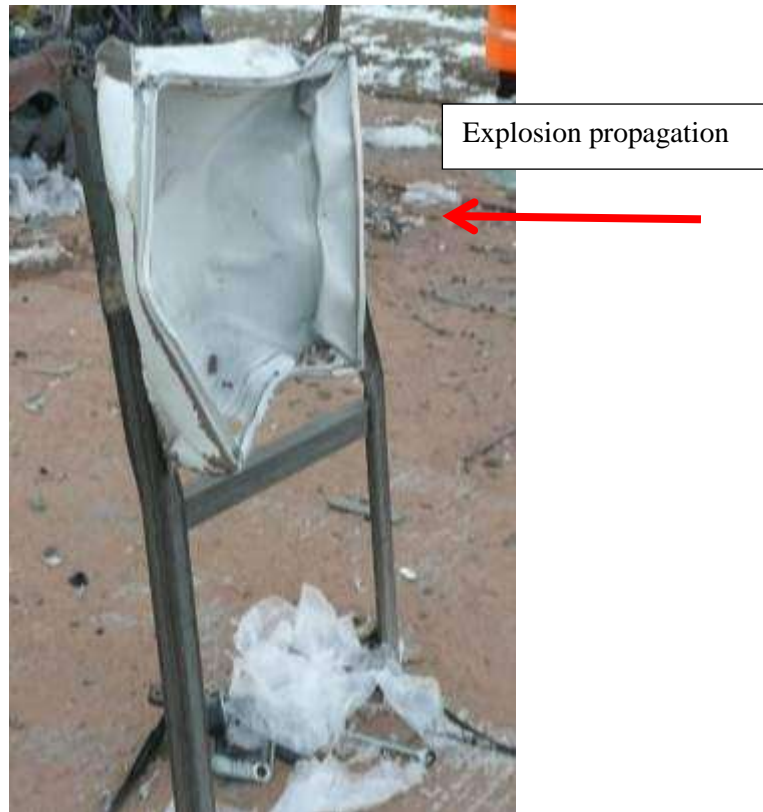
Figure 231: Deformation in the support frame of a 600 x 600 x 150 mm steel box subject to a detonation

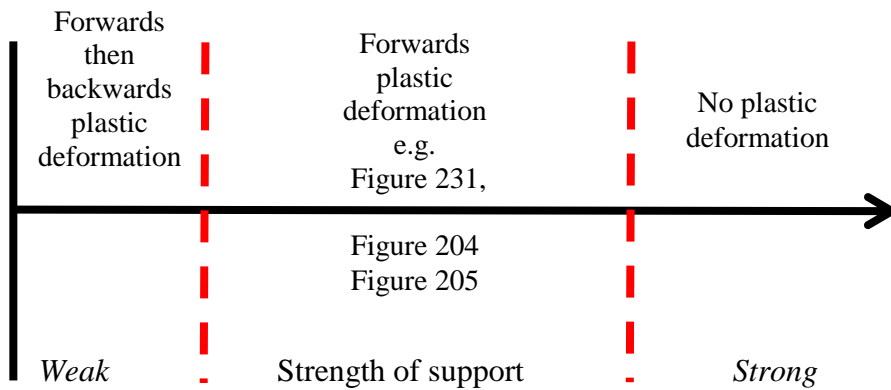
Figure 232: Schematic showing the types of deformation to be expected in a detonation

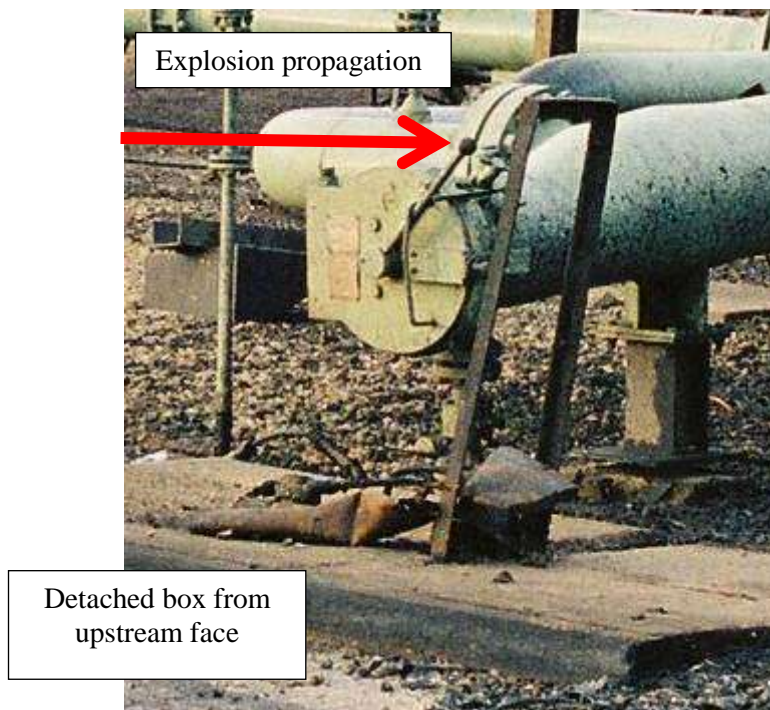
Figure 237: Forward deflection of a steel frame at Buncefield

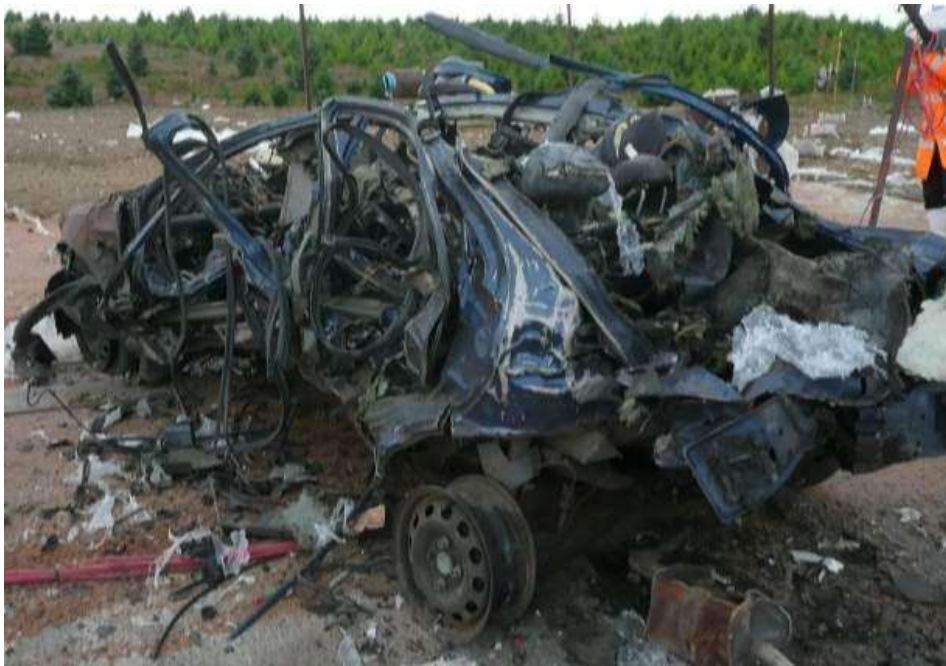
Figure 238: Damage to the side of a car facing oncoming detonation

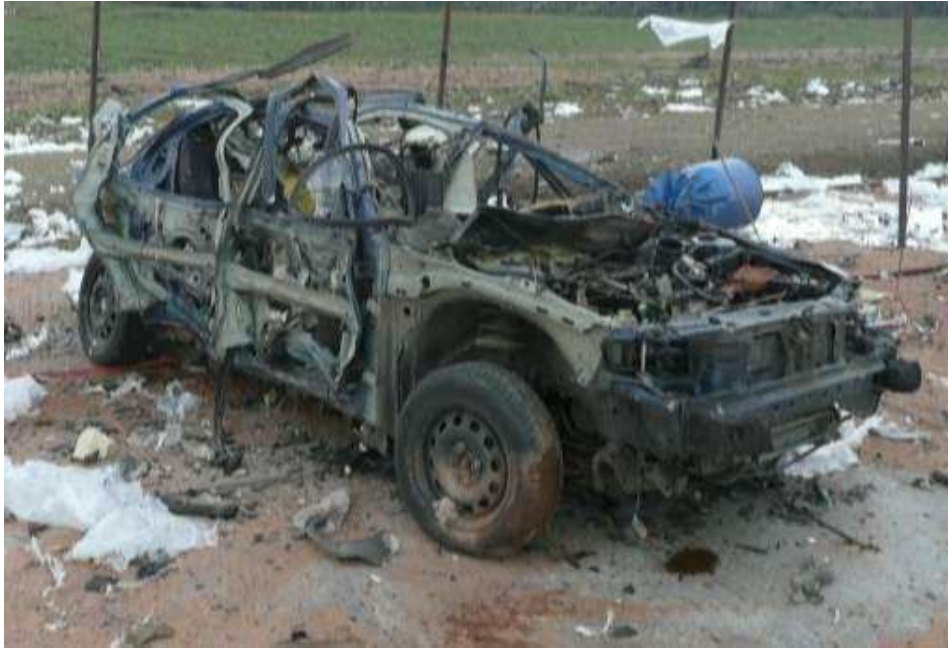
Figure 239: Damage to the side of a car facing away from a detonation

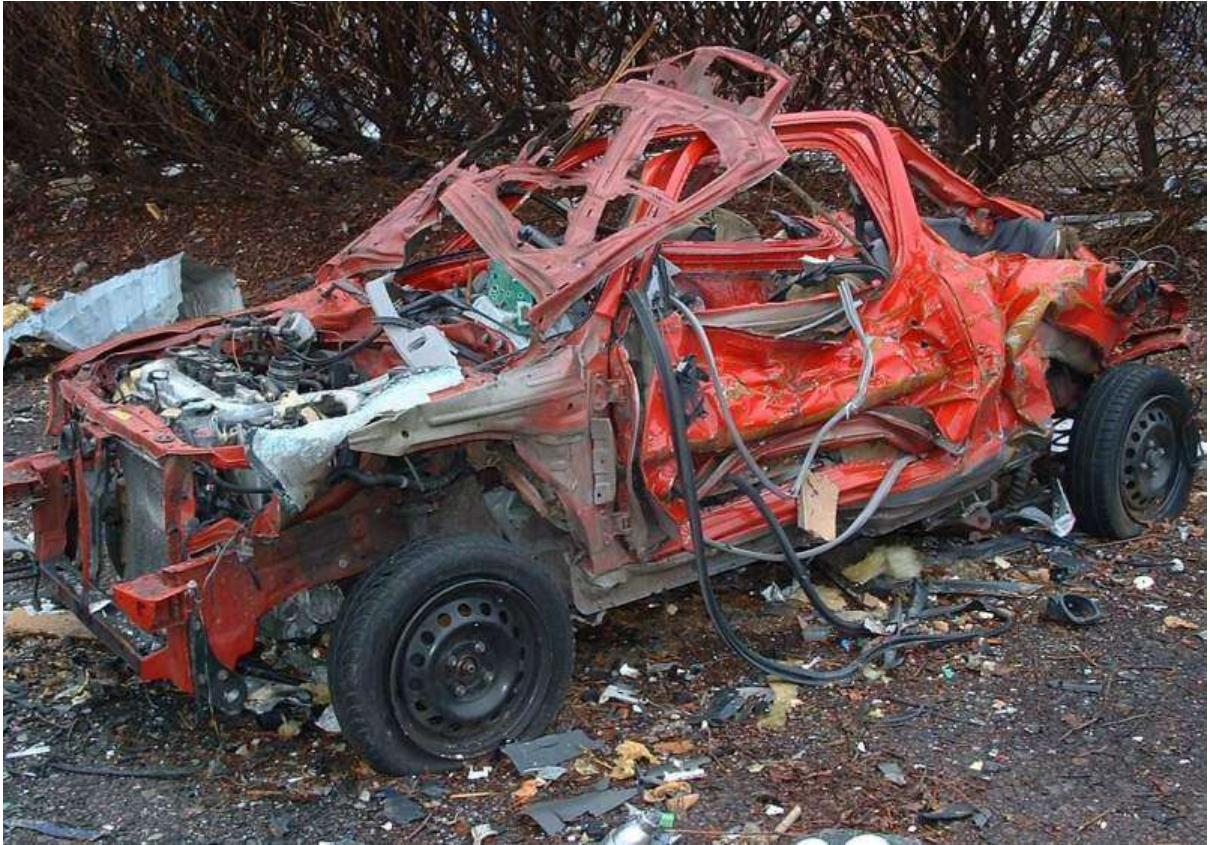
Figure 240: Car damaged in Buncefield VCE

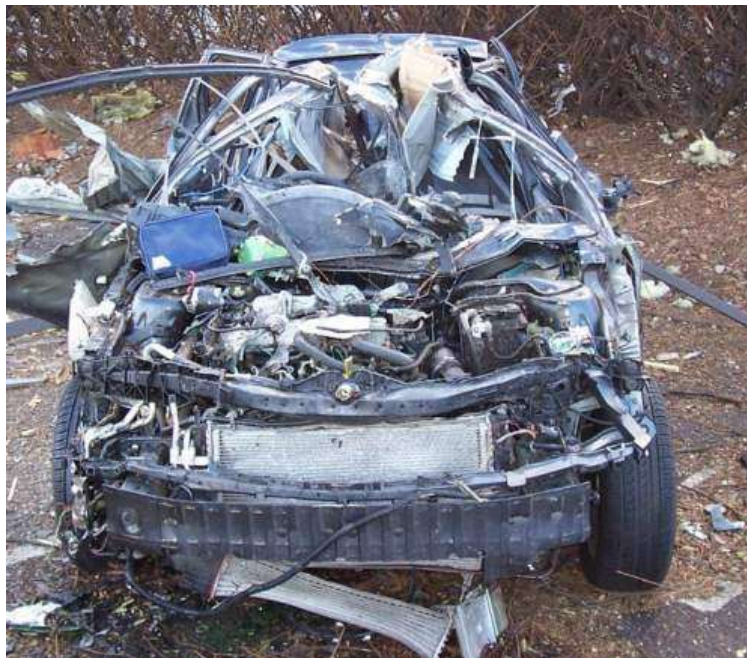
Figure 241: Car damaged in Buncefield explosion – explosion direction left to right

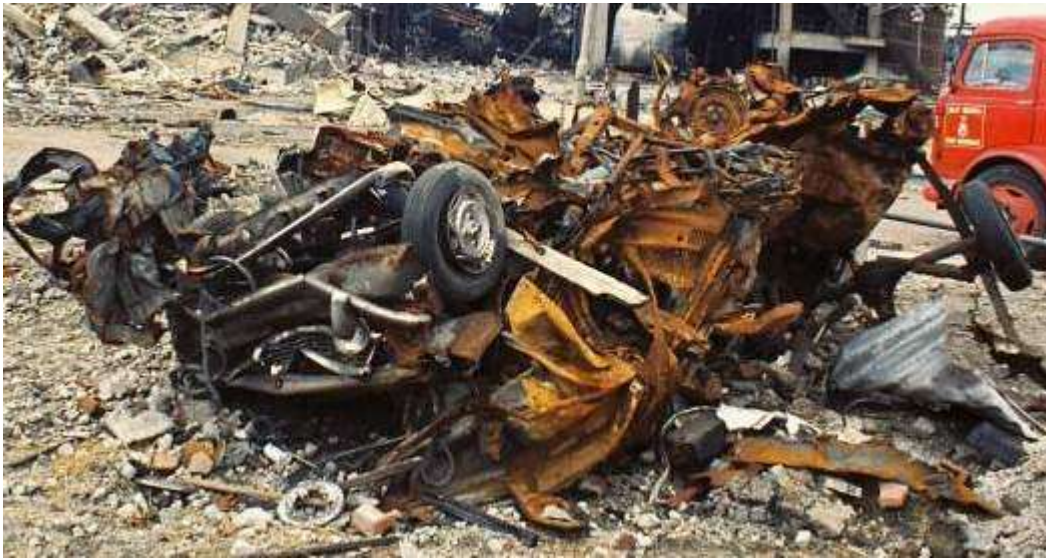
Figure 242: Car damaged by a detonation at Flixborough

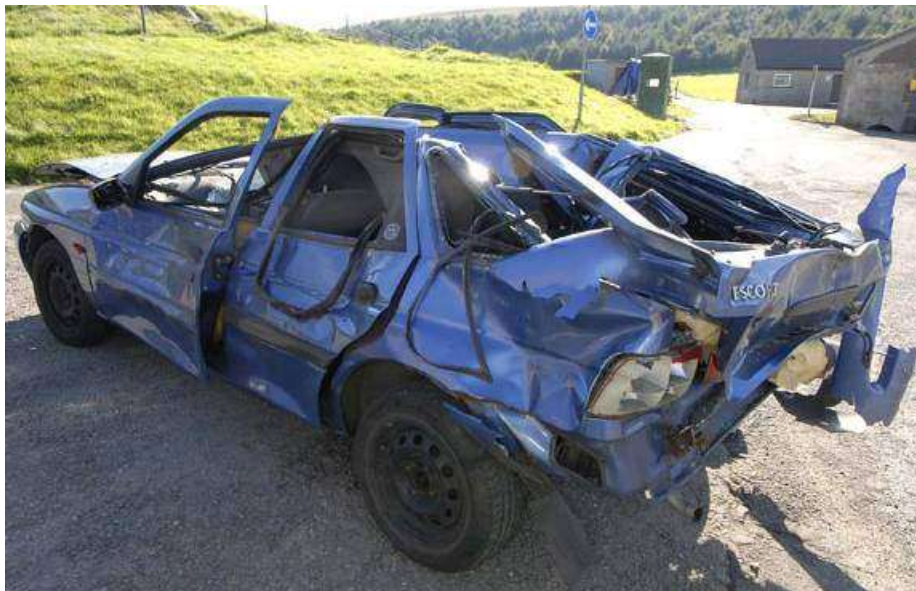
Figure 243: Car subject to 1 bar (14.5 psi) overpressure in a reinforced explosion chamber

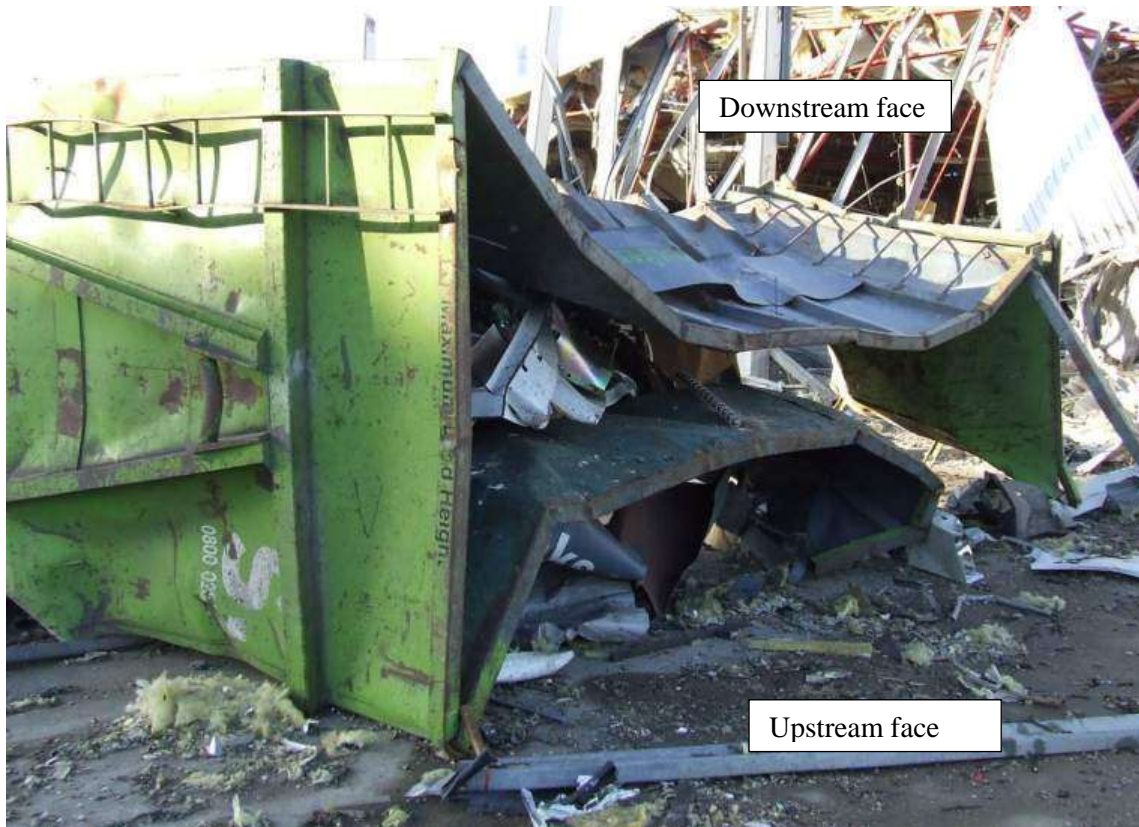
Figure 244: Deformation of a skip exposed to VCE from the side (the skip has been rolled over onto the upstream face)

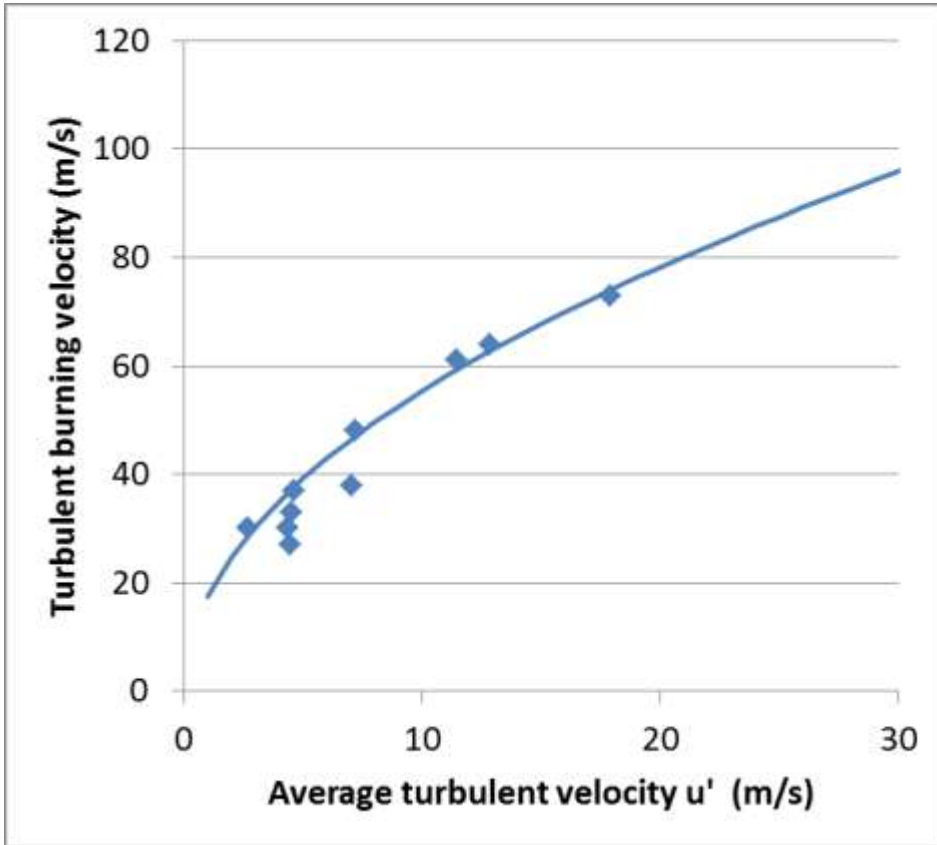
Figure 249: Burning velocity data at low Karlowitz numbers (Gardener et al 1998)

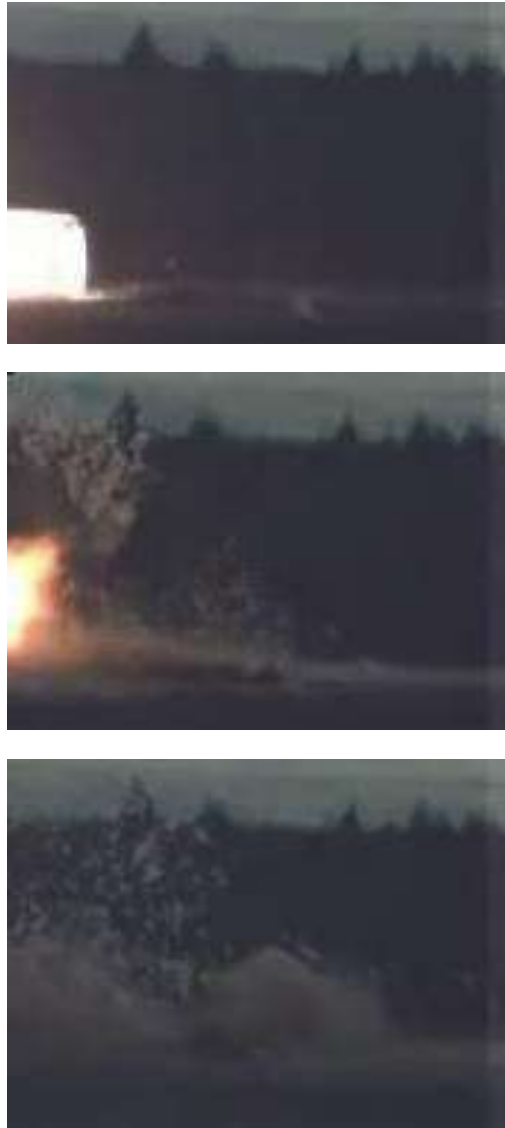
Figure 251: Re-elevation of dust caused by a gas explosion

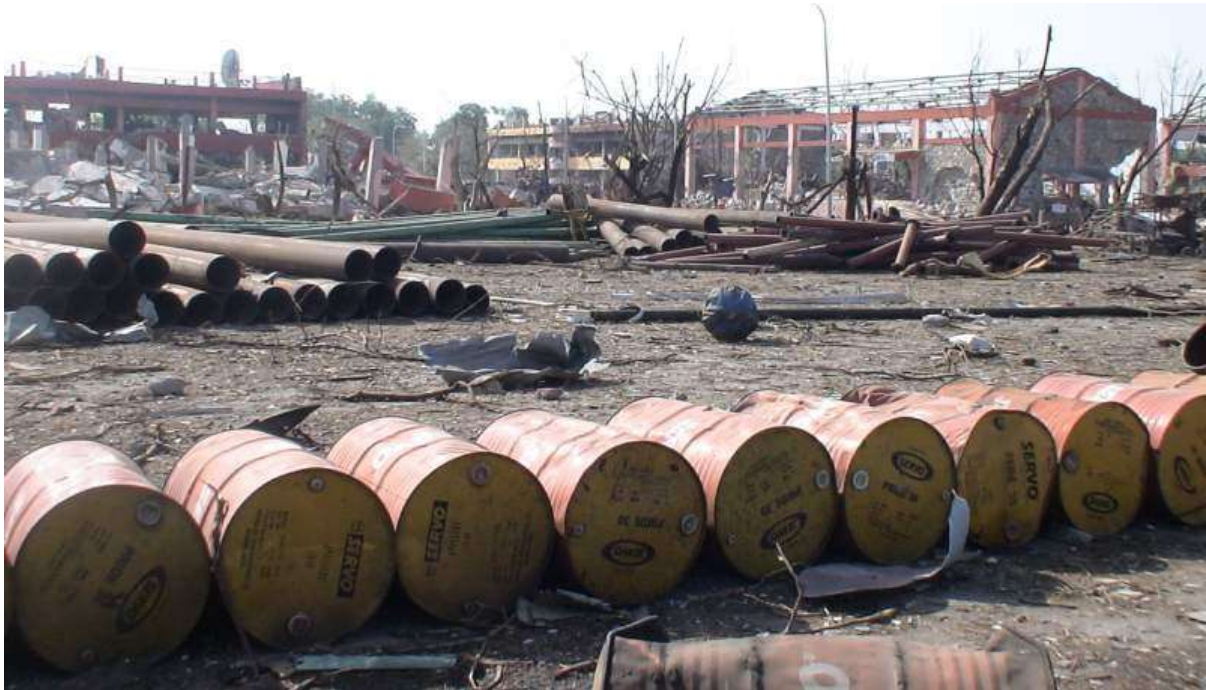
Figure 253: Evidence of rapid horizontal variations in explosion pressure at Jaipur.
