# Northeast Gas Association

Transmission Integrity Committee

Presentation to PHMSA

Chicago, IL July 15-16, 2008

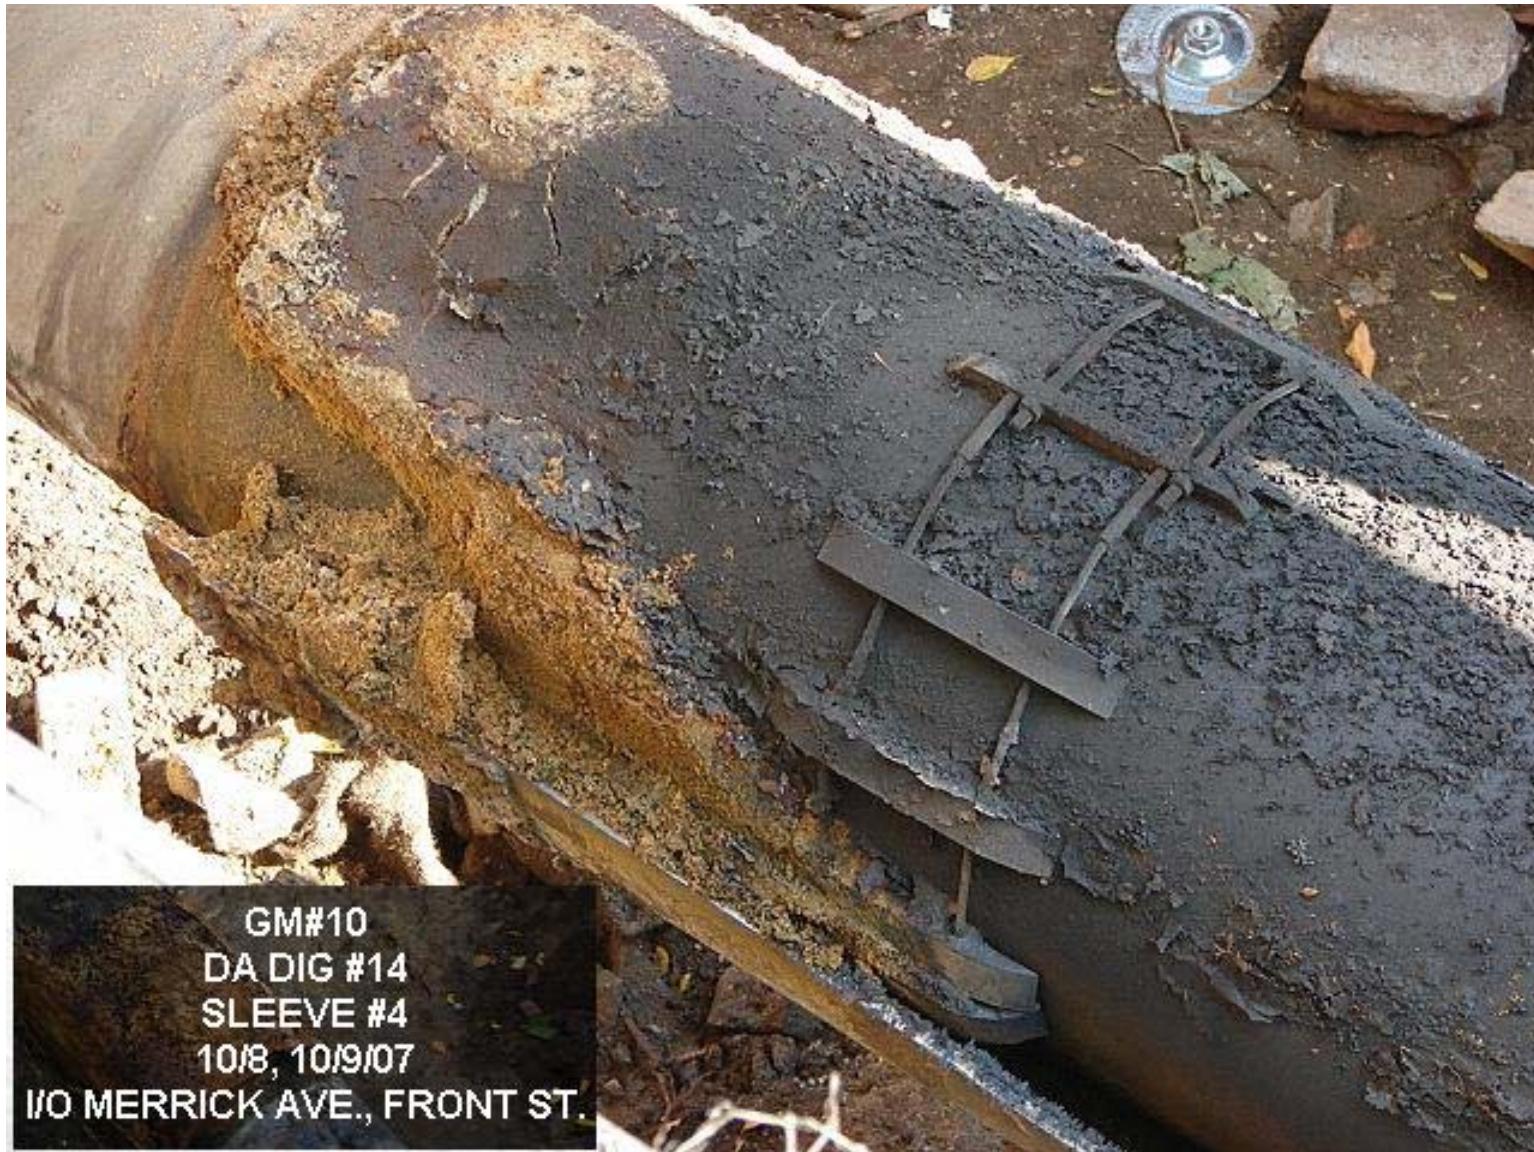
GM#10  
DA DIG #14  
SLEEVE #4  
10/8, 10/9/07  
I/O MERRICK AVE., FRONT ST.

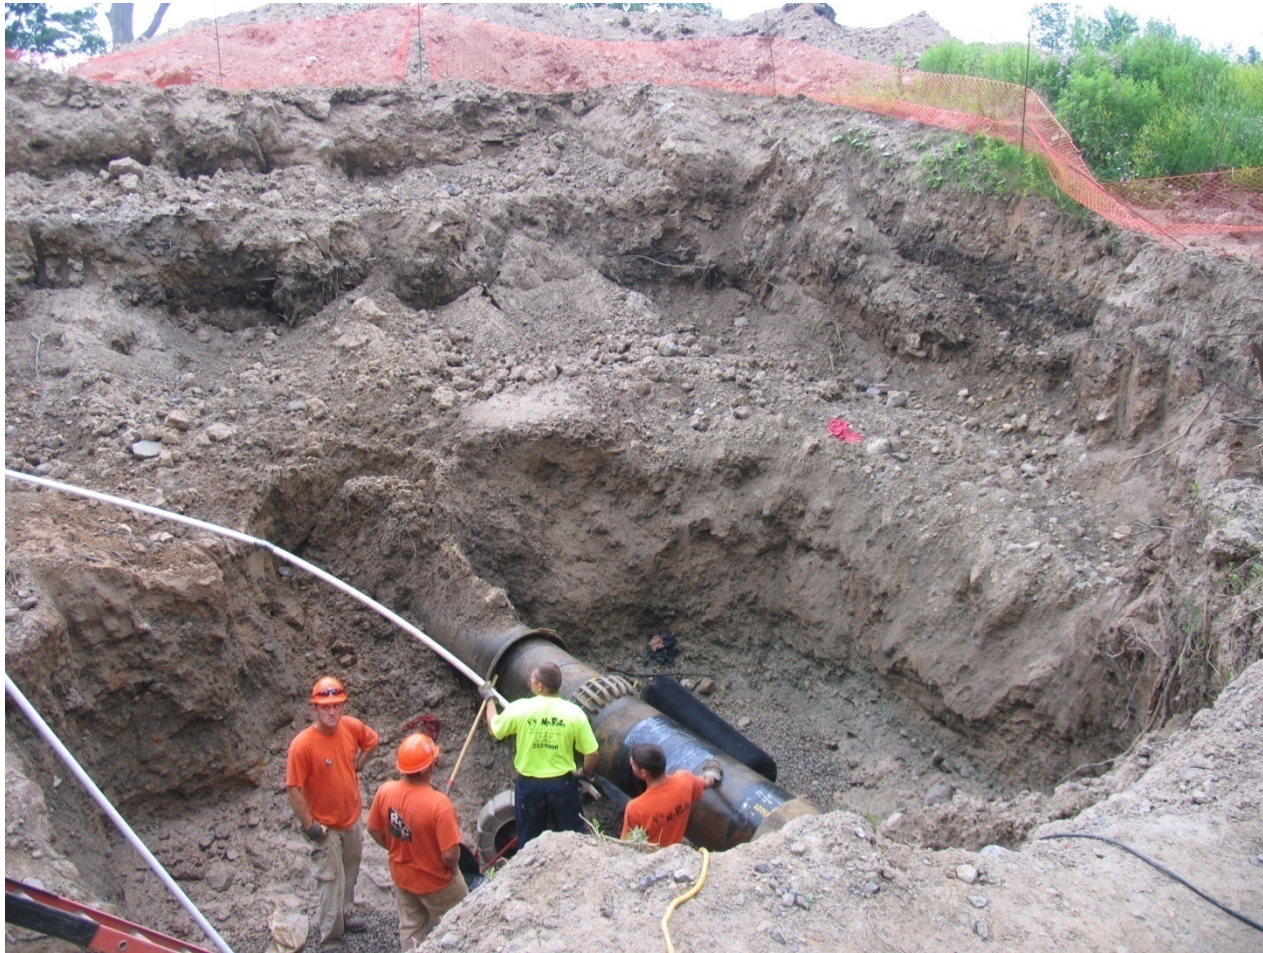
**24" carrier pipe in 30" casing**  
**Depth of Cover – 9' Depth to excavation bottom– 14'**  
**Final excavation – 40' width X 30' length**  
**Location – New York State, rural**  
**Company – Rochester Gas and Electric**

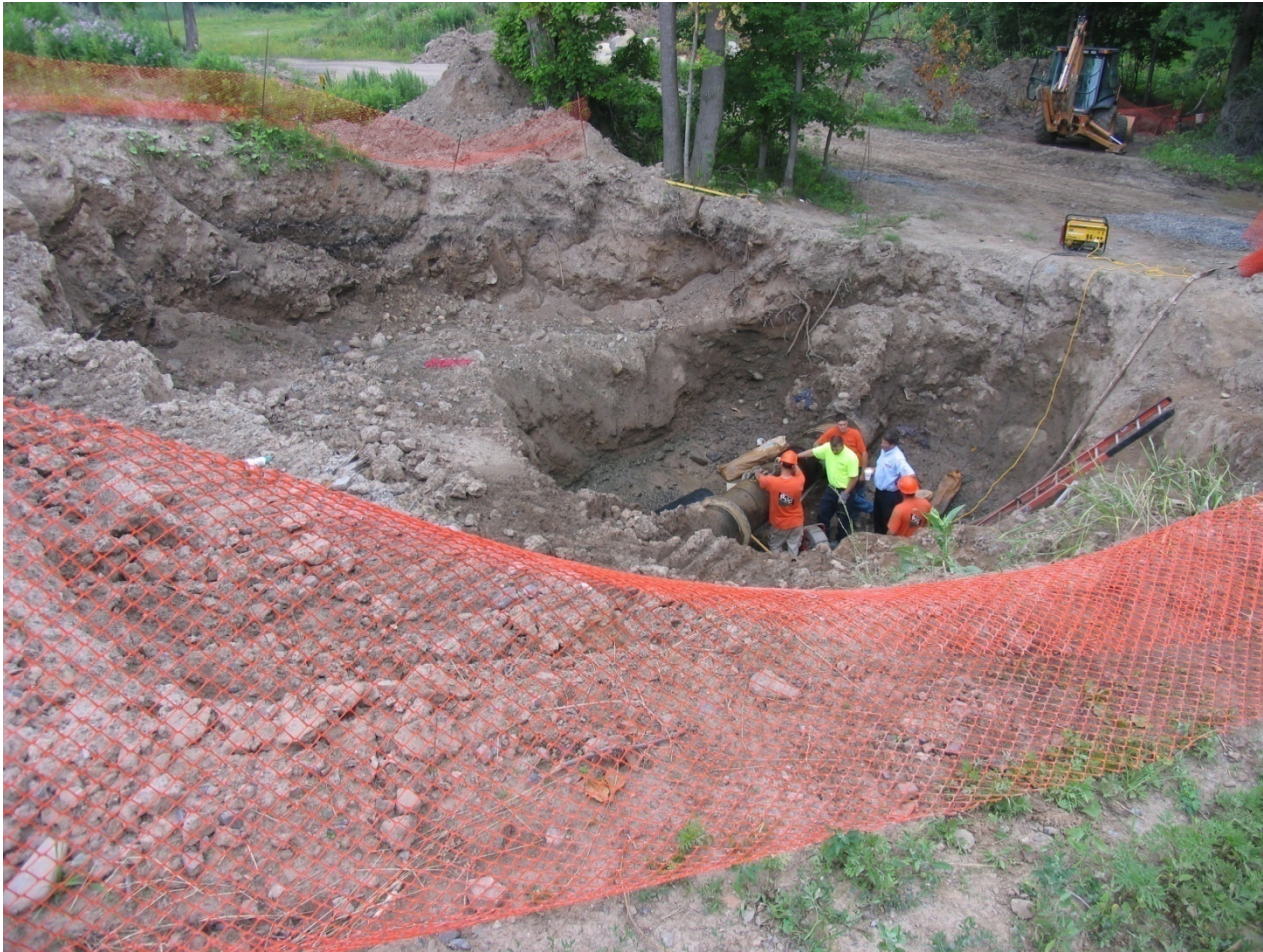
**Location – New York State, rural  
Company - Rochester Gas and Electric**

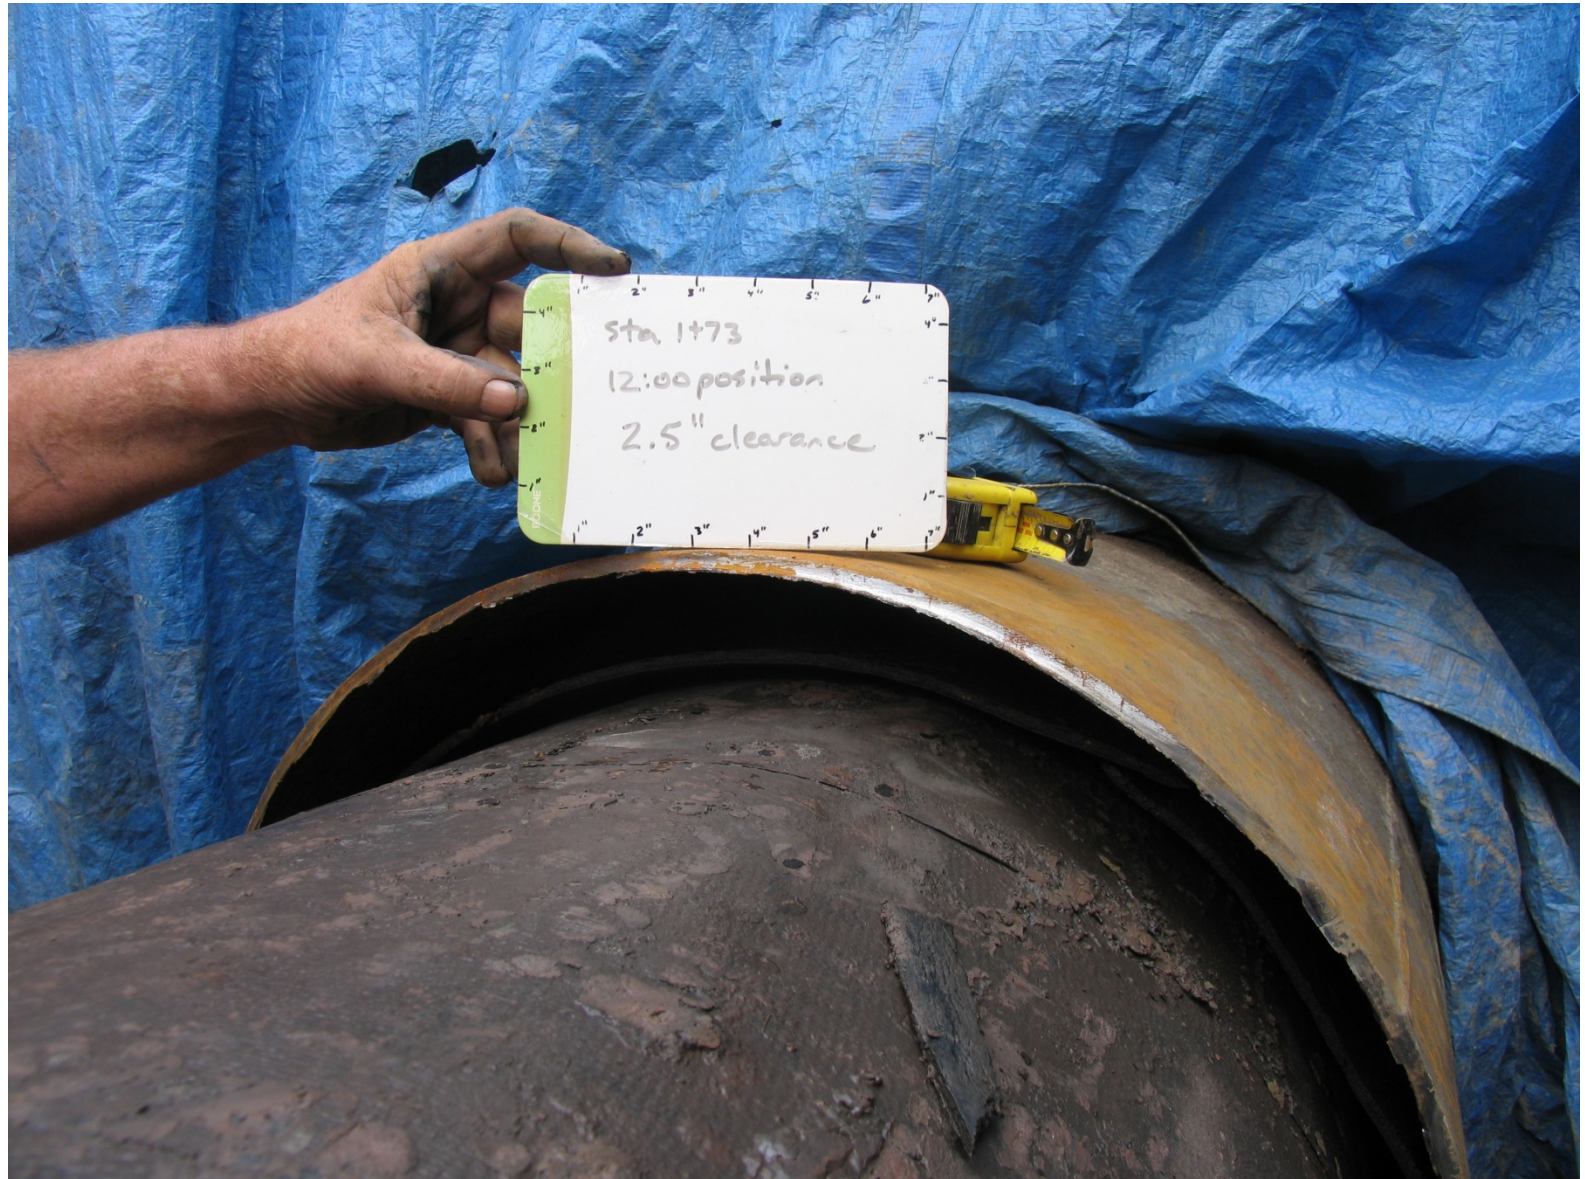
# 30" Casing & 24" Carrier Pipe Company – Rochester Gas and Electric

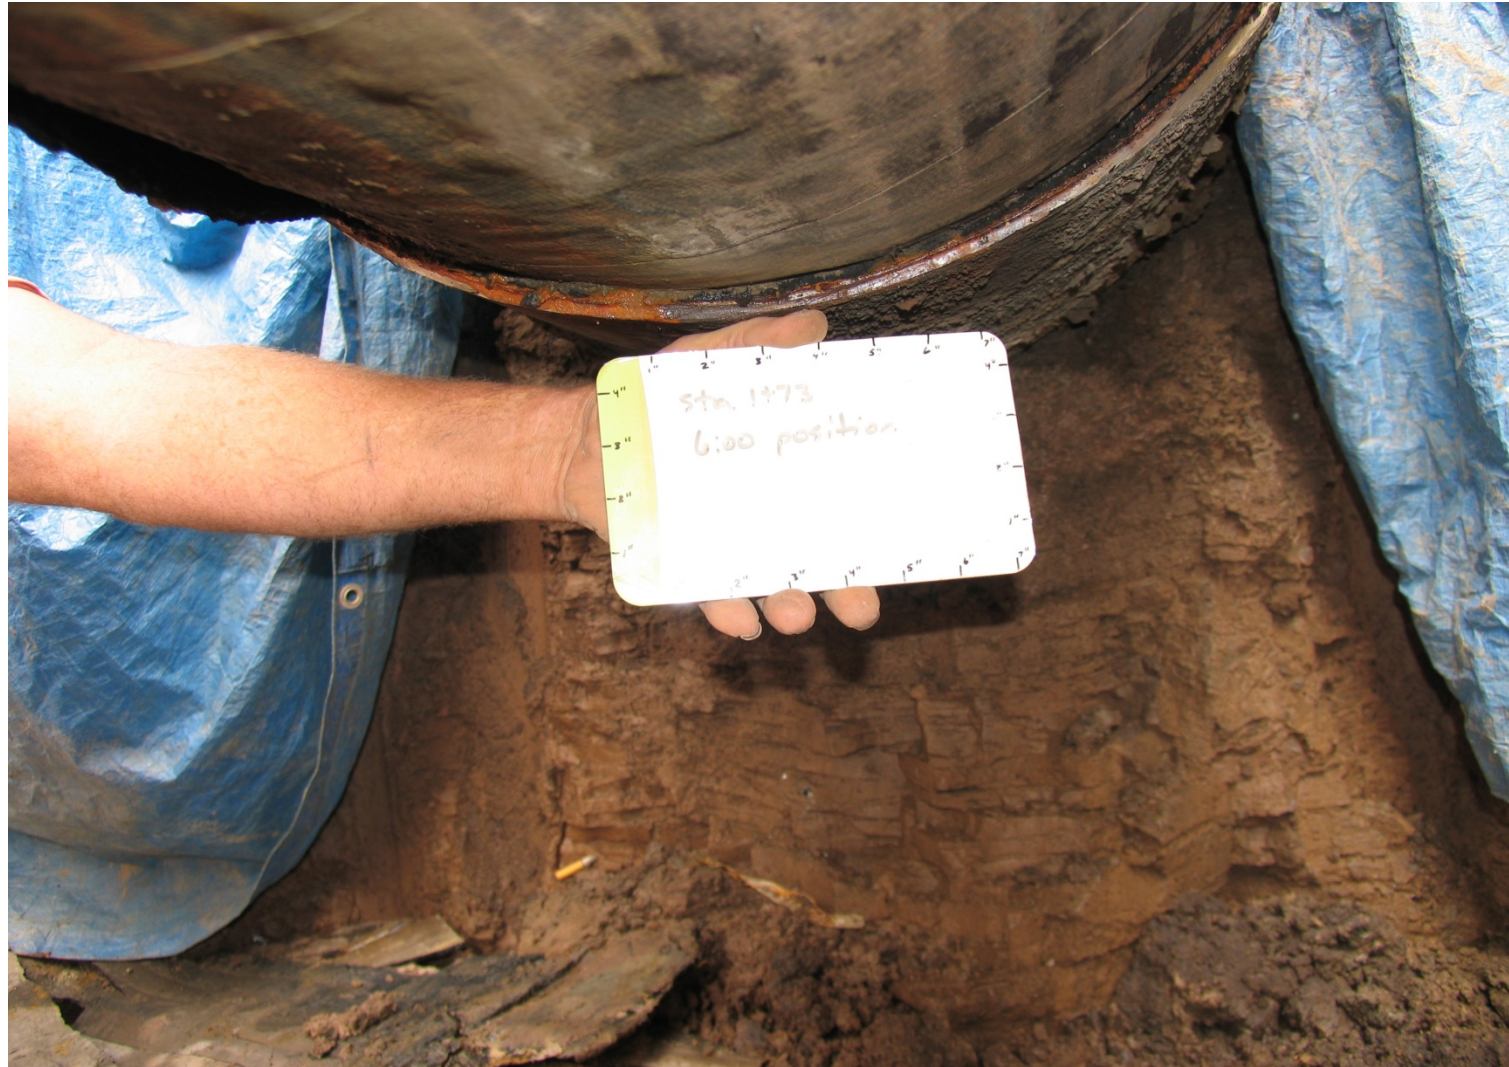
**26" Casing & 22.5" Carrier Pipe  
Company – Rochester Gas and Electric**

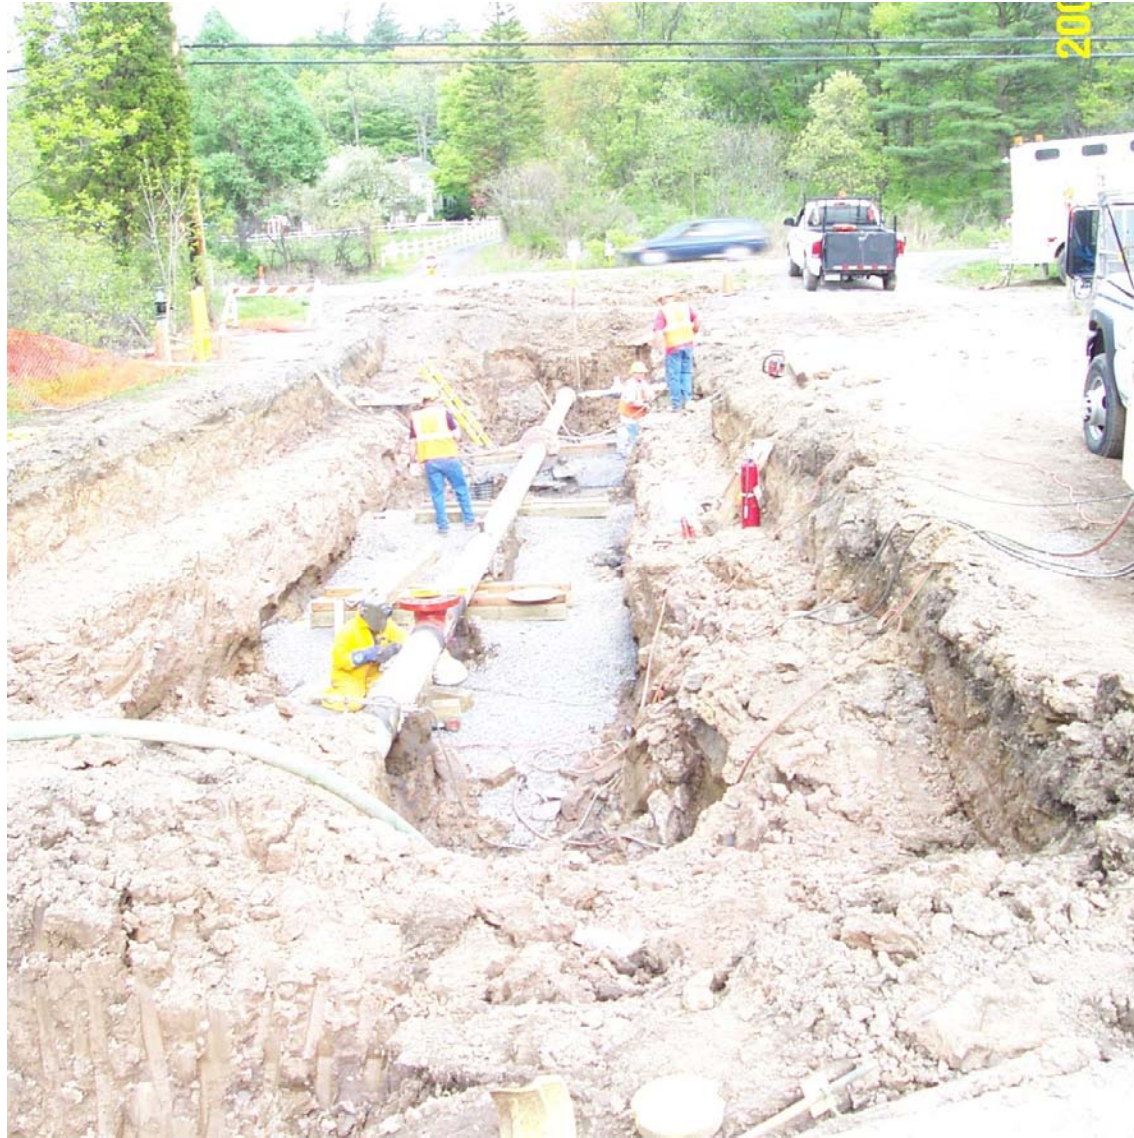
## Road Casing Parallel To RR Company – Central Hudson Gas & Electric

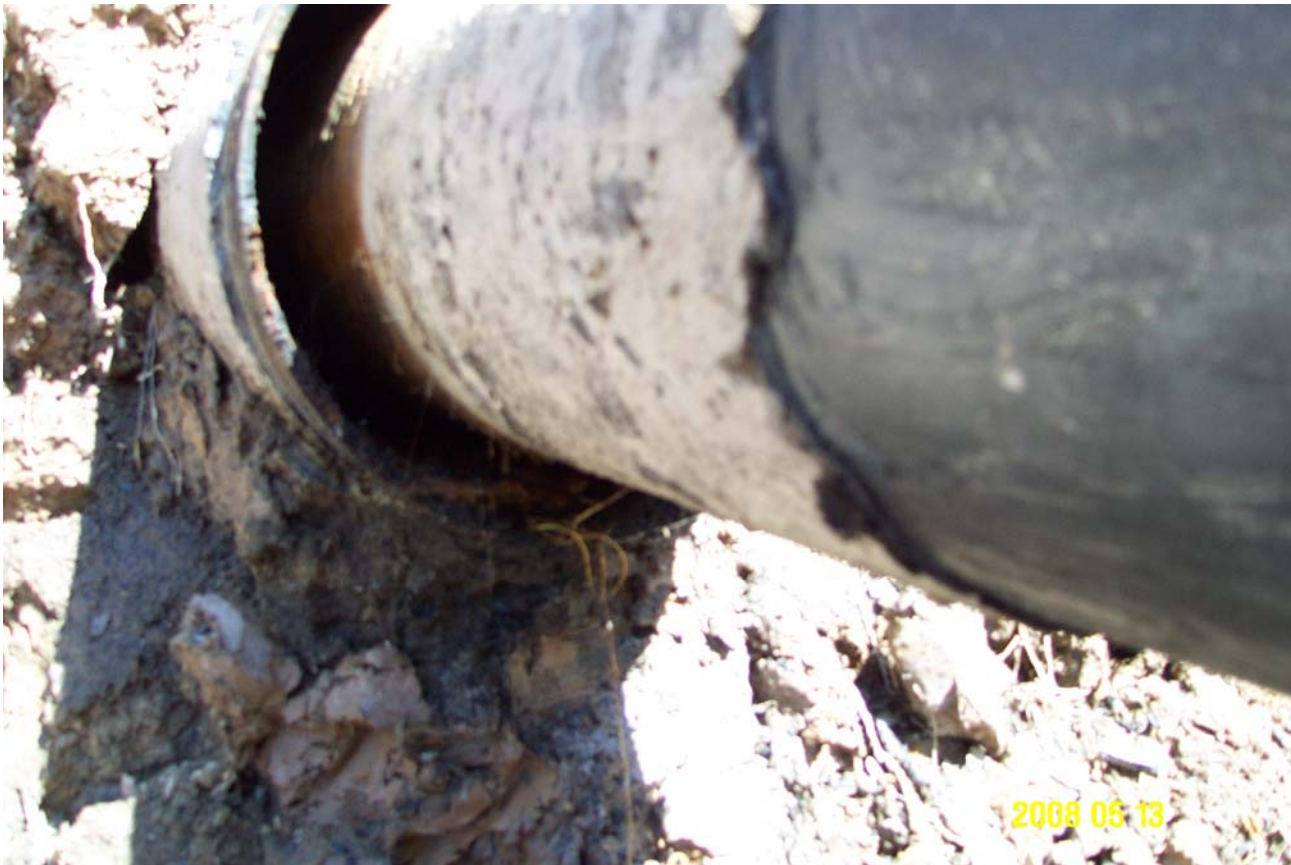
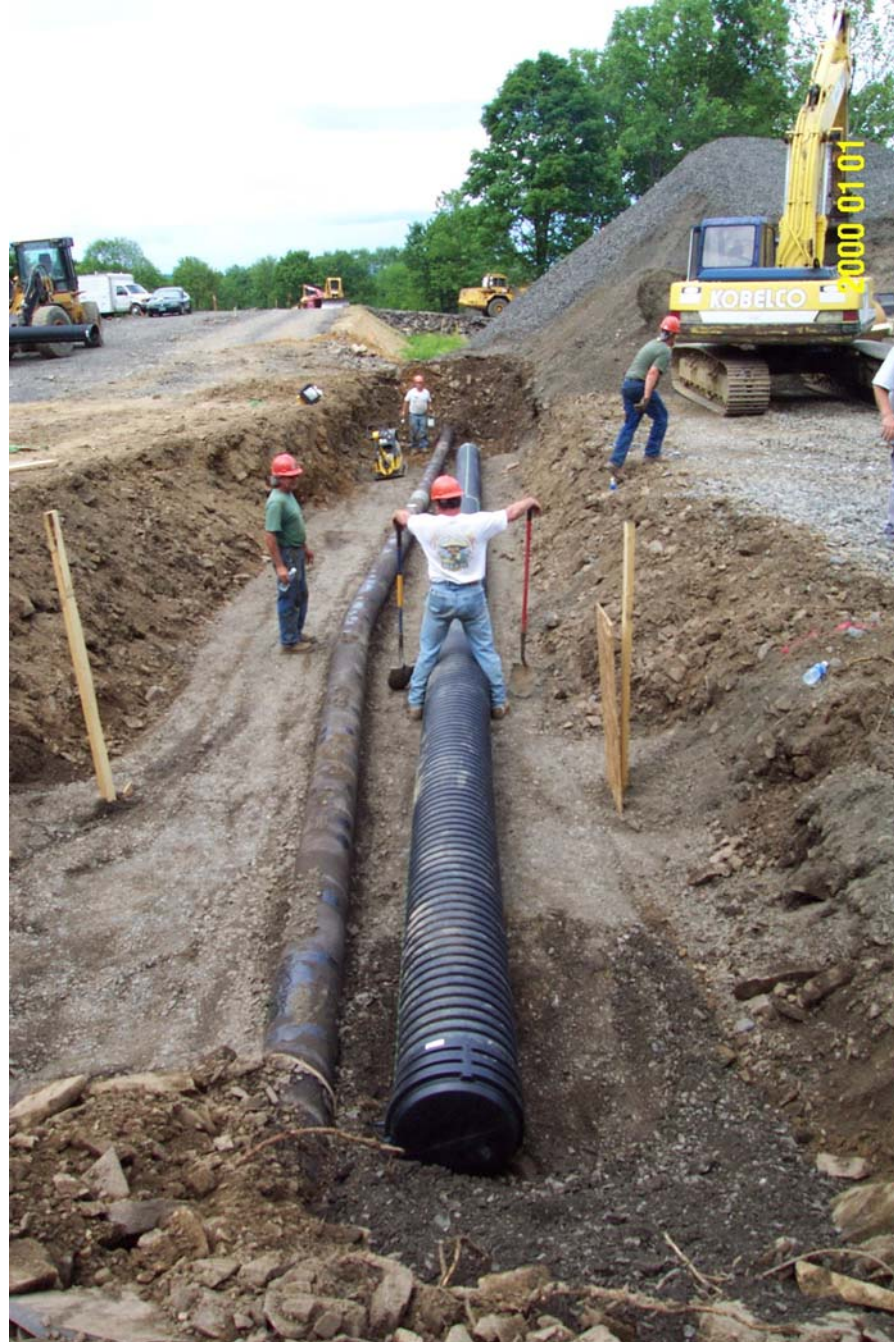
**1957-10.75" Coal Tar Coated Carrier  
14" Casing (13.25" ID)  
Company – Central Hudson Gas and Electric**
