New Technologies for Direct Assessment Monitoring Techniques Carrier Pipes within Cased Crossings

By Joseph Pikas
Corrosion and CP Specialist
Impro-Technologies
jpikas@impro-technologies.com

Direct Assessment for Cased Crossings Monitoring and Criteria

By Joe Pikas

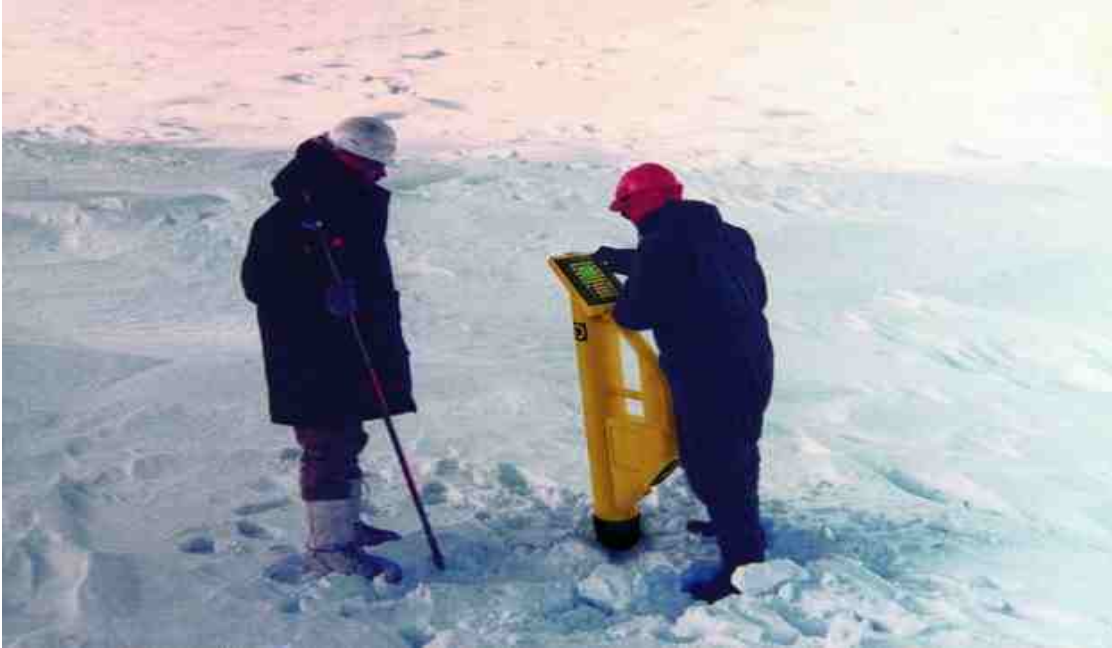
- Current Attenuation (C-Scan or PCM)

- Electromagnetic tool for screening coatings and defects on buried pipes to detect coating defects or metallic shorts.
 - Near signal loss or significant spike in signal current attenuation.

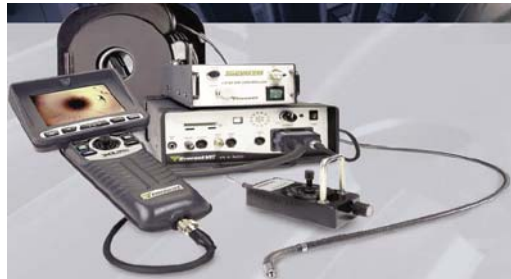
- Borescope (Typical Equipment Used to Monitor Annulus between Casing and Carrier Pipe)

- No Coating Damaged
- Temperature/Humidity
 - Pipe 60 F and Annulus 65 F with 70% Relative humidity

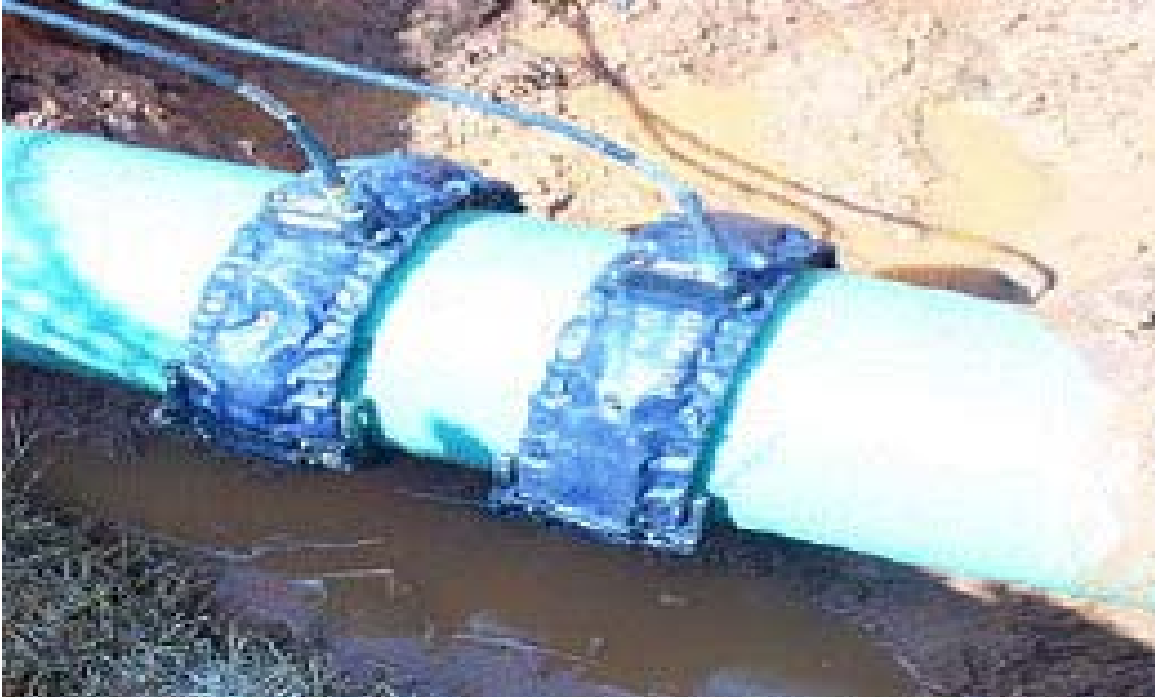
Test Area 89.7' from Indication

Results of Metallic Short with Corrosion

- Potential Test < 2 mV (Possible Short)
- Internal Resistance Test (< 0.015 ohms)
- Four Wire IR Drop (U/S side)
- Borescope (No Atmospheric Corrosion Found)
- Humidity (70% Relative Humidity and $\Delta t = 5 F$)
- Long Range Guided Wave Results
 - 20 to 27% metal loss in the 11 o'clock position 3' outside U/S end of casing

- **Metallic Short - U/S side of Road Crossing**
 - Potential, Resistance and 4 Wire Tests indicated a metallic short
 - Low P/S, C/S & OCP potentials
 - Little or no potential difference between each one.
 - Low internal resistance between casing and pipe
 - Four wire drop test U/S side
 - Electromagnetic test showed spike or near signal loss
 - Verification using Long Range Guided Wave showed 20 to 27% metal loss
 - Prove up using a bridging pit gage or conformable array to measure metal loss
