Pipeline Safety Research and Development Forum
October 31 to November 1, 2023

STRAIN TOLERANCE OF LINEPIPE

SEISMIC RESISTANCE OF NPS 24 X 17.6 X65 HFW PIPE

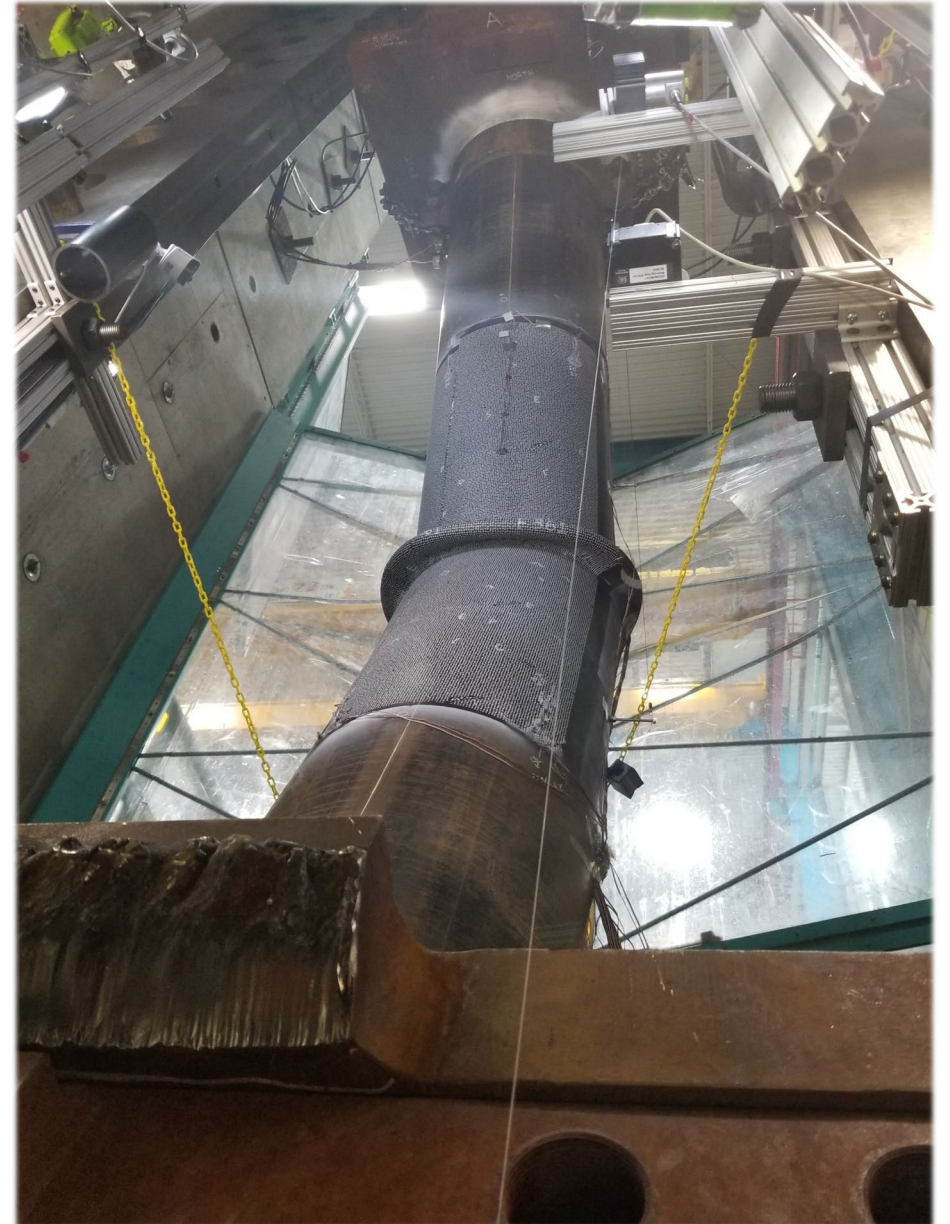
15 MN (3,500 kip) load frame

Specimen capacity:

15 m (49 ft) length

1.5 m (59 in) diameter

27 MNm (20,000 ft-kip) moment
arms and bending actuator

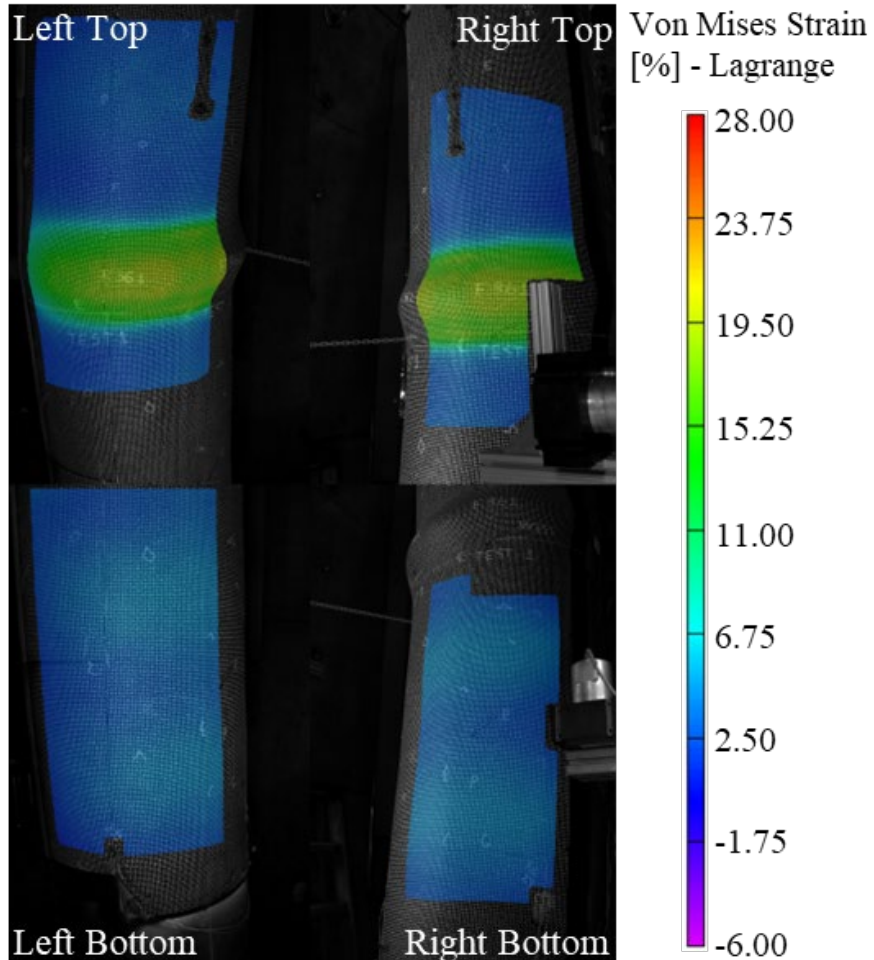
17.8° Bend Angle

Strains Measurements During Testing

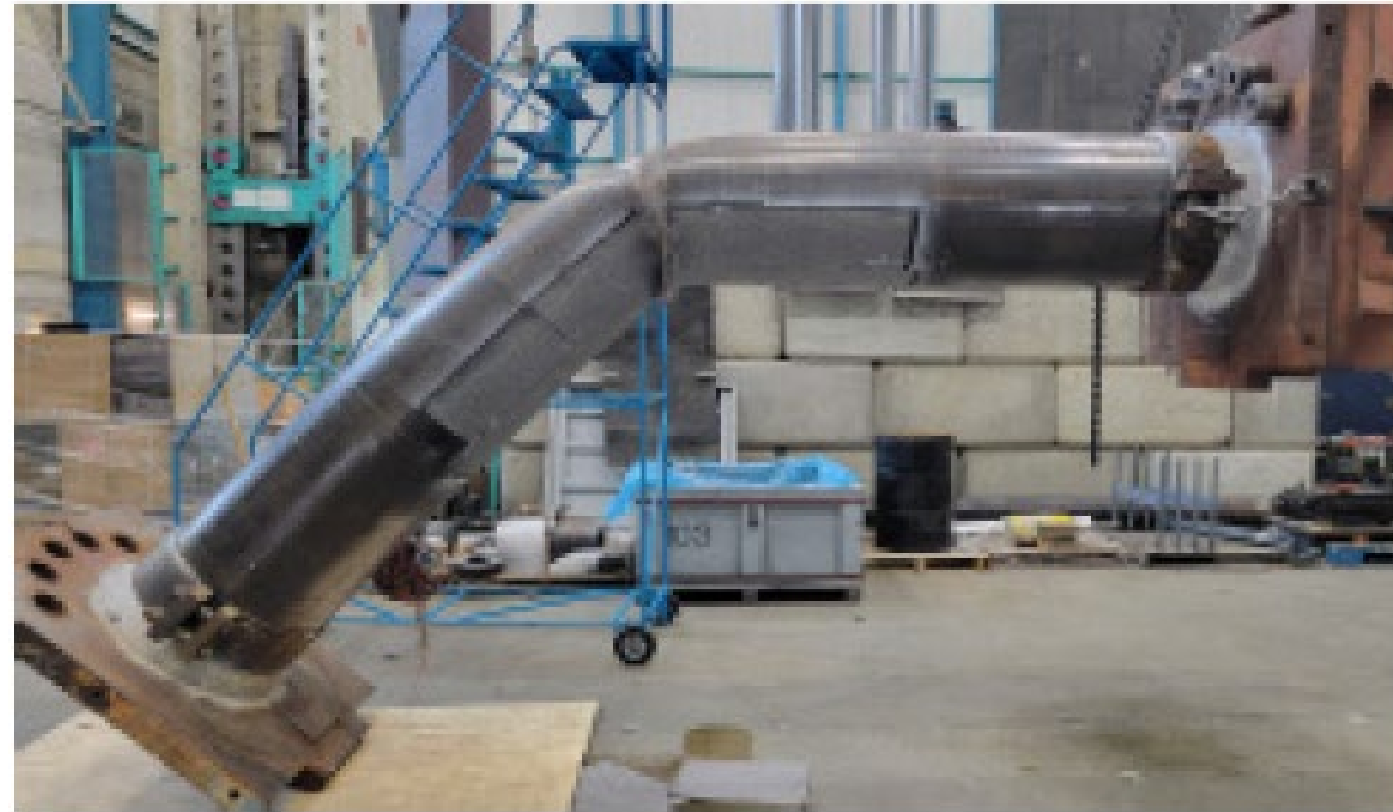
Achieved a 51.2° bend angle

**Observed severe buckling
with self-contact**

**Found no leakage or loss of
containment**

- NPS24 X65 pipe bend test
 - 51.2° bend angle
 - Buckle developed past the point of self contact
 - No leakage or loss of containment
 - Cracking/tearing likely due to local strain reversal
- Other C-FER Testing Experience
 - Pressure capacity does not seem to be significantly undermined by high axial strains
 - Pipe body materials have sufficient ductility to accommodate significant axial strains

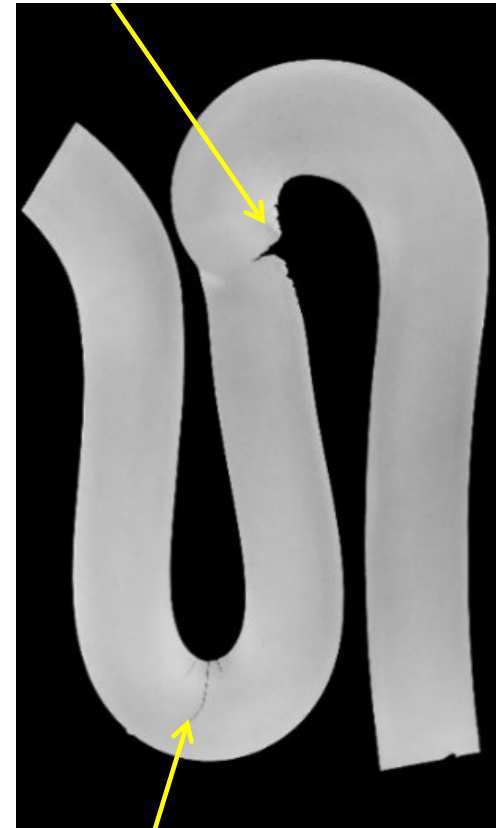
Tear from OD

- Crack on inner surface of buckle crest
 - 69% of wall
- Tearing through outer surface of buckle valley
 - 36% of wall
 - Possible local strain reversal
- Approaching critical state but no leakage

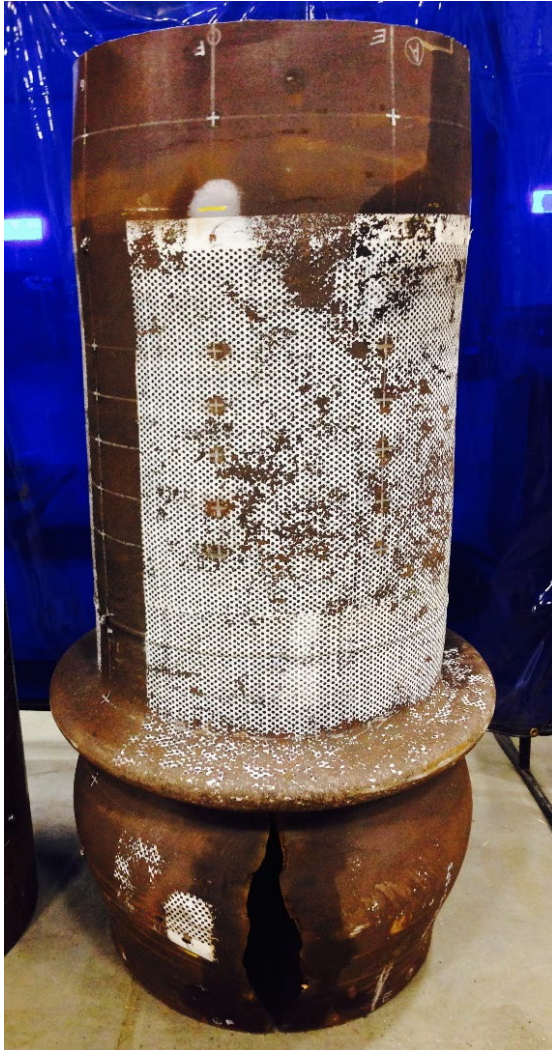
Axial Pre-strain Followed by Burst

Specimen Identification	2D Axial Pre-strain	Burst Pressure	Maximum Hoop Strain at Burst
	(% ϵ)	(MPa)	Top/Bottom (% ϵ)
1	0	31.2	6.4
2	-1.11	31.9	7.7
3	-17.2	28.2	31.4 (19.3 at burst location)
