AERIAL MAGNETOMETRY FOR THE PRECISE 3D-POSITIONING OF PIPELINES

Non-intrusive solution in geotechnical and hydrotechnical context

Identification of technical challenges and solutions to improve pipeline safety and protect the environment.

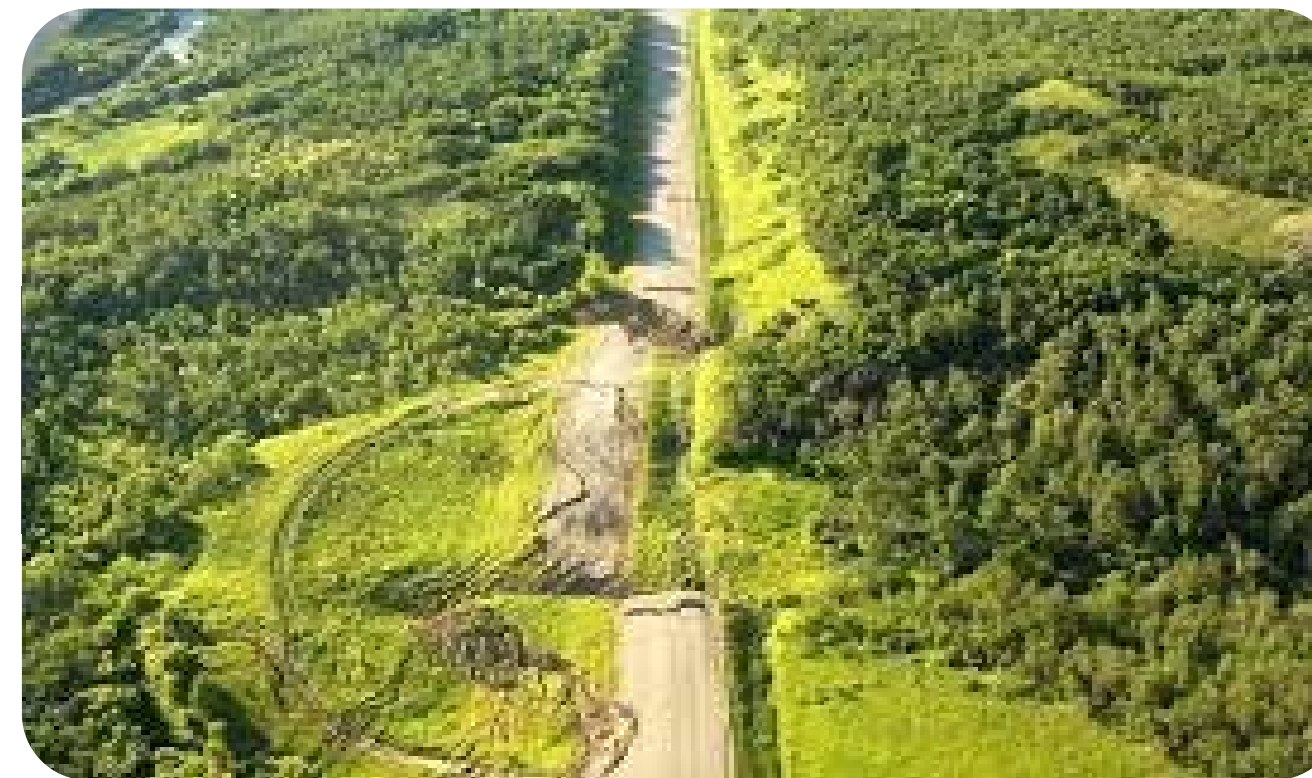
Landslide at the pipeline ROW

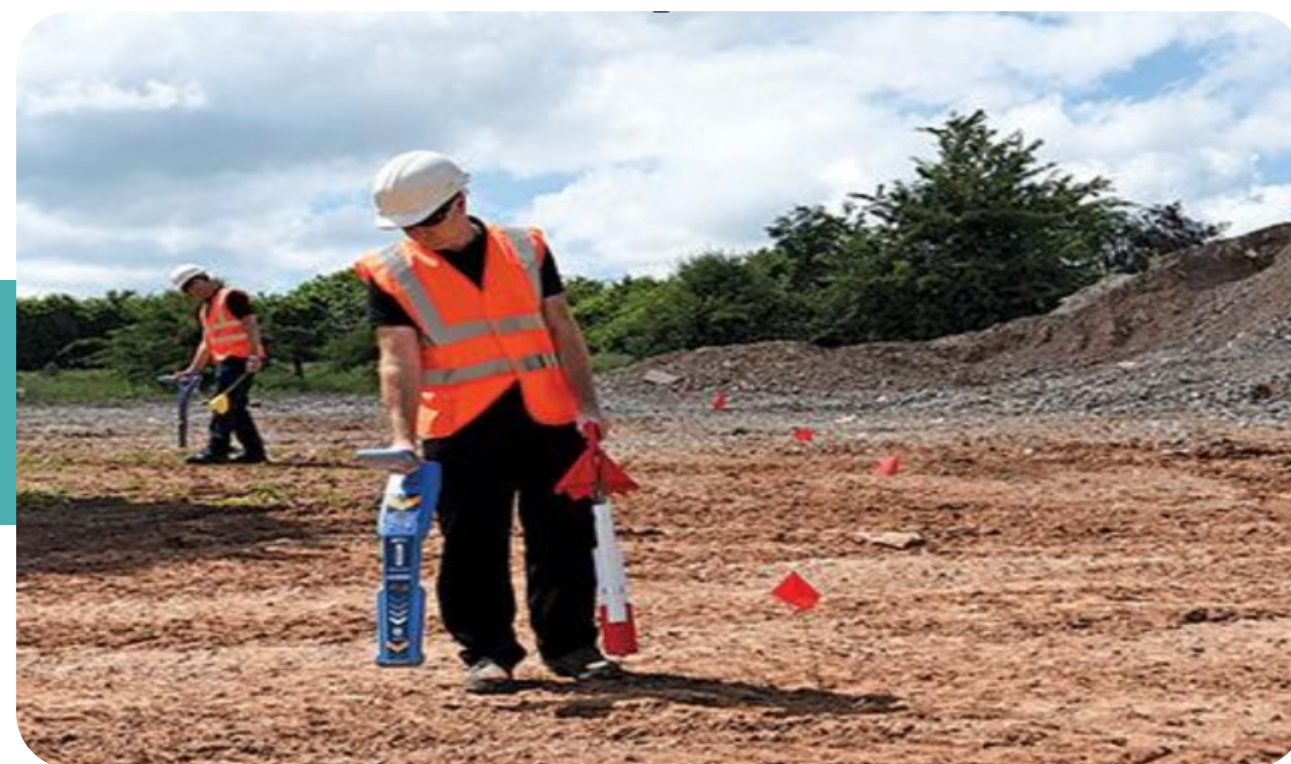
ON-SITE INSPECTIONS

Position of the asset determined using handheld EM locators and soil sampling

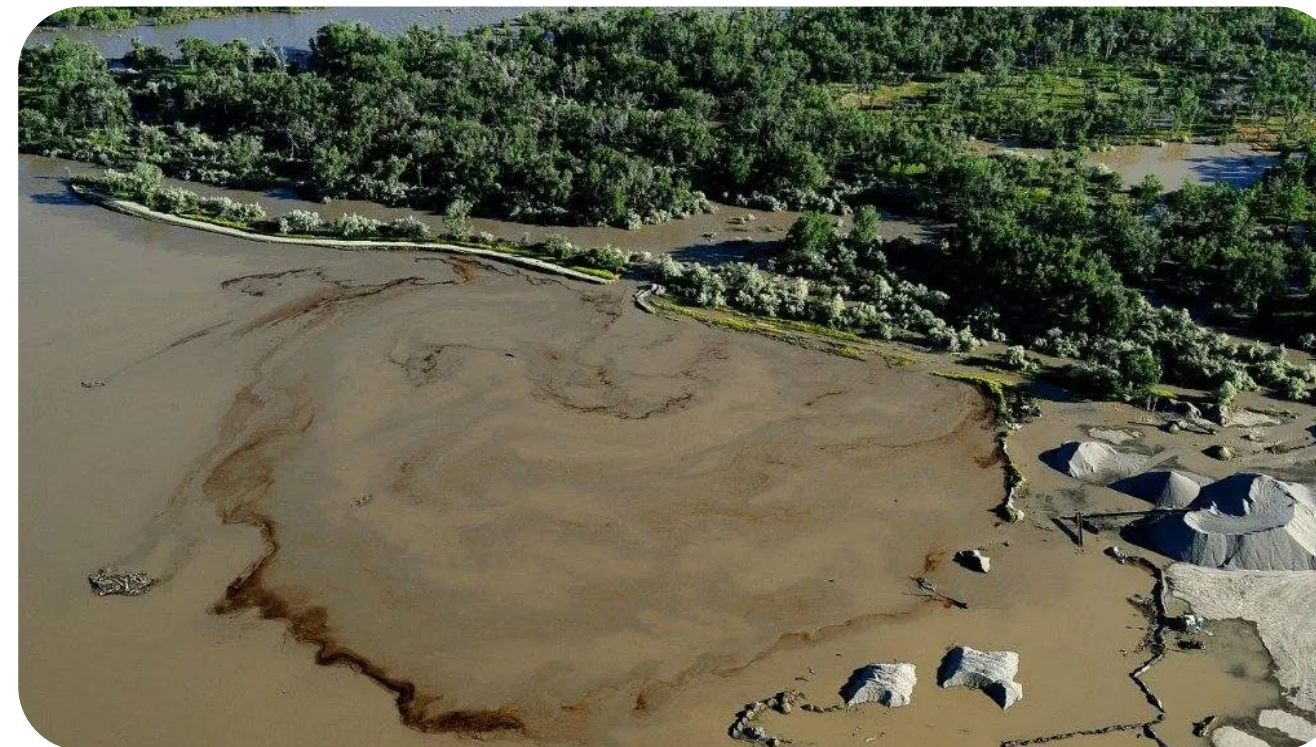
Pipeline failure at river crossing

Yellowstone river

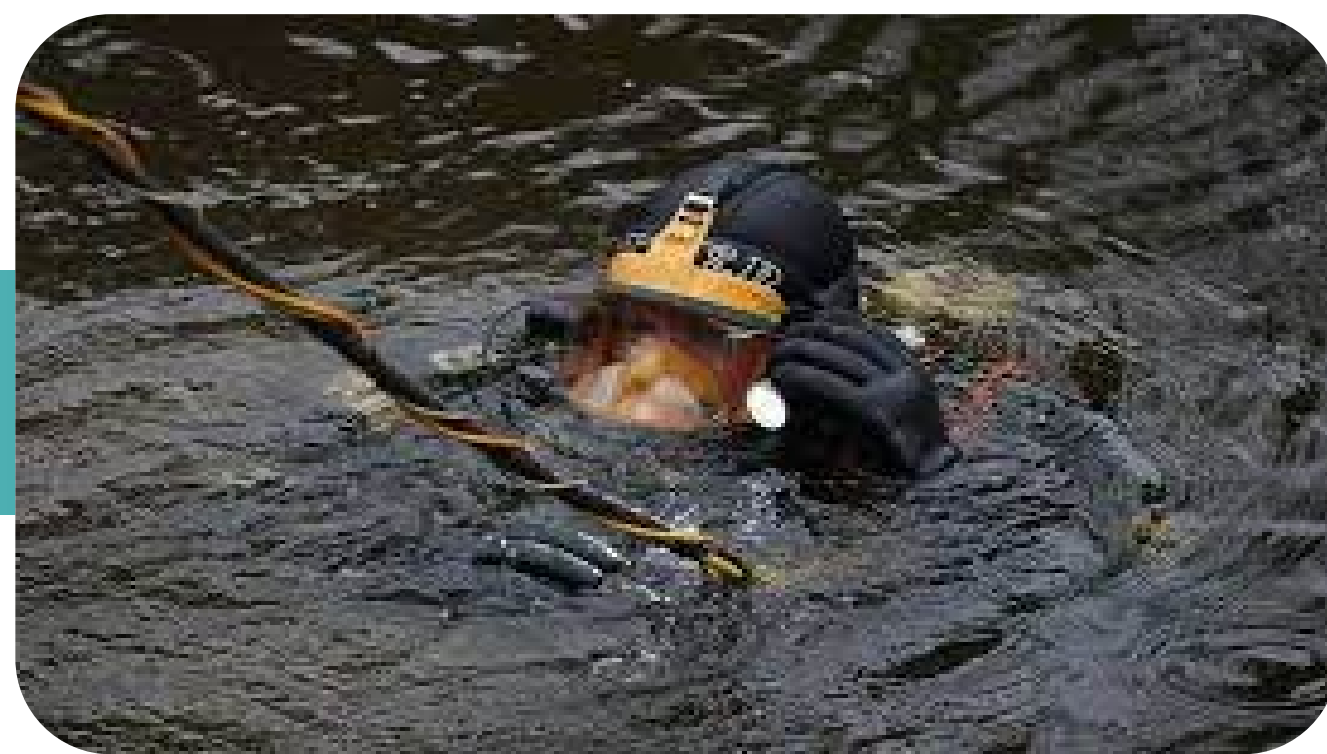
Divers inspection

Depth of cover assessment on the riverbed using handheld EM locators

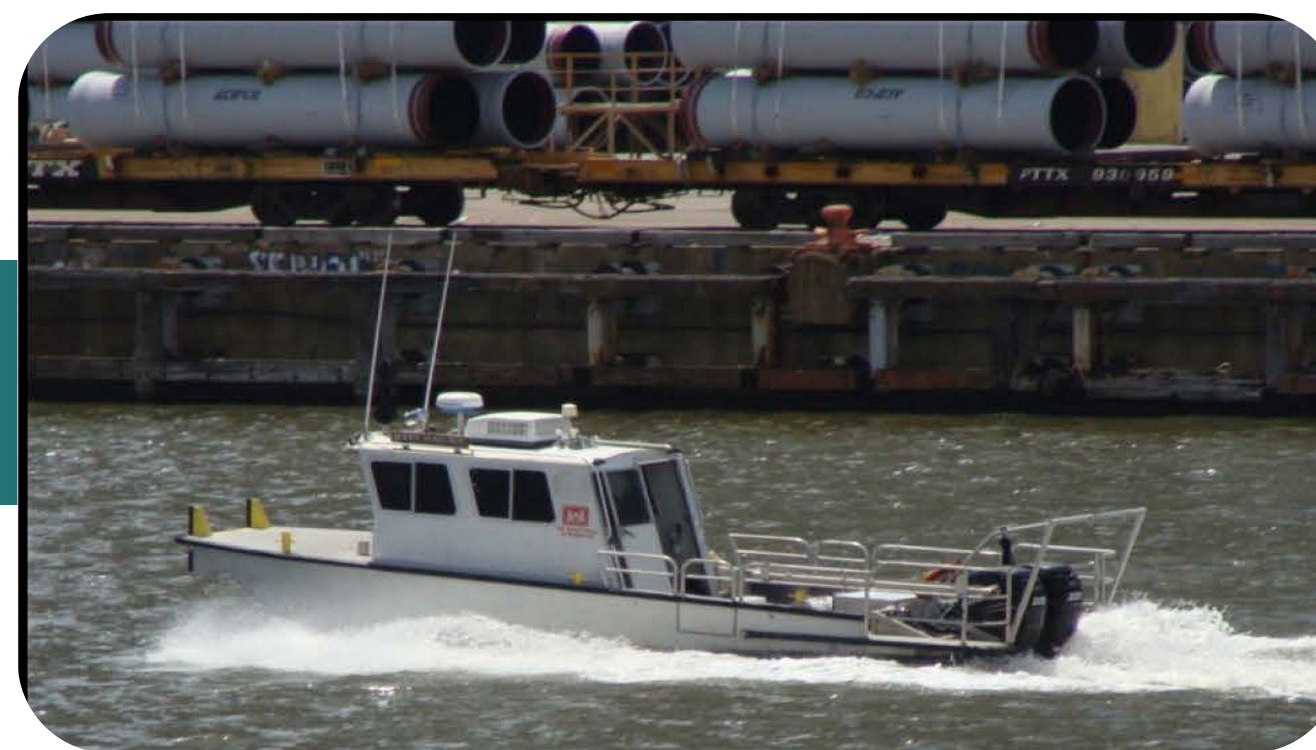
Boat inspection

Bathymetric survey using boats and large river crossings

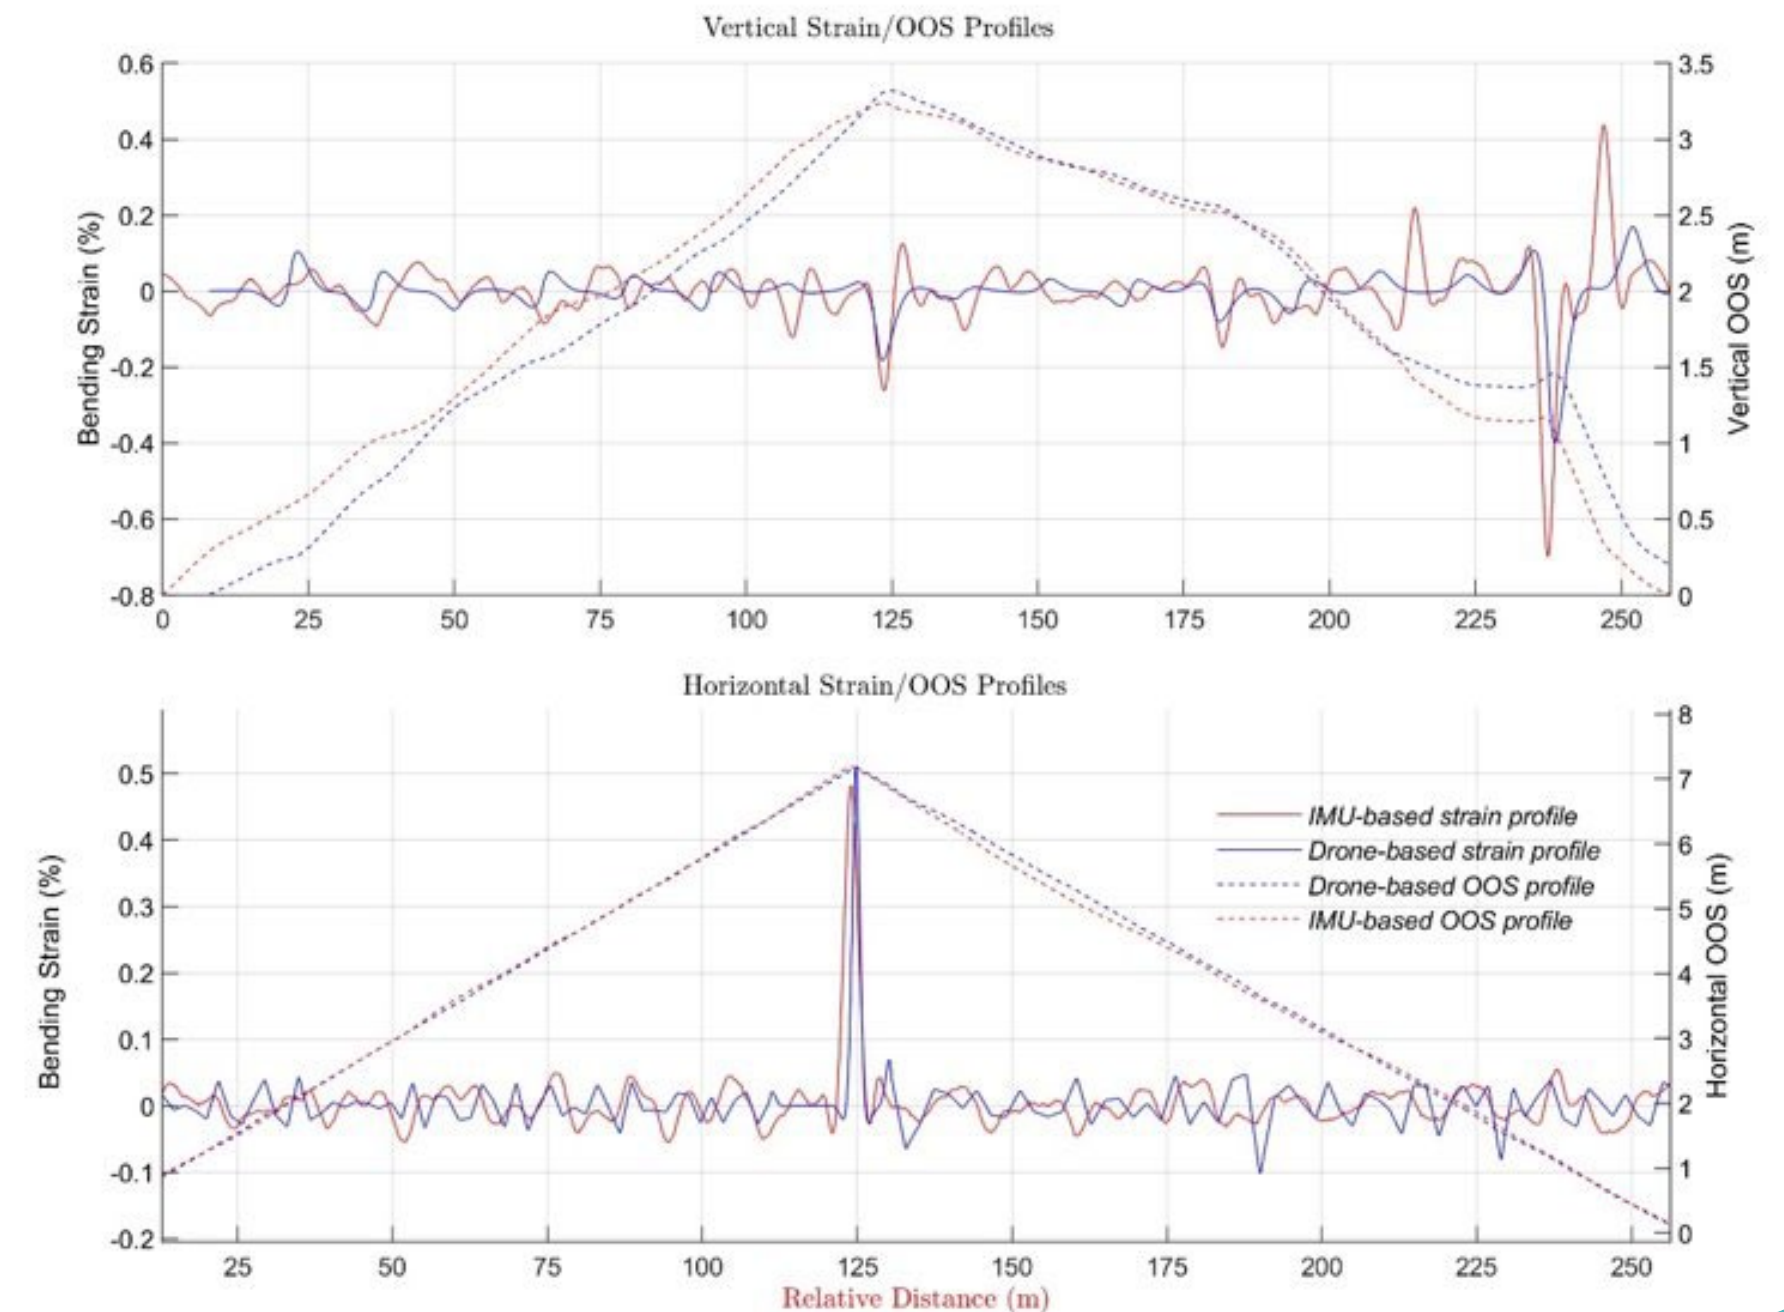
This 3D position can be derived into Out-Of-Straightness calculations and Bending Strain estimations

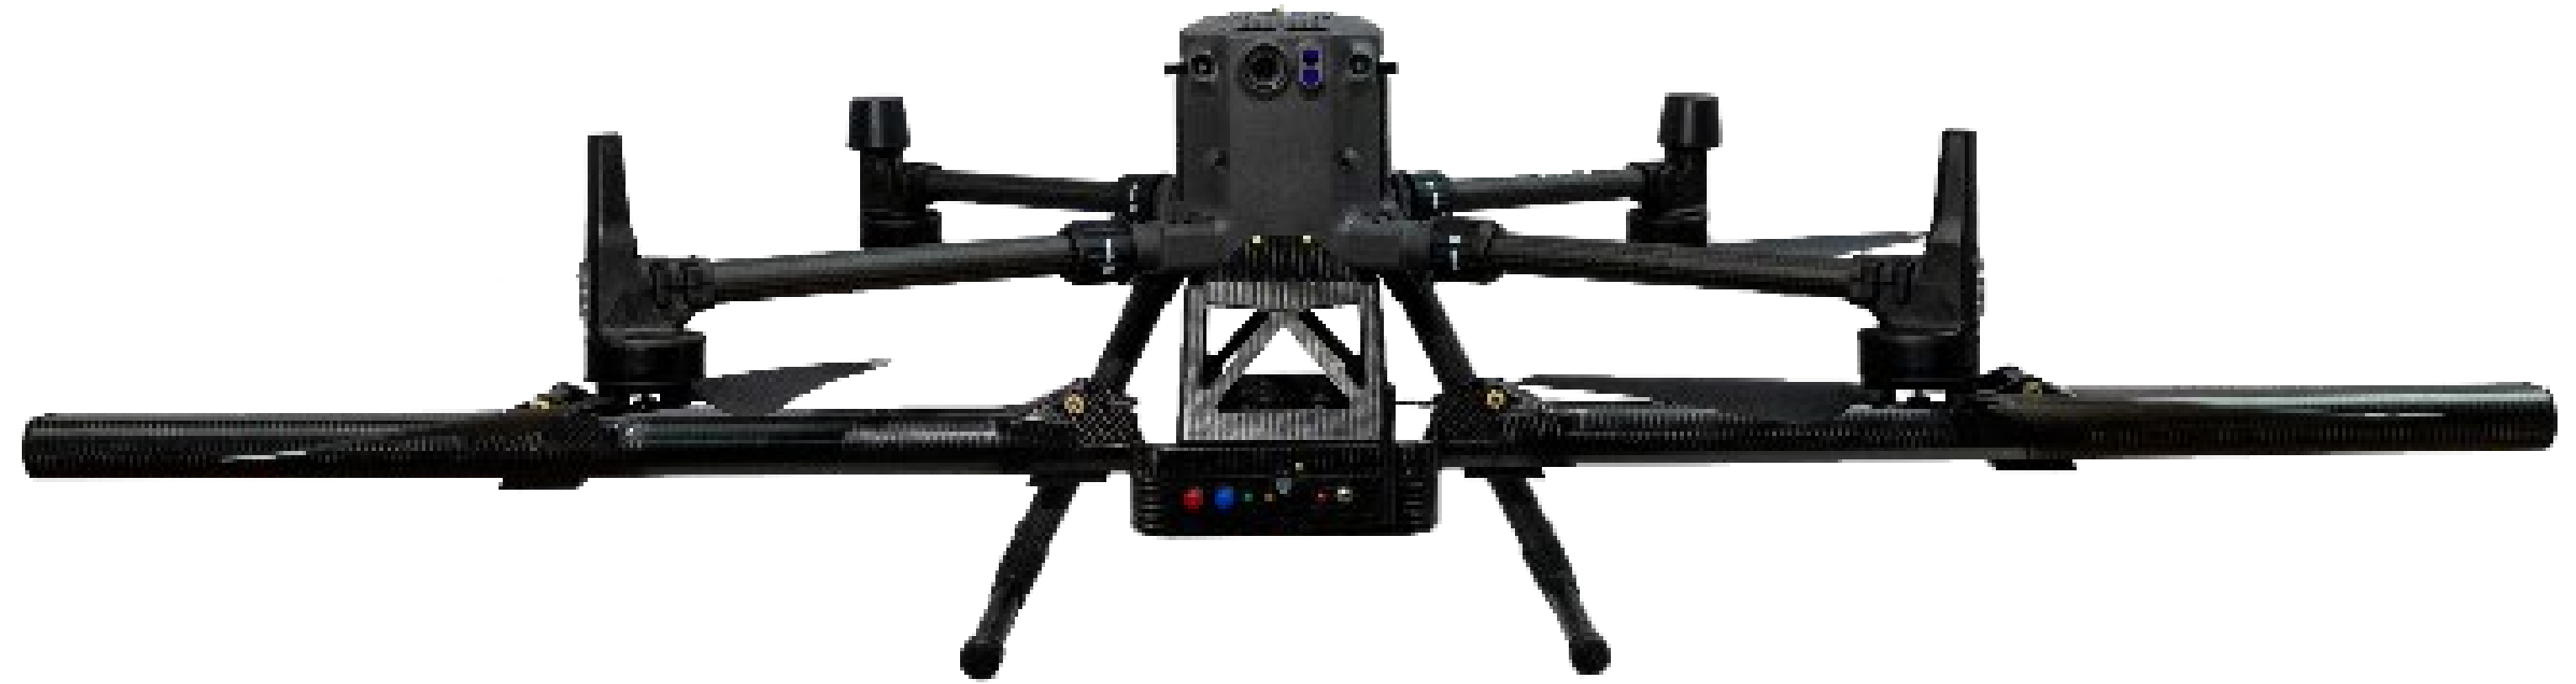
4.4 lb carbon fiber payload

63" wingspan enabling underwater mapping.

Skipper NDT's embedded system mounted under an off-the-shelf UAS

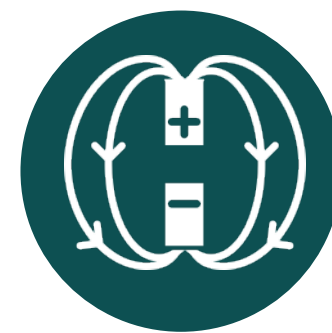
Magnetometers

- Fluxgate 3-axis magnetometers
- Light, robust with high acquisition frequency
- Allows calibration/compensation process

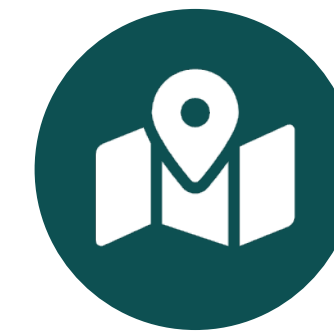
GNSS

- Real time Precise Point Positioning (PPP) correction services
- Accuracy $\pm 1.5''$ cm at 95% rms worldwide
- Facilitates operations and logistics

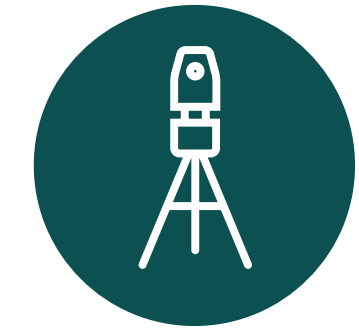
Navigation sensors

- Inertial Measurement Unit (IMU) for level-control
- Telemetric sensors for topography
- Allow post-processing corrections

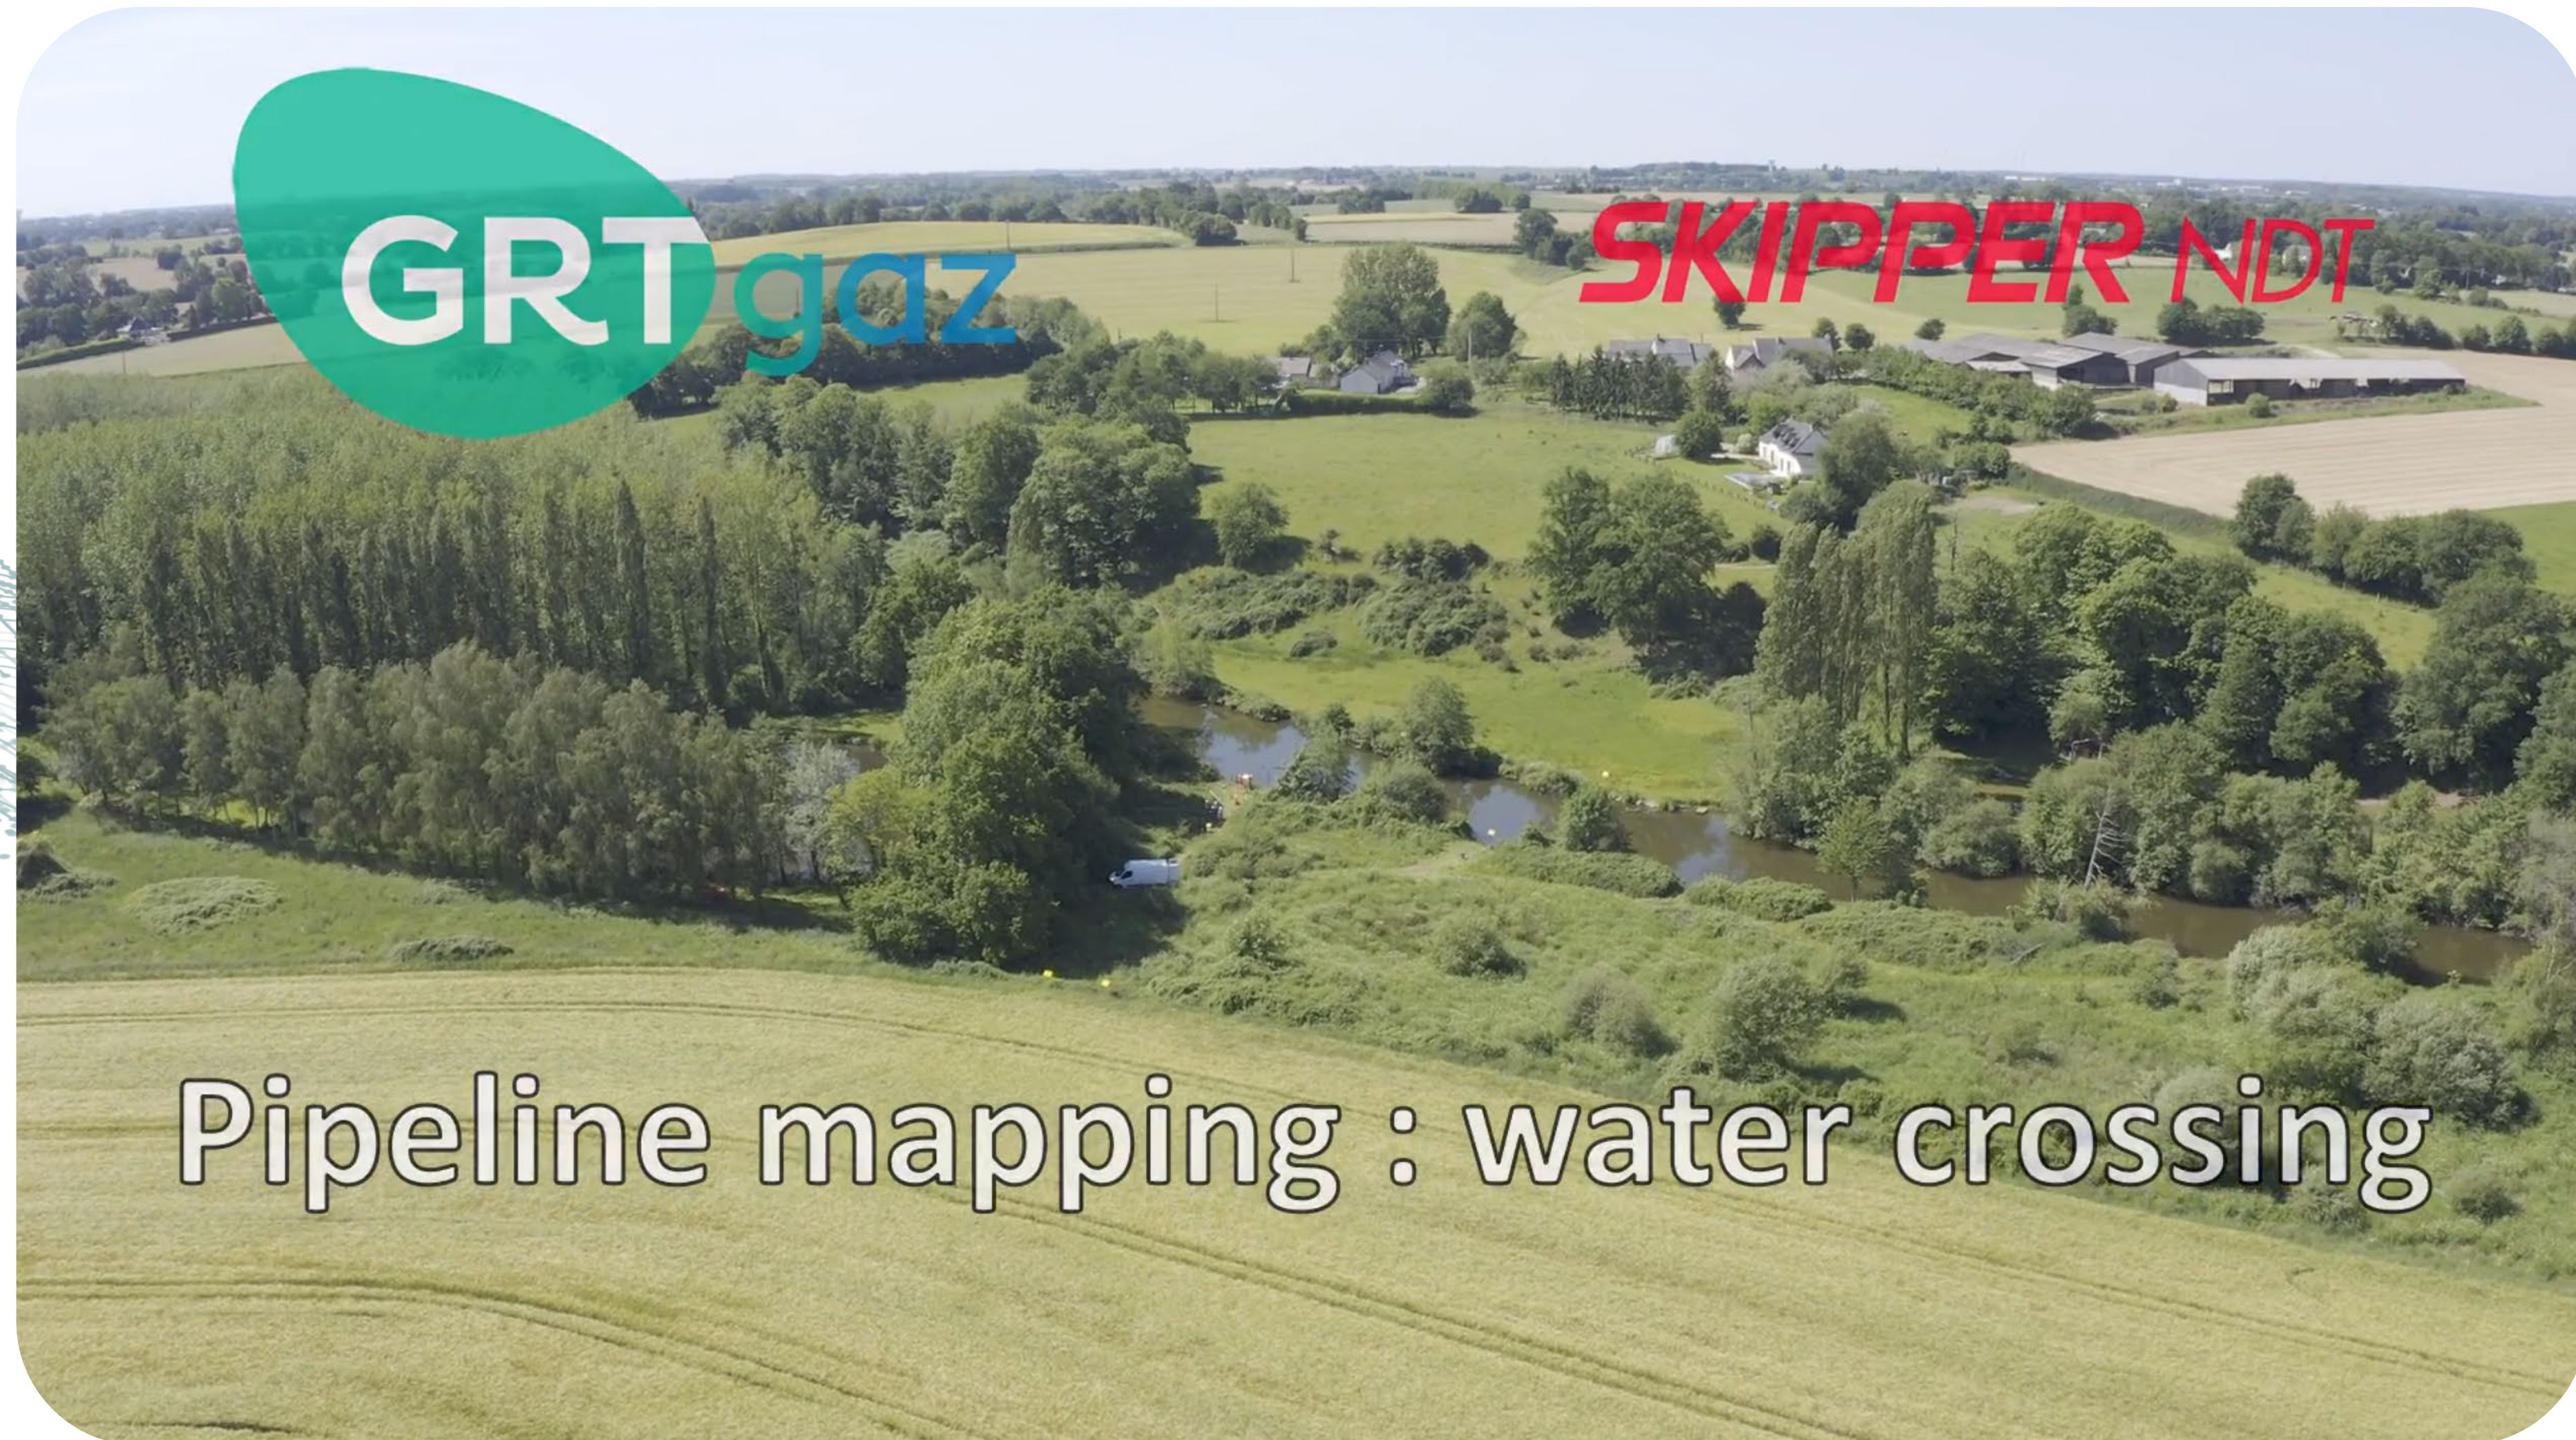
Automated, precise, reproducible and safe process compared to traditional tools

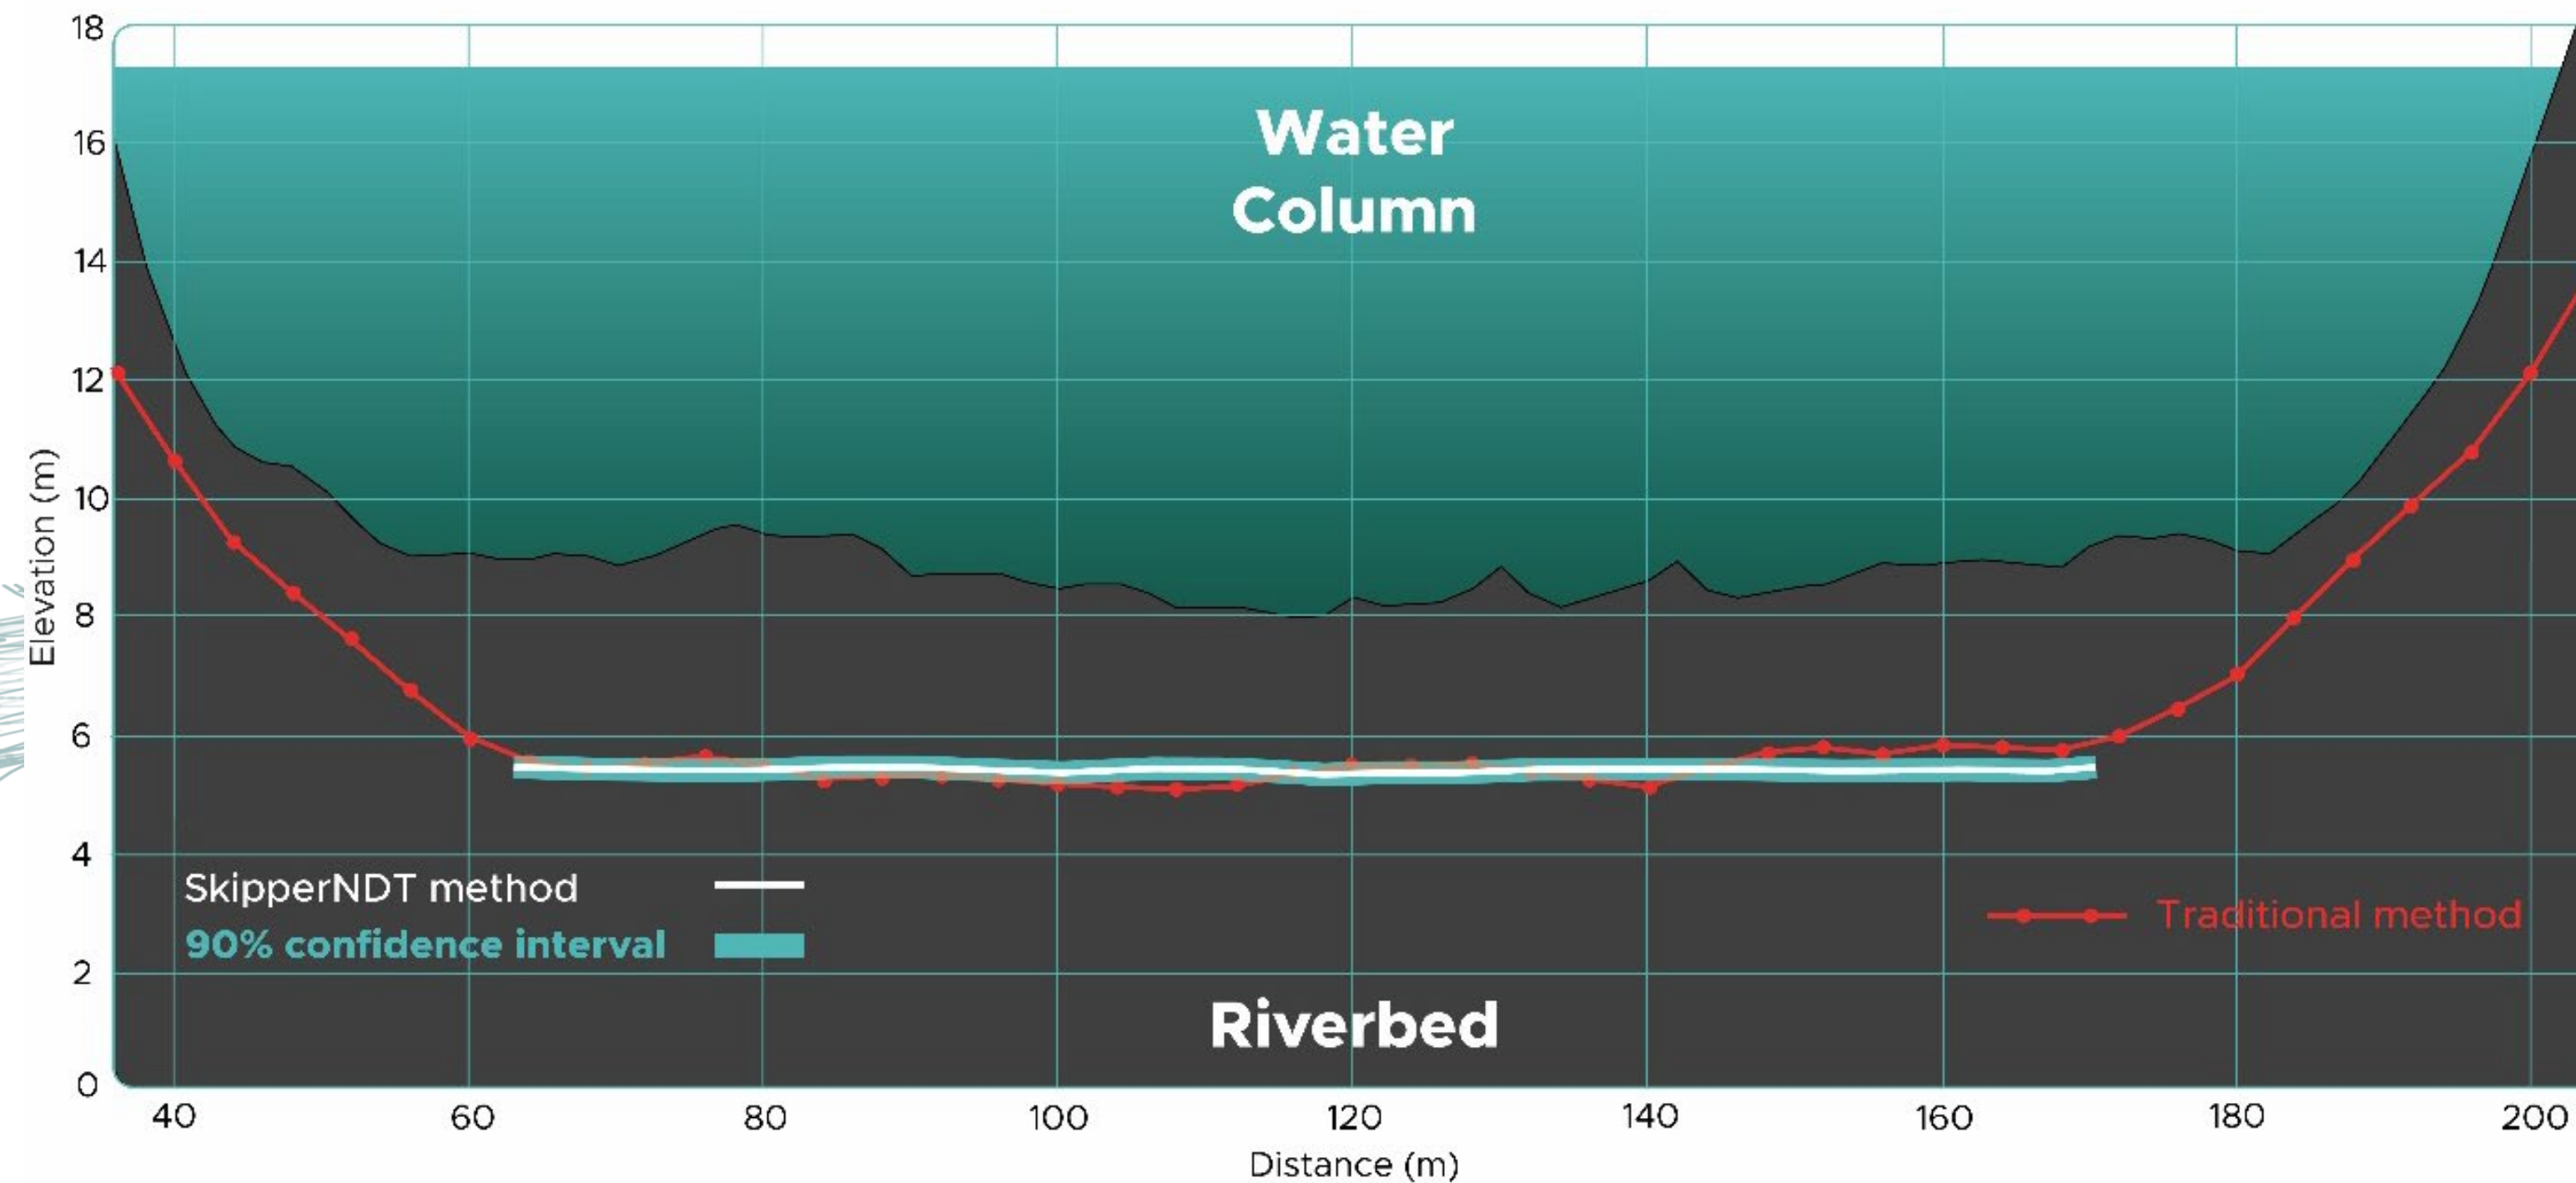
Elevation profile compared with traditional method: 1.2" VS 8.6"

Accurate and precise 3D measurements

Elevation profile correctly measured at 42.6 ft maximum distance from sensor to centerline

Unlocked XY-positioning capabilities compared to the traditional "straightness assumption"

- Traditional method : 6.5 to 13 ft
- Magnetic mapping : 19.6"

- Average elevation value are equal for both methods at 16.4 ft AMSL

- Traditional method : 8.6" STD
- Magnetic mapping : 1.2" STD

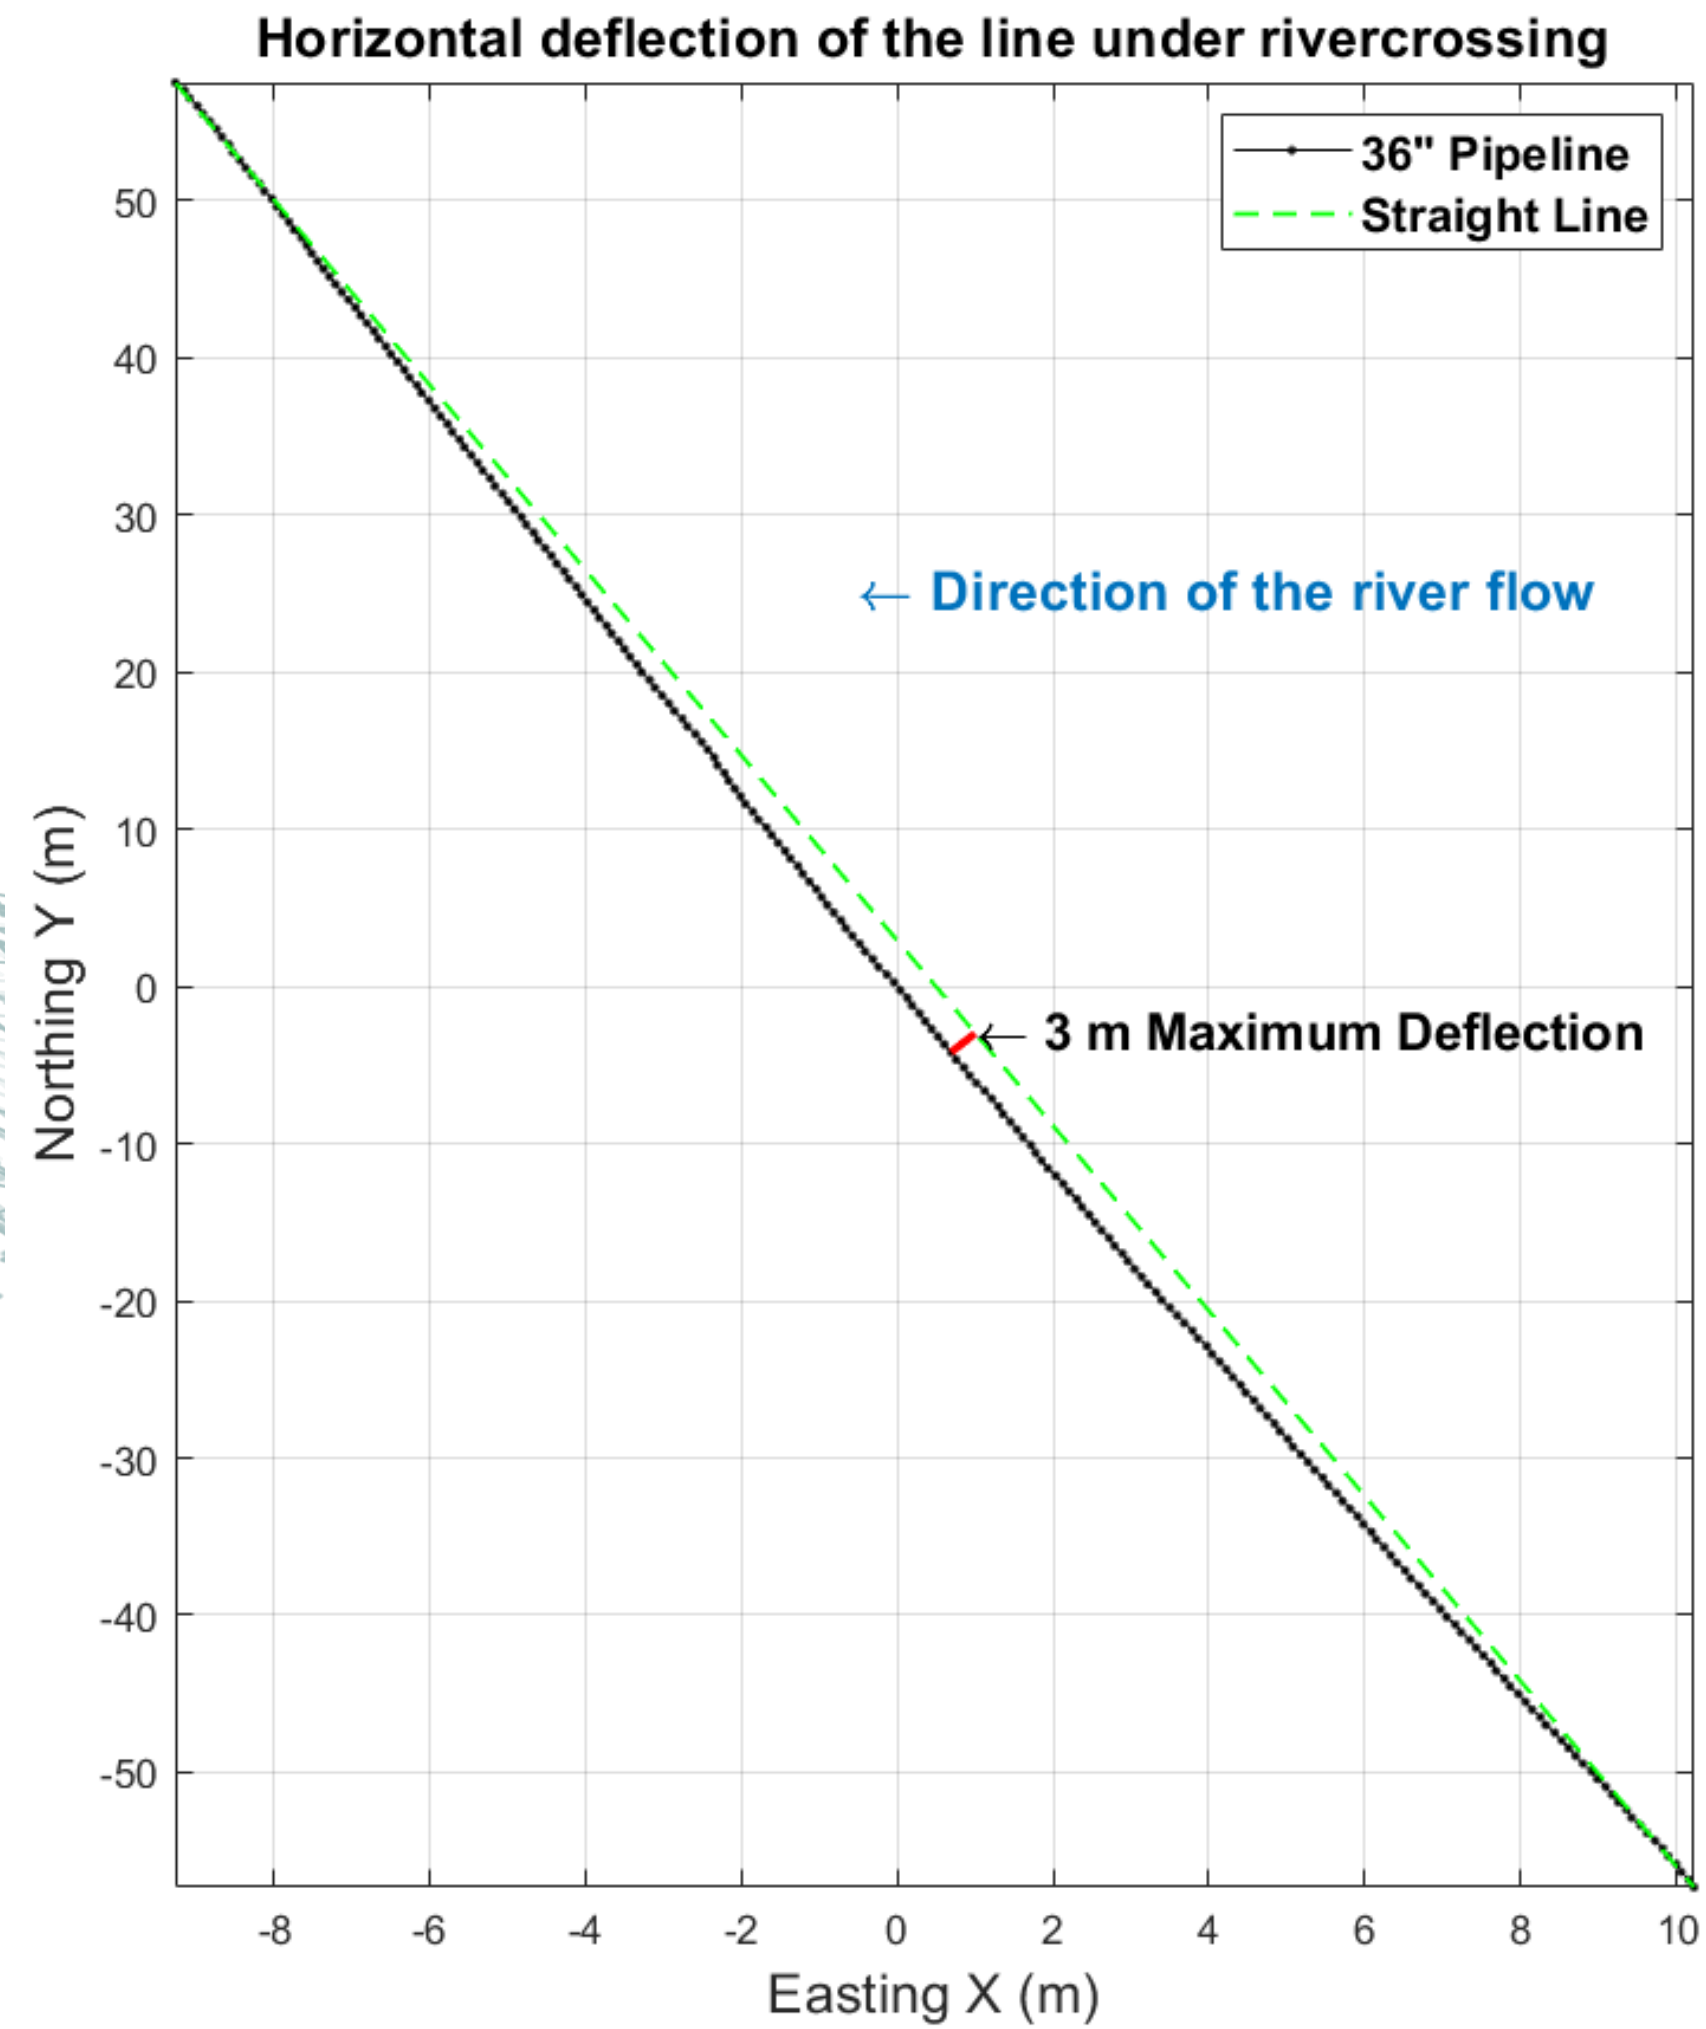
Planimetric analysis and Out-Of-Straightness
