Multi-Sensor Platform for Right of Way Defense

Pipeline Safety R&D Forum 2023

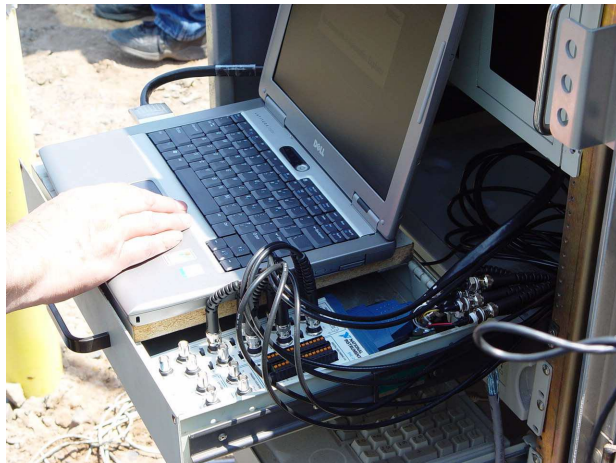
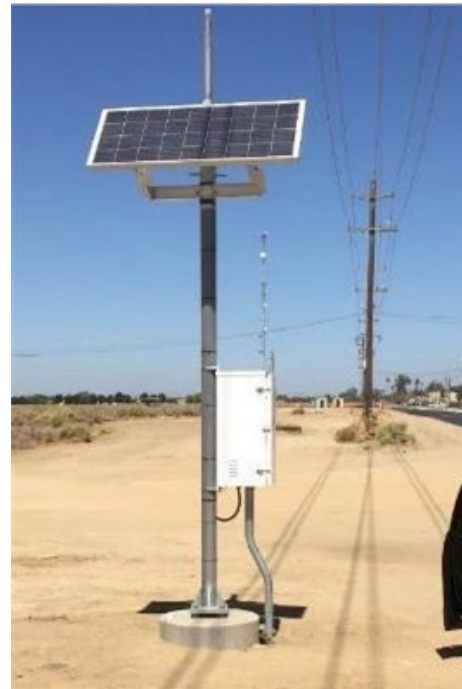
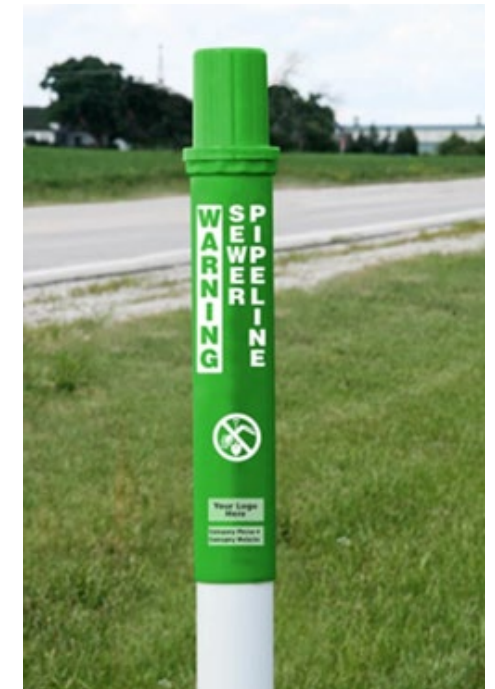
Right of Way Monitoring Timeline

- The technical progress has been driven by improvements in:
 - Sensing
 - Low-power electronics
 - Miniaturization
 - Wireless communication

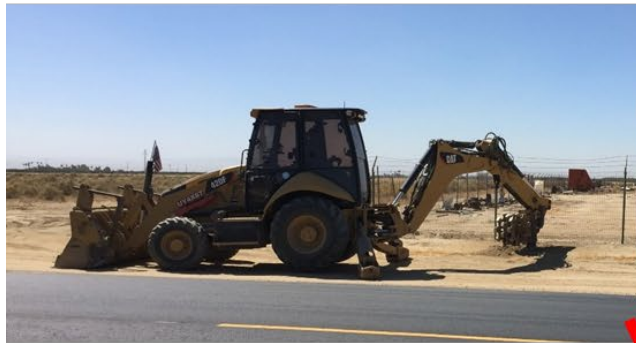
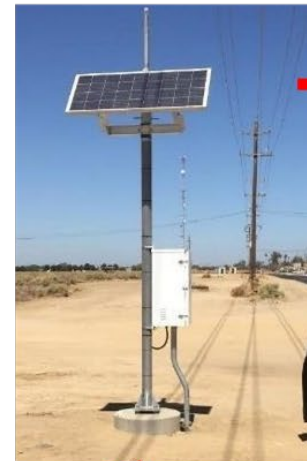
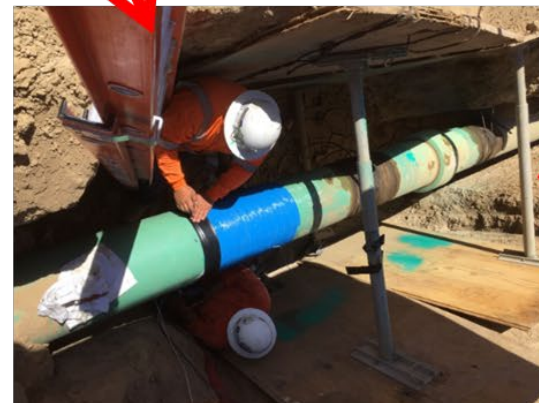
- Project with CEC/OTD deployed a system in the field.

A sensor-based system that monitors for ROW activity

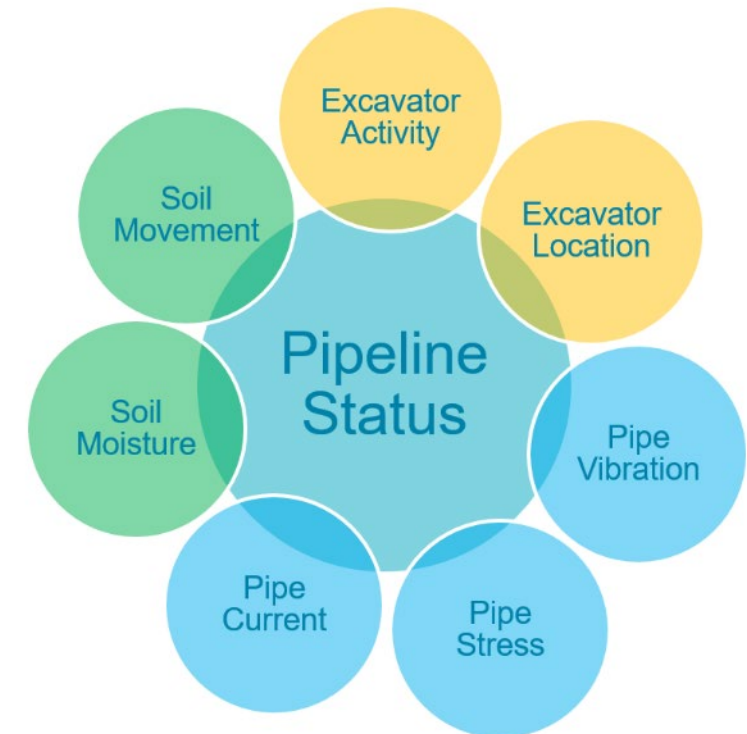
- The objective is to provide operators with timely situational awareness of threats to pipeline integrity.
 - There are multiple threats on the pipeline right of way (ROW)
 - Third party damage is the most visible threat
 - There are also slower acting, cumulative risks to consider
 - Extreme weather and geohazards must also be considered
 - Multiple sensing technologies are needed

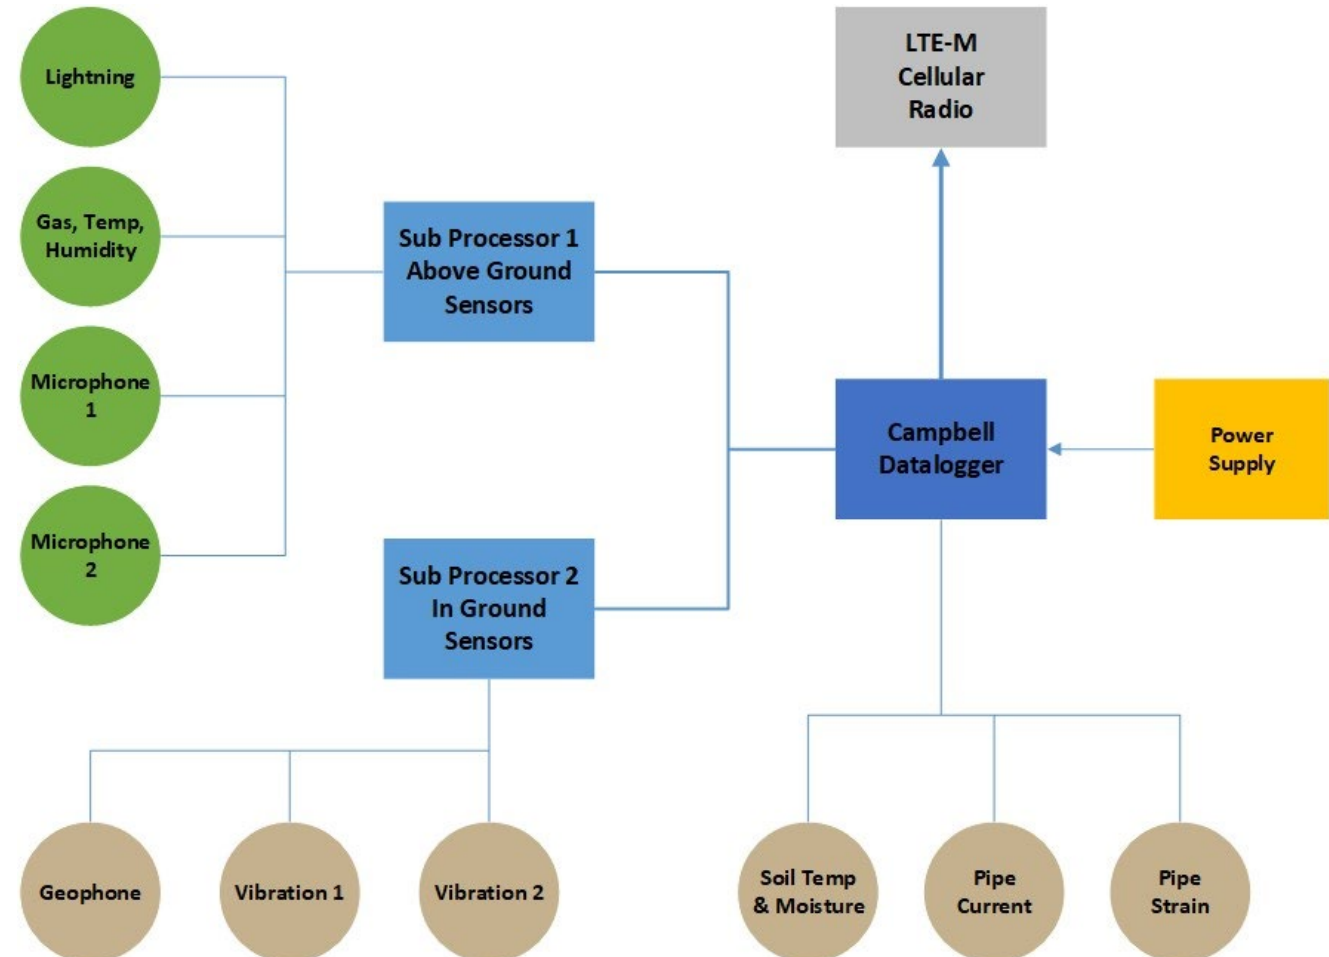
- A suite of sensors is needed to detect ROW threats.
 - Attached to the pipe
 - Vibration, Stress, Current Density
 - In the adjacent soil
 - Moisture, Temperature, Motion
 - Above ground
 - Gas presence, Sound dB, Air temperature, Humidity

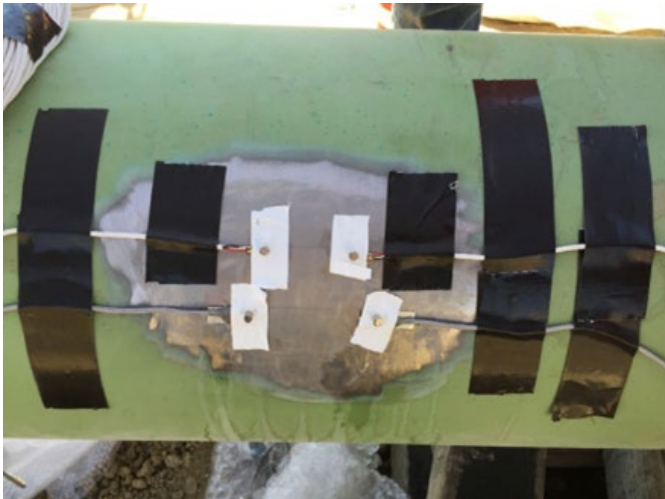
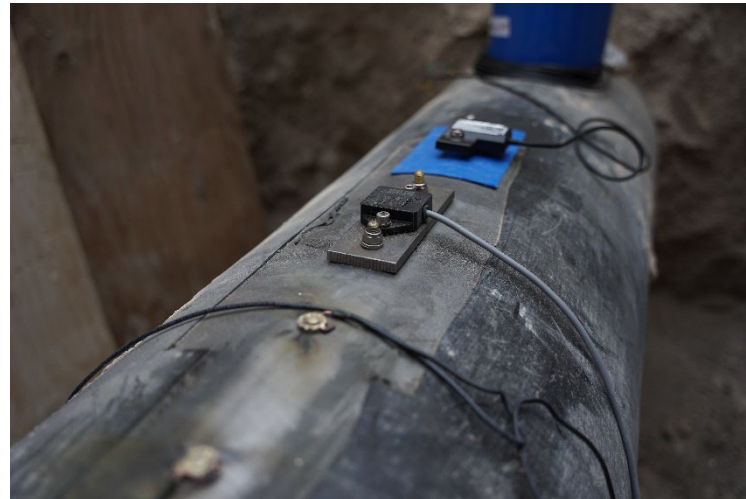
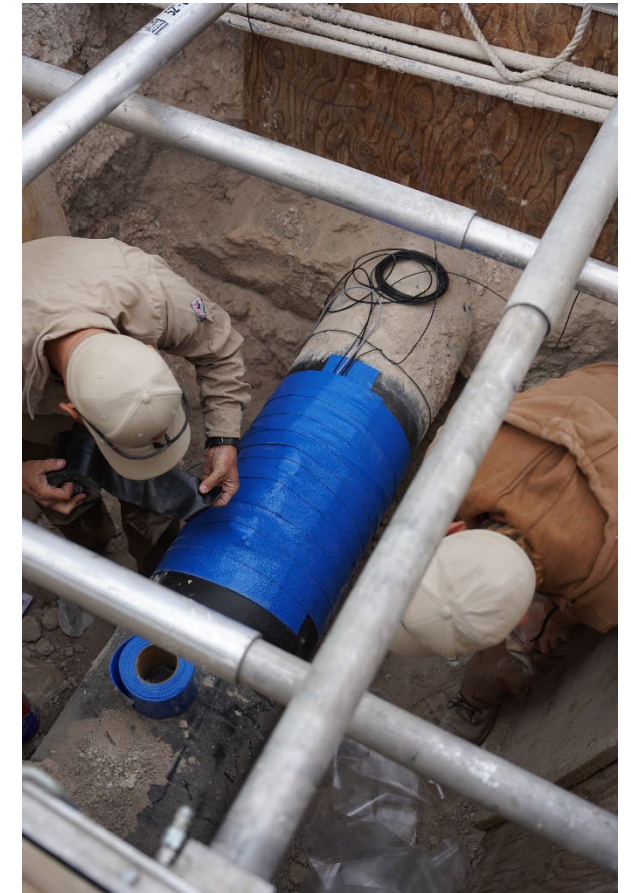
- An improved method for pipe sensor attachment, pin brazing, was successfully tested.
- Operators generally allow pin-brazing on live pipelines.
- The original adhesive bonding method was impractical under most field conditions.

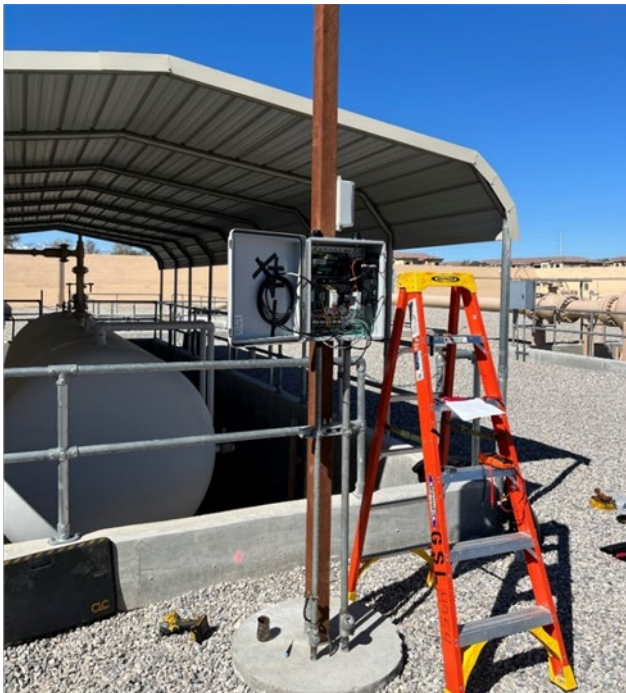
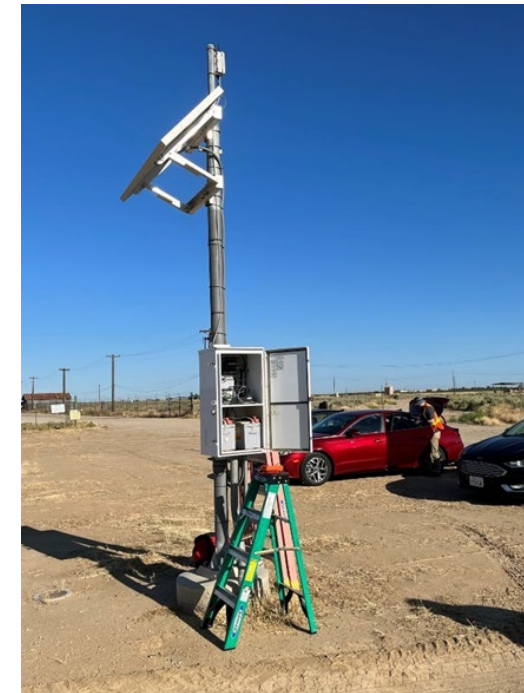
- For the original system, the vibration sensors and supporting instrumentation were provided by a third party that was separately contracted by CEC.
- This part of the instrumentation did not perform well during the earlier field test.
- This sub-system was redesigned for the current project and is operating reliably.

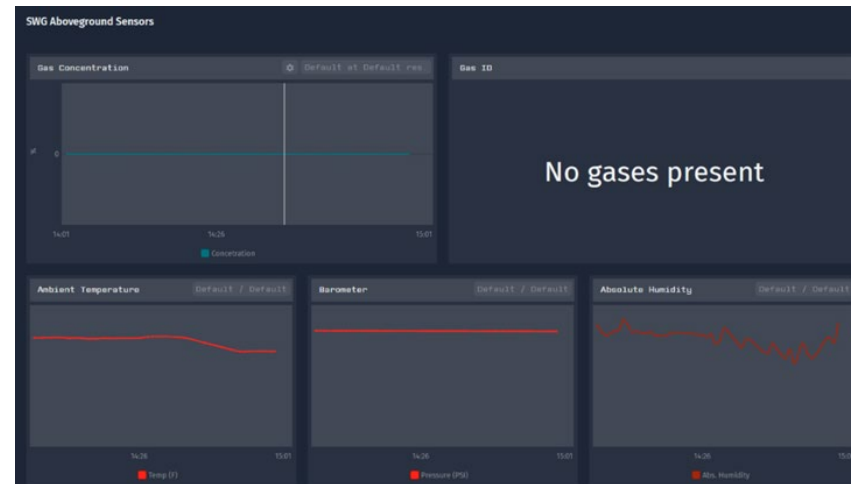
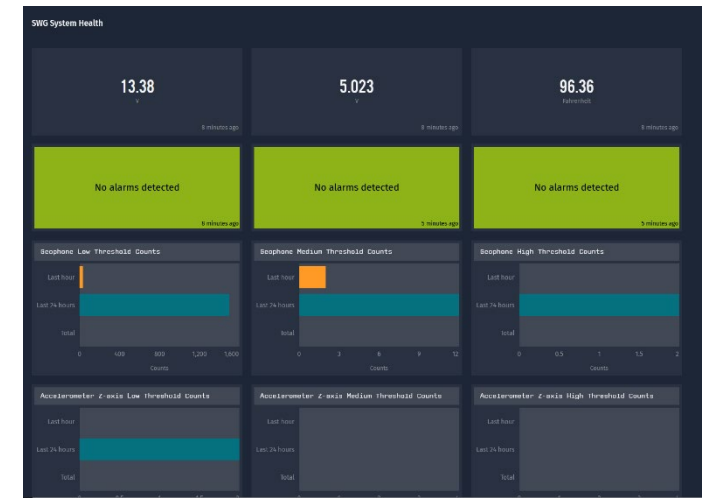
- Data is flowing from test sites, through AWS, and into a visualization dashboard.
- The earlier dashboard version used multiple pieces of software to produce visualizations and alarms.
- The current version uses a single “IoT” software platform to perform all these functions.
- The single platform approach has improved availability/reliability of the dashboard.

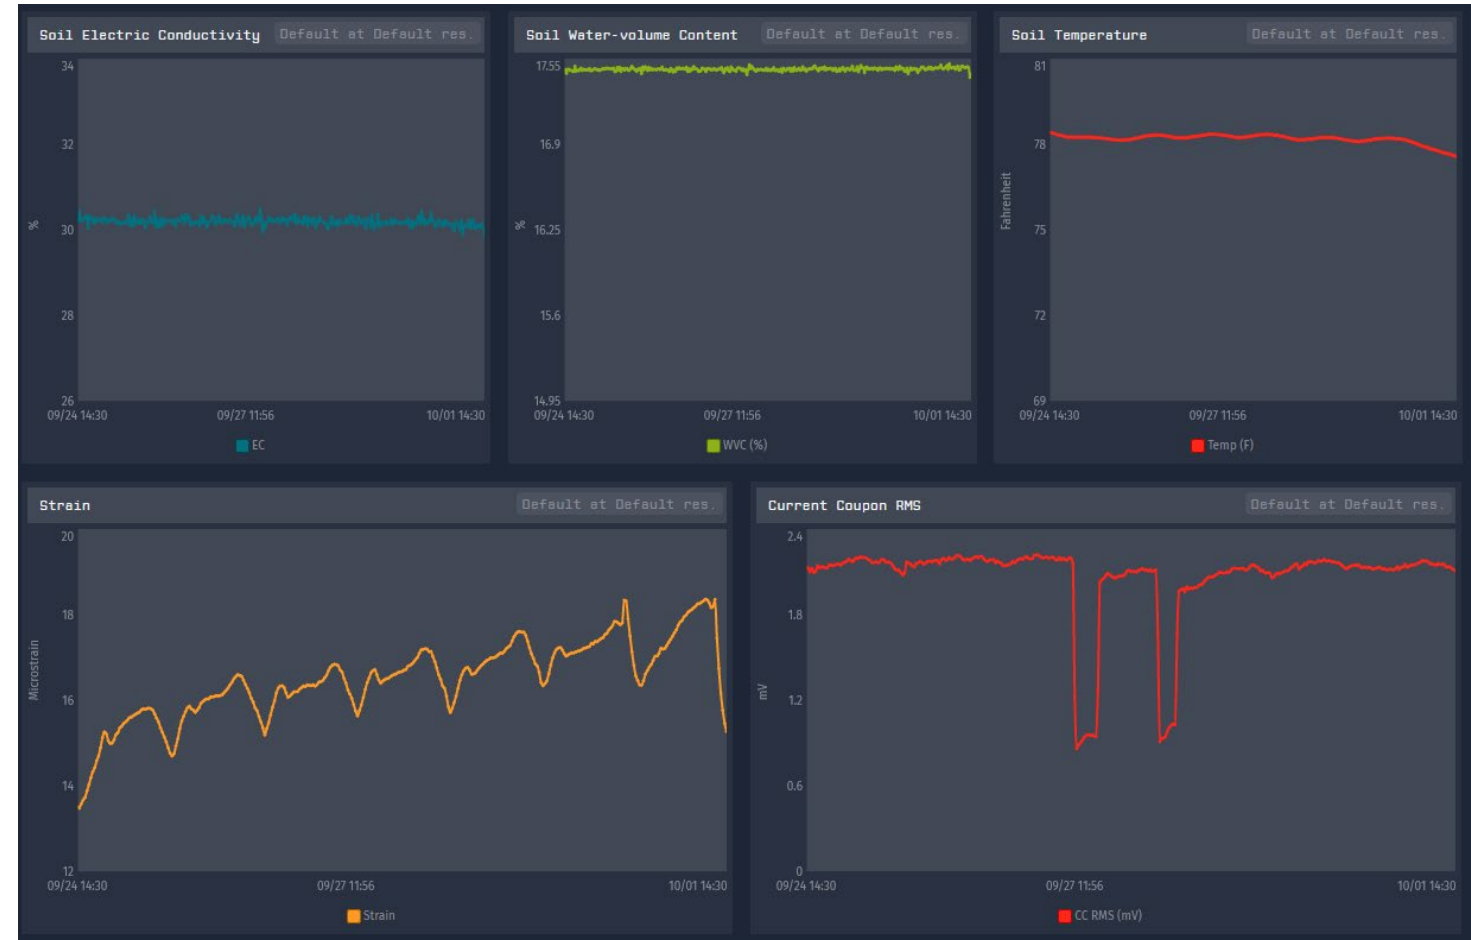
- Seven days of data showing a discontinuity in the CP current through 1 cm² coupon.
- Soil temperature, moisture, and conductivity are relatively flat over this period.
- Utility verified that rectifiers were shut off for maintenance for several hours at a time.

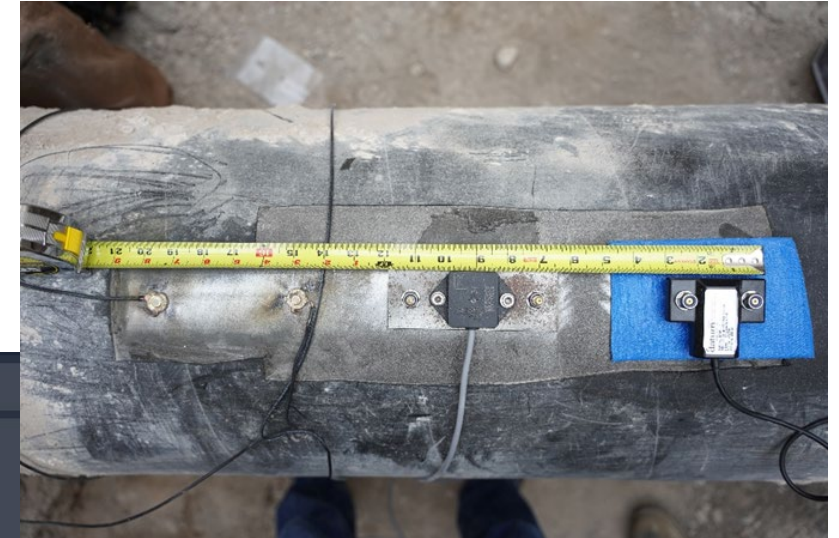
- Data shows accelerometer data over 7 days.
- Accelerometer is mounted on the upper surface of pipe.
- The activity appears to correspond with traffic through the facility and days of the week.

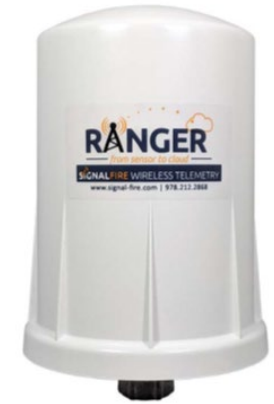
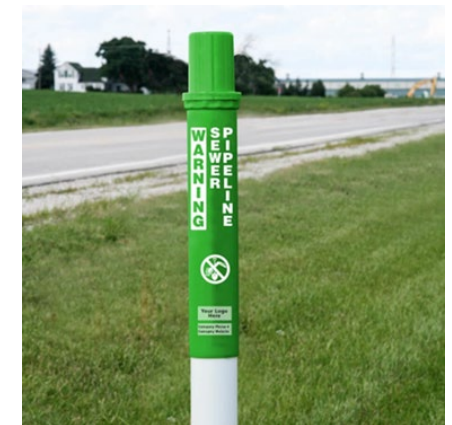
- The original RPMA radio system is not well supported.
 - For the near-term tests, cellular modems are being used.
 - LoRaWAN could be used on appropriate sites.
- Getting permits to install the equipment in the ROW is difficult.
 - Several promising sites were lost to permitting issues, driving schedule delays.
 - The newest test site is “inside the fence” and did not require permitting.
 - The older, upgraded site was already permitted and built.
- Future equipment must be made smaller and less expensive.
 - Fewer sensors per location may facilitate this.
