Managing Challenges with Pipeline Seam Welds

Identifying Gaps in Technology

Bruce Nestleroth- Battelle

Arlington, Virginia July 20, 2011

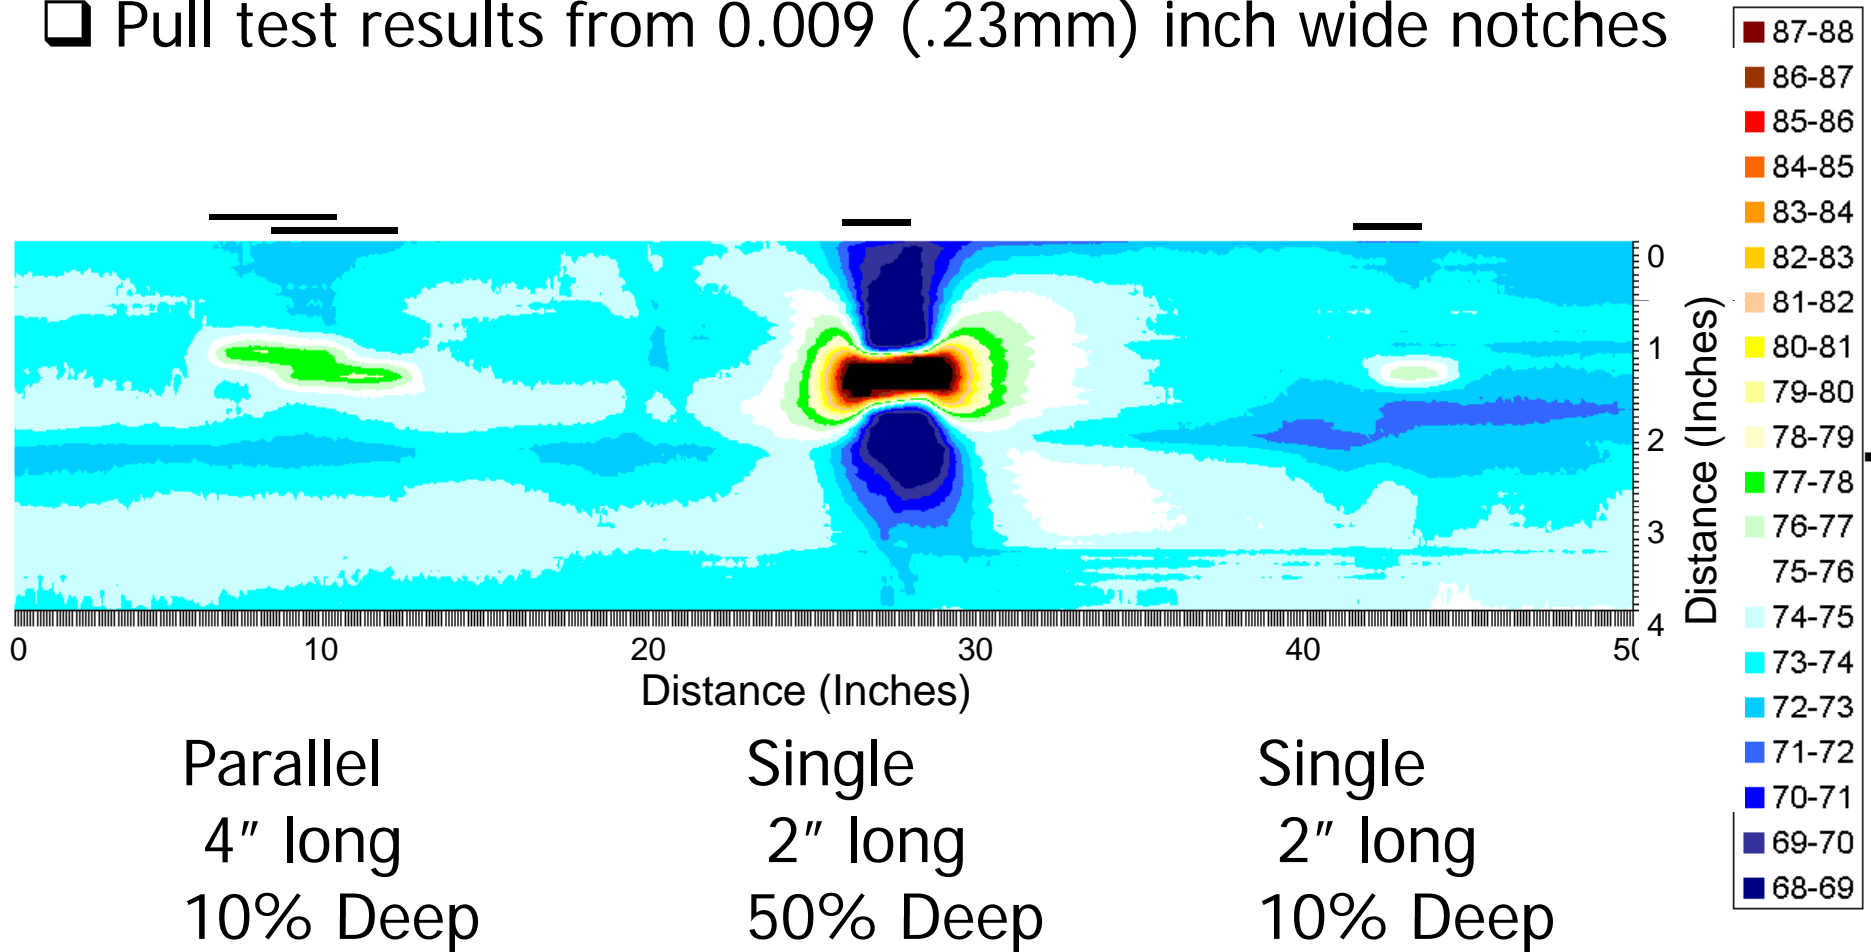
Test Results on Notches

□ Pull test results from 0.009 (.23mm) inch wide notches

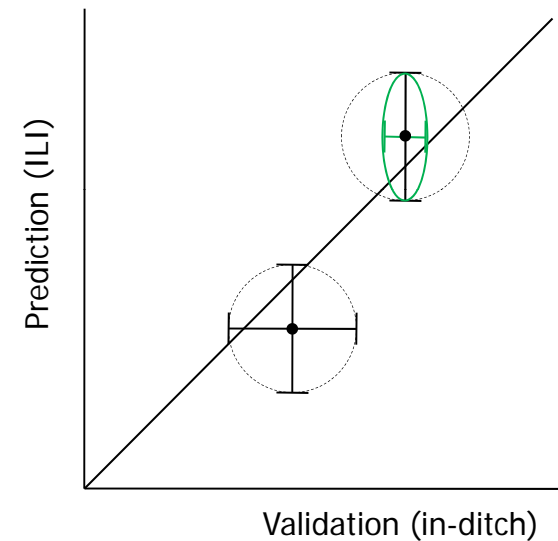
Assume the ILI and Field measurements are independent.

$$\sigma_Z = \sqrt{\sigma_{\text{ILI}}^2 + \sigma_{\text{Field}}^2}$$

$$\sigma_{\text{ILI}} = \sqrt{\sigma_Z^2 - \sigma_{\text{Field}}^2}$$

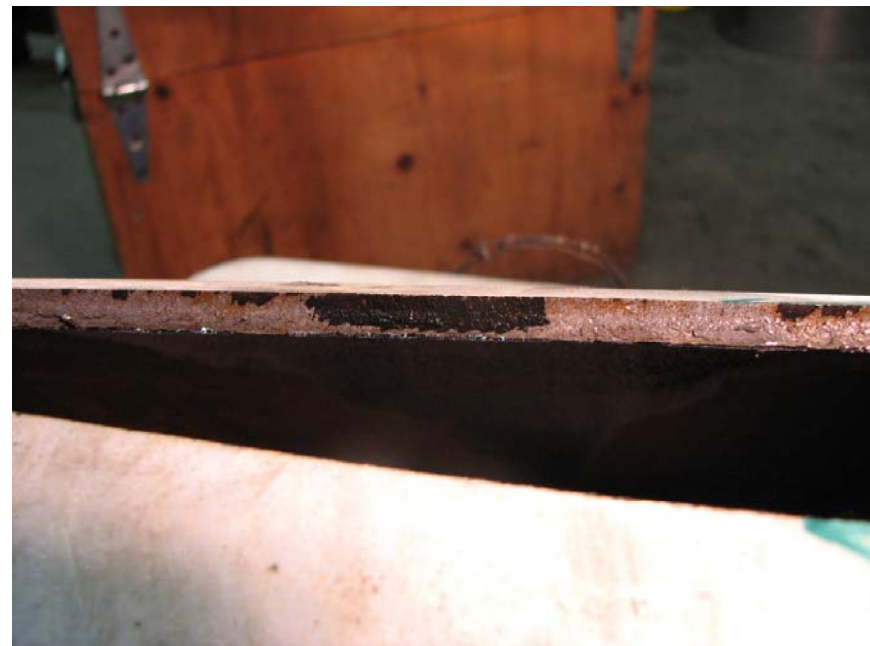
- ❑ Similar considerations as for ILI
 - Good performance for single cracks for Phased Array or TOFD
 - However, not all ILI features are cracks
- ❑ Circ MFL Type A seam feature example
- ❑ 95%wt x 1.75 inch
 - Not a “crack”- cold weld, not covered by ILI spec but still reported
- ❑ Actual Pburst = 1360 psi
 - Pb(95%wt) = 586 psi pred
 - Pb(80%wt) = 1304 psi pred
- ❑ No evidence of fatigue
- ❑ UT reflector
 - What is sizing reliability?
 - TOFD UT
 - Phase Array UT

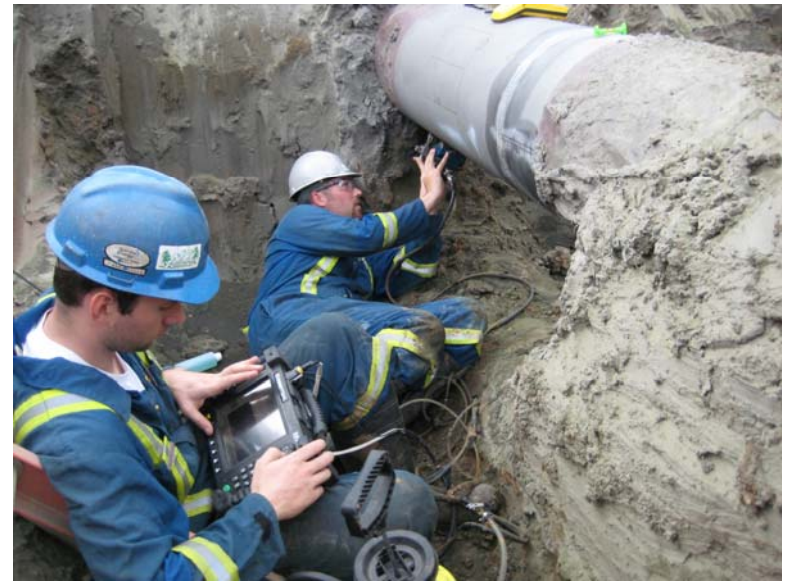
Figure 5 Linear PA Beam Pattern Example

NDE Crack Depth by Ultrasonic Testing

- ❑ Issue is Weld and Defect Geometries
 - ToFD very accurate for single cracks
 - +/-0.1 mm possible
 - Phased Array in Practice
 - +/- 1.0 mm depth
 - A gap is to understand performance for;
 - Hook cracks, profiles
 - Translucent Cold Bond Features

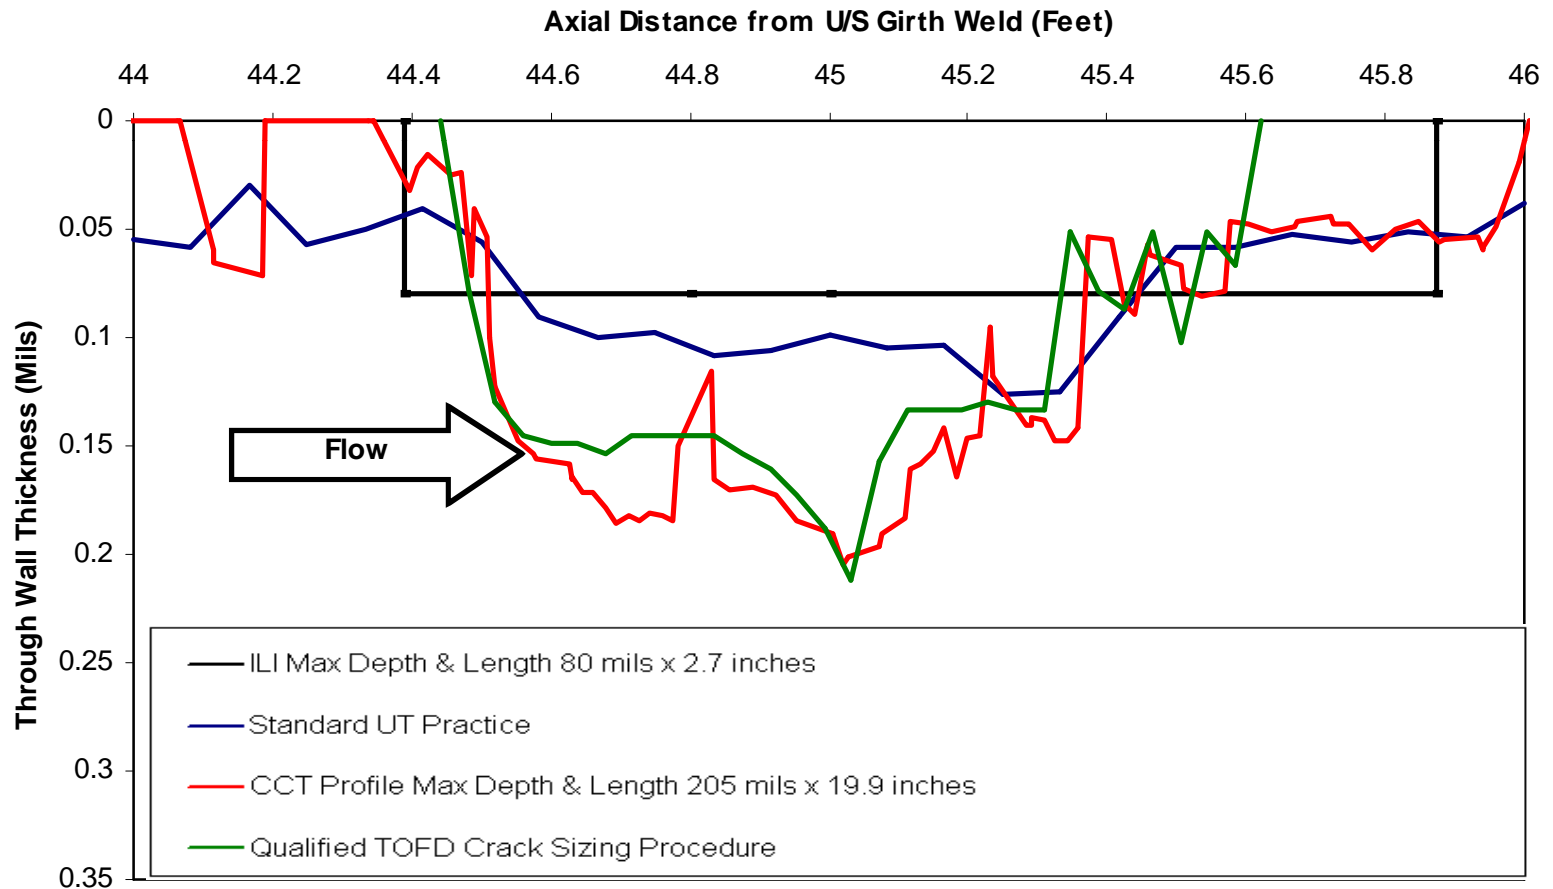
- Actual profile from cross-sectioning

Comparison of ILI, Actual Hook Crack Depth Profile, and In-Ditch UT Measurements

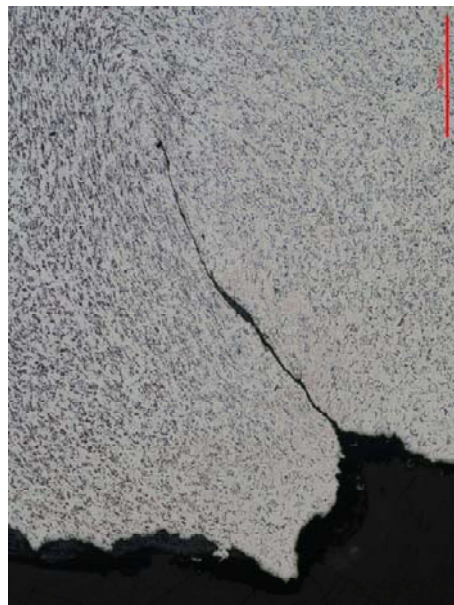
LToFD identified ID and OD crack tips

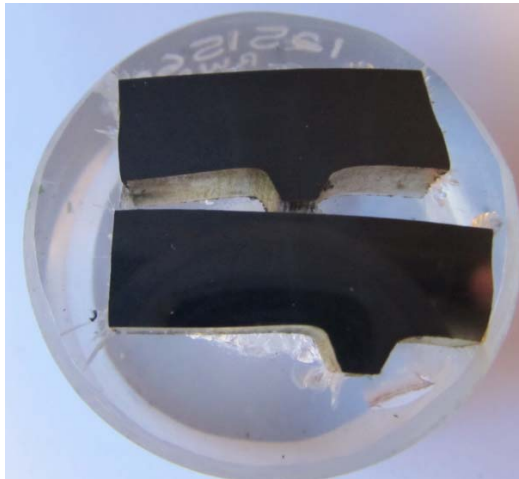
- ❑ 0.064 inch depth (20% wt) actual total depth
 - No OD surface length, 0.25 inch ID actual length
- ❑ 0.045 inch depth (13%wt) 1.8 inch ToFD length
 - Clear Planar reflector seen by LToFD

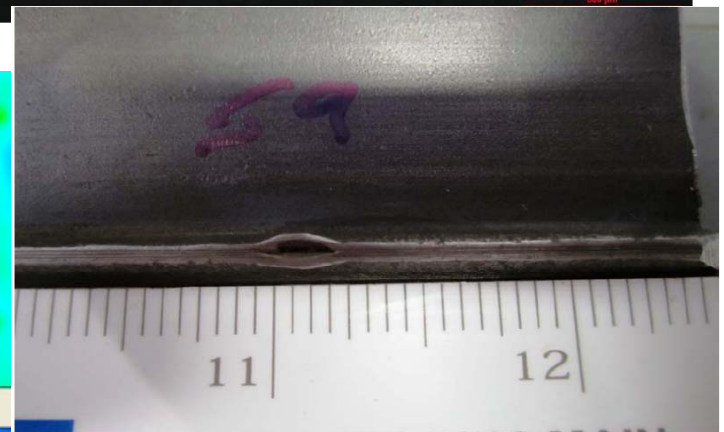
ID Seam Anomaly
