# Working Group #1: Cast Iron Pipe Rehabilitation – Con Edison & NYSEARCH

Rick Trieste and Gautam Kakaiya

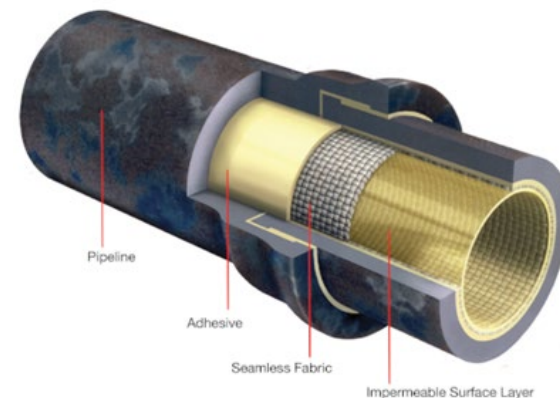
# Cured in Place Liner (CIPL) solutions for CI rehabilitation

- CIPL is a three-component system, referred to as an elastomer-fabric-adhesive structure.
- The synthetic fabric jacket provides the strength characteristics for resistance to internal and external pressure, soil movement, and radial expansion.
- The elastomer skin provides the impermeable barrier that prevents the escape of gas.
- The adhesive is a two-part resin that bonds to form the composite and adheres the fabric jacket to the pipe wall.

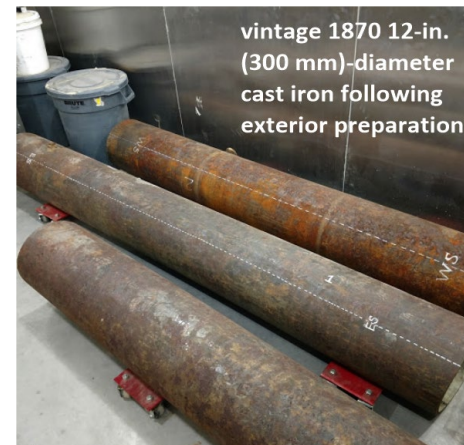
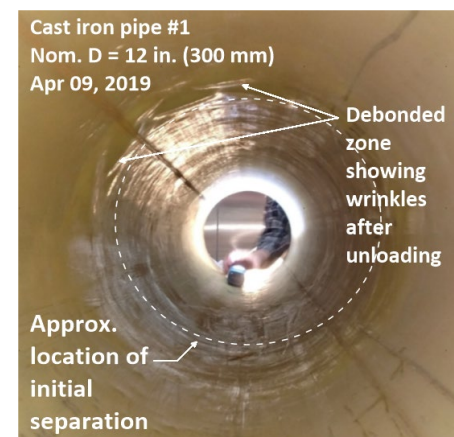
# NYSEARCH – Studies in Durability and Longevity of CIPL systems

- NYSEARCH completed a second study in 2019 to confirm displacements driven by thermal expansion/contraction will not cause fiber damage.
- Two excavated lined 12” host pipes and two newly lined steel pipes.
- Subjected to thermal cycling to simulate slow cooling driven by seasonal variations in the field.
- Temperature Cycle & associated nominal displacements based on design temperature changes due to seasonal variation in the Northeastern US.
- Results noted clean debonding and no fiber damage in all tests.
- Liners maintained pressure integrity.
- Through a combination of the 2015 study, and the follow up 2019 study, NYSEARCH’s body of work provides experimental verification of the longevity and durability of CIPL liners for CI and steel pipe repair and rehabilitation.
