Evaluating Corrosion Mechanisms with Extended Coupon Analysis

Bruce Cookingham, BP Alaska

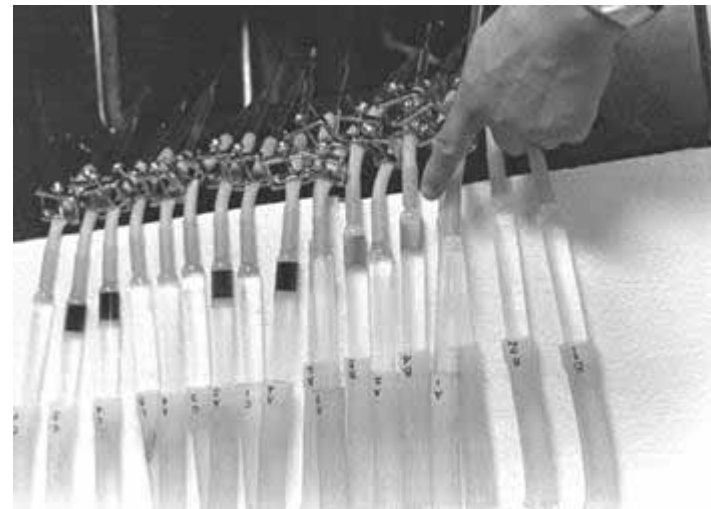
After various exposure periods, the coupons were preserved, embedded and examined using phase contrast and UV fluorescence microscopy, transmission electron microscopy and scanning electron microscopy.

Corrosion and biofilm were mapped using various techniques.

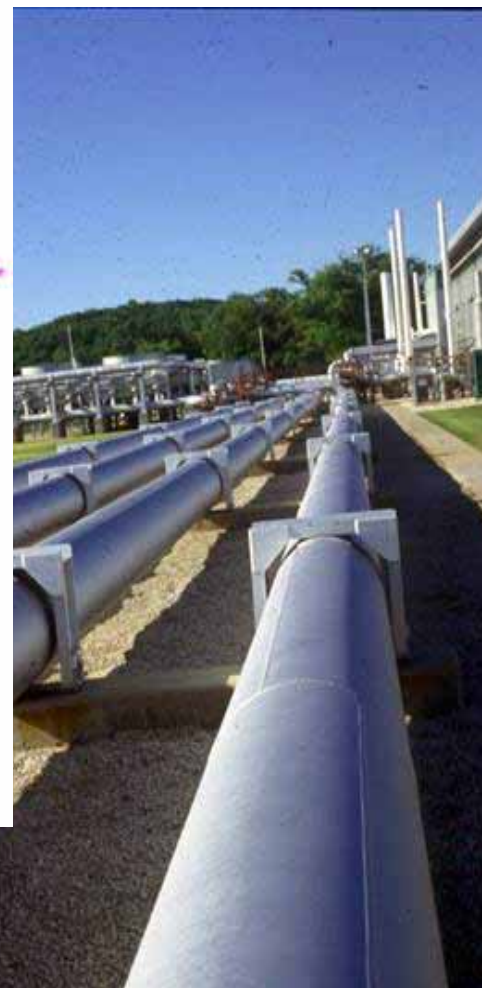
Extended analysis coupons (EM coupons) are exposed to process fluids in the same manner as weight loss coupons

After exposure, special handling and preservation are required to preserve biofilm and corrosion products

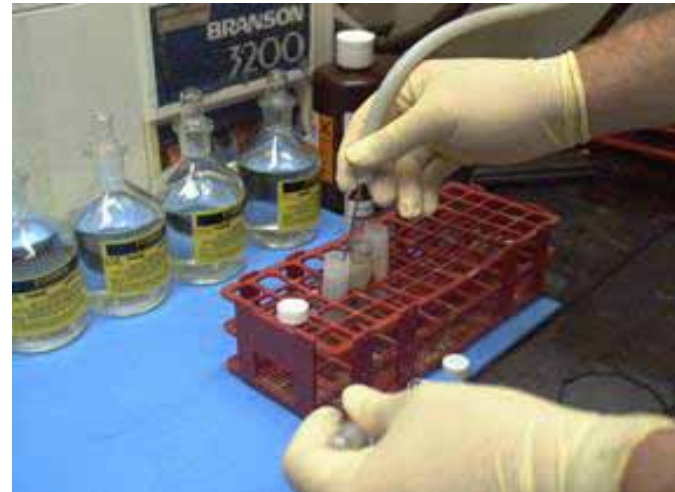
Within 24 hours of removal, the coupons are fixed in 2% glutaraldehyde, rinsed and dehydrated using an ethanol series. The coupons are then embedded in an acrylic resin.

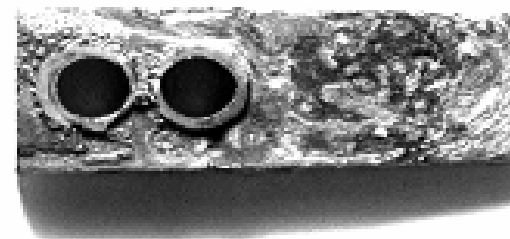
By the time severe damage is observed on a coupon, mitigation becomes reactive instead of proactive.

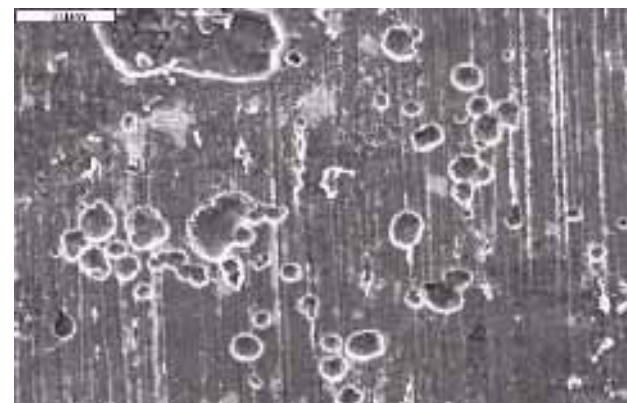
Detection and identification of initiating pits is possible using microscopy; this can be important in the avoidance of advanced corrosion.

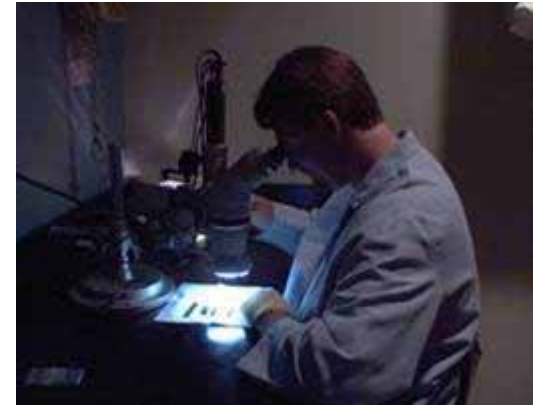
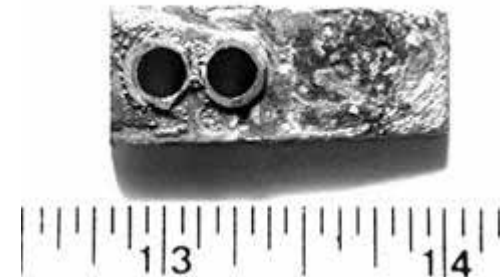
Optical Microscopy

Coupons examined using a stereomicroscope, typically at 10x and 40x.

The pit density, maximum depth, and maximum diameter of pitting are measured.

The corrosion type and the corrosion severity are noted and recorded using a standardized grading.

Optical exam provides an overall perspective on corrosion severity, morphology and distribution.

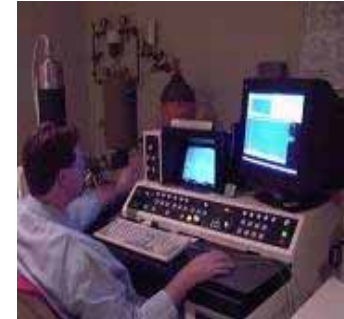
SEM exam of coupon is performed for identification of pit initiation morphology.

SEM exam also identifies -

- Relationships between initiating and advanced pits/corrosion.
- Spatial correlation between actual corrosion on coupon and deposits/biofilm on replica.
- Potential significance of scale in relation to corrosion damage.

- SEM Severity: categorization, on a micro scale, of the severity of corrosion observed
- SEM Type: categorization, on a micro scale, of the type of corrosion observed, such as pitting or etching
- SEM Pit Type: classification associated with the predominant pit initiation mechanism, biotic or abiotic
- Scale Morphology: when scale is present a physical description is provided
