Hard Spot Assessment & Integrity Analyses

Tuesday, December 13th, 2022

PHMSA PUBLIC WORKSHOP

HARD SPOT ASSESSMENT & INTEGRITY ANALYSES

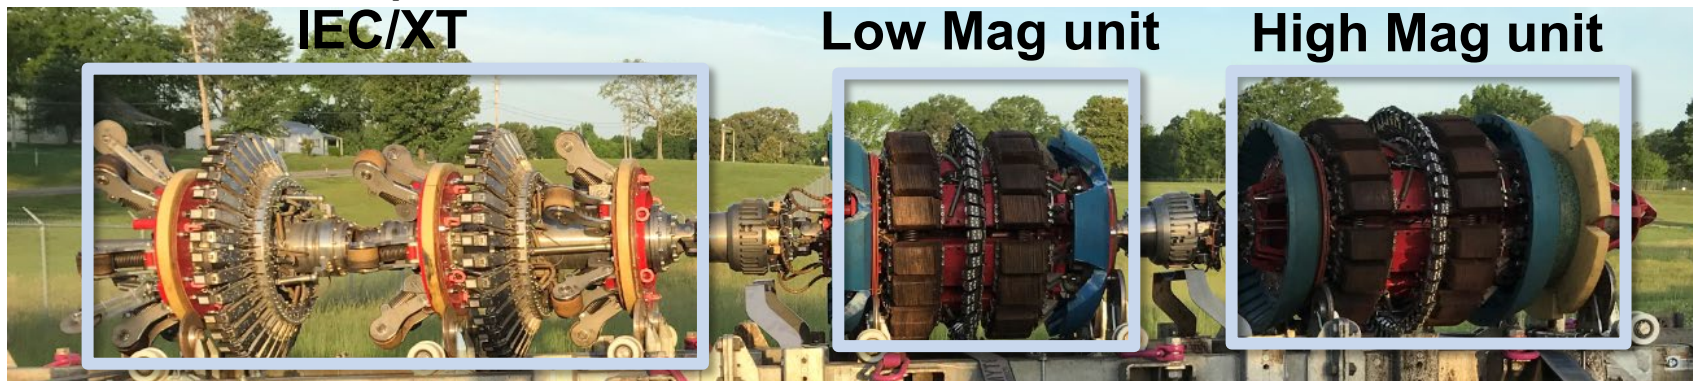
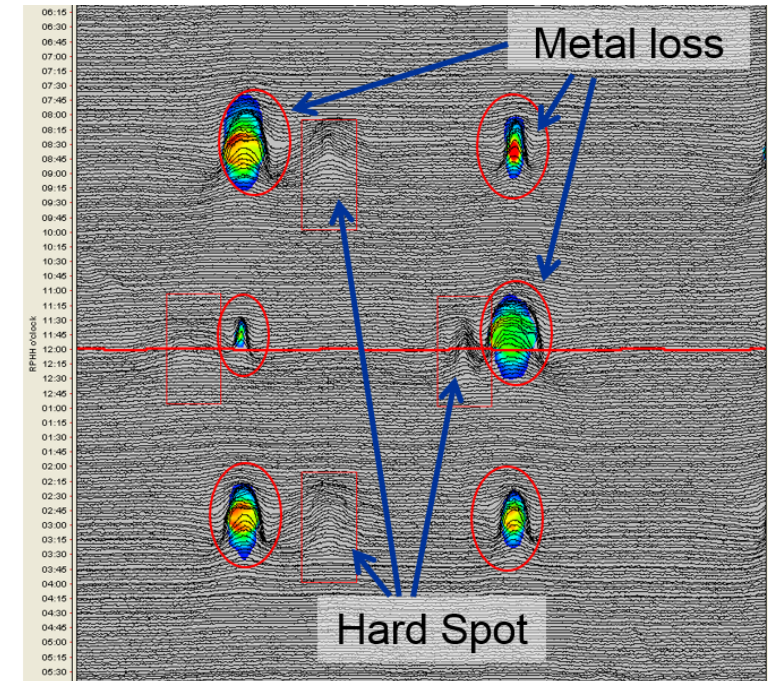
DMG ILI tool setup:

- Dual Magnetization (DMG) utilizes standard magnetic flux technology (MFL):
 - Conventional MFL magnetizes on a high level (high mag.) to saturate a pipeline with a magnetic field to be **independent from microstructure changes**.
 - DMG also magnetizes on a low level (low mag.) to **detect microstructure changes**.

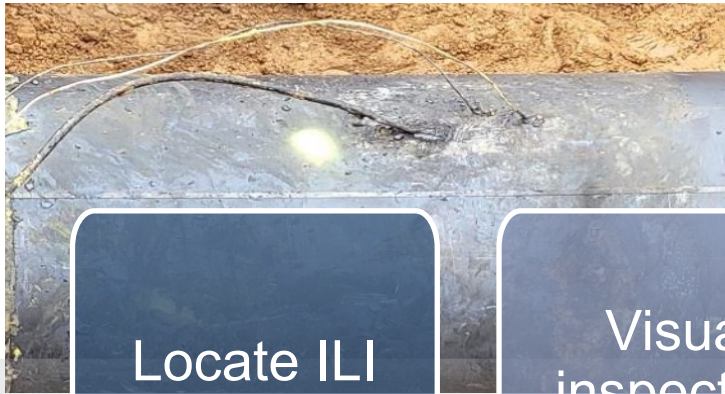
1. Visual Inspection

Locate ILI call out

Visual inspection (MPI)

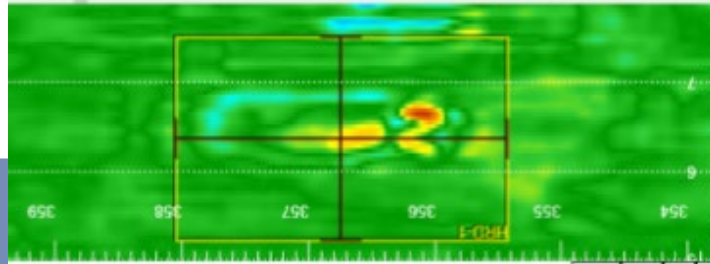
2. Supplementary Technology to locate ILI call out Eddy Current Array Technology

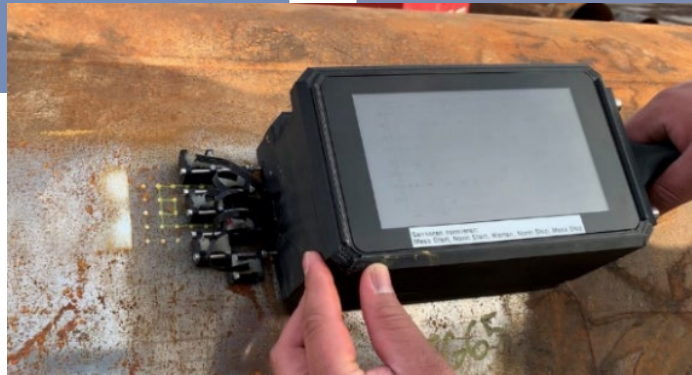
Remnant Magnetic Field Measurement Technology

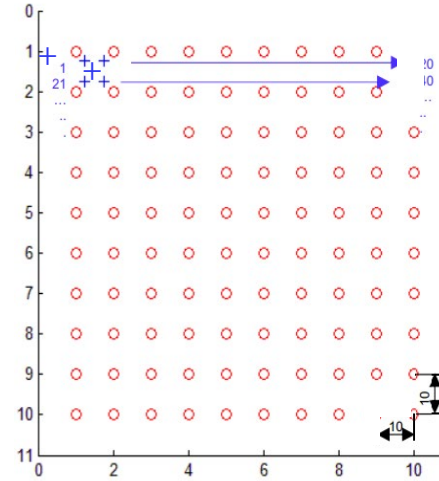
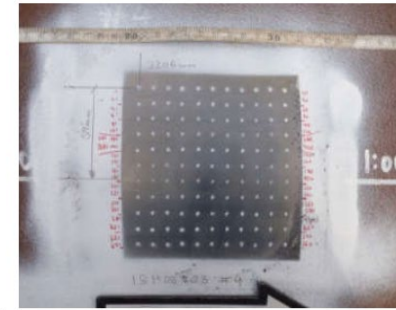
4. Hardness Measurement

179	179	179	183	189	200	212	198	192	182	195	187	184	187	184
175	174	199	192	203	249	261	257	229	196	195	187	178	174	175
165	192	194	198	221	260	266	267	270	242	201	180	176	172	172
174	189	194	237	256	265	268	266	262	250	210	203	194	185	183
179	191	199	238	258	274	267	265	259	264	246	201	190	185	181
186	182	203	240	251	256	268	263	278	262	266	230	252	217	171
178	186	205	246	247	245	267	270	271	258	271	226	206	197	189
180	187	186	213	246	256	261	264	265	265	263	200	185	185	186
179	177	176	190	196	235	243	241	242	227	261	203	182	186	184
186	172	174	182	188	186	198	200	199	191	220	203	184	188	180

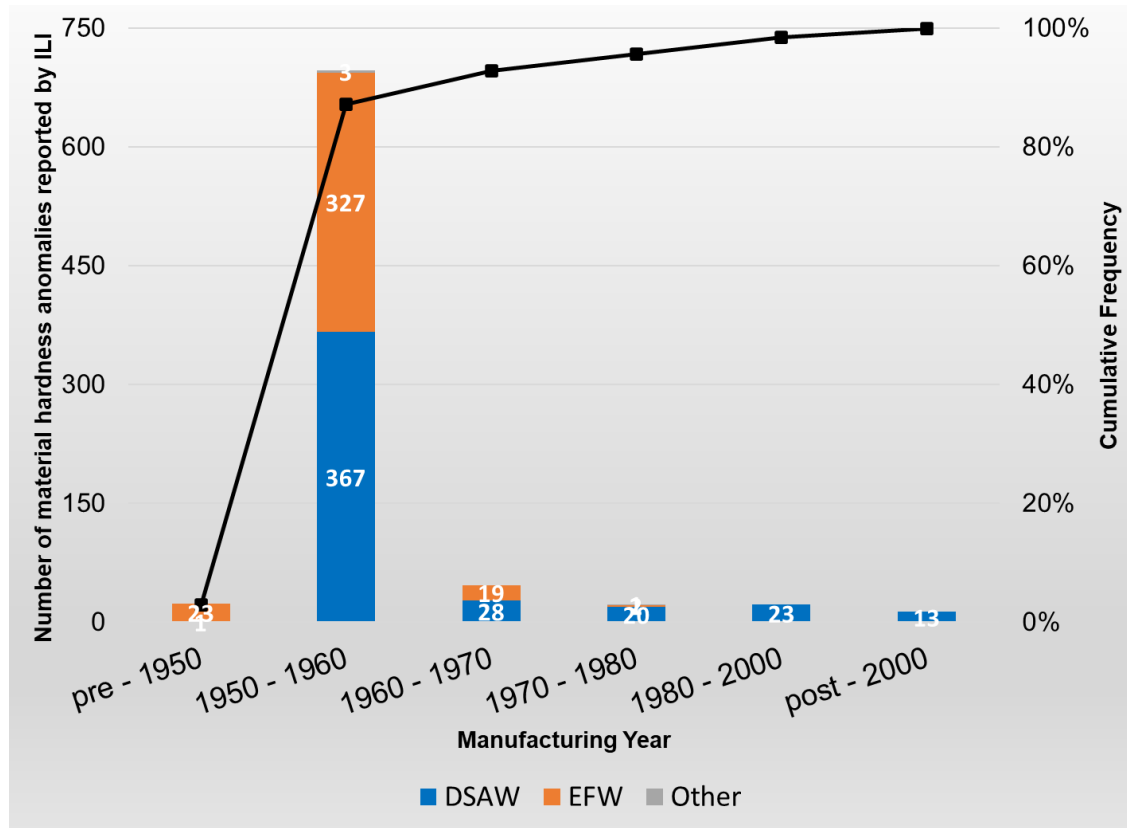
ILI Reported Anomalies

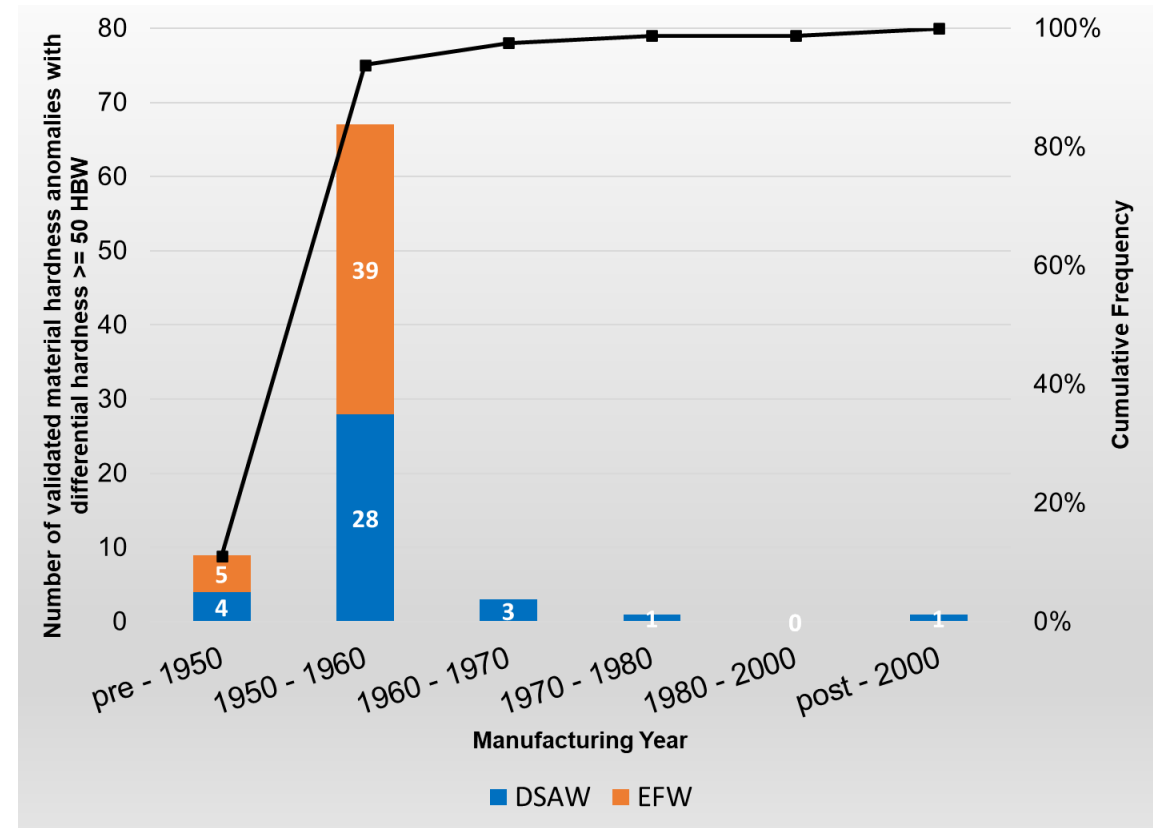
Validated Material Hardness Anomalies with Hardness Differential ≥ 50 HBW

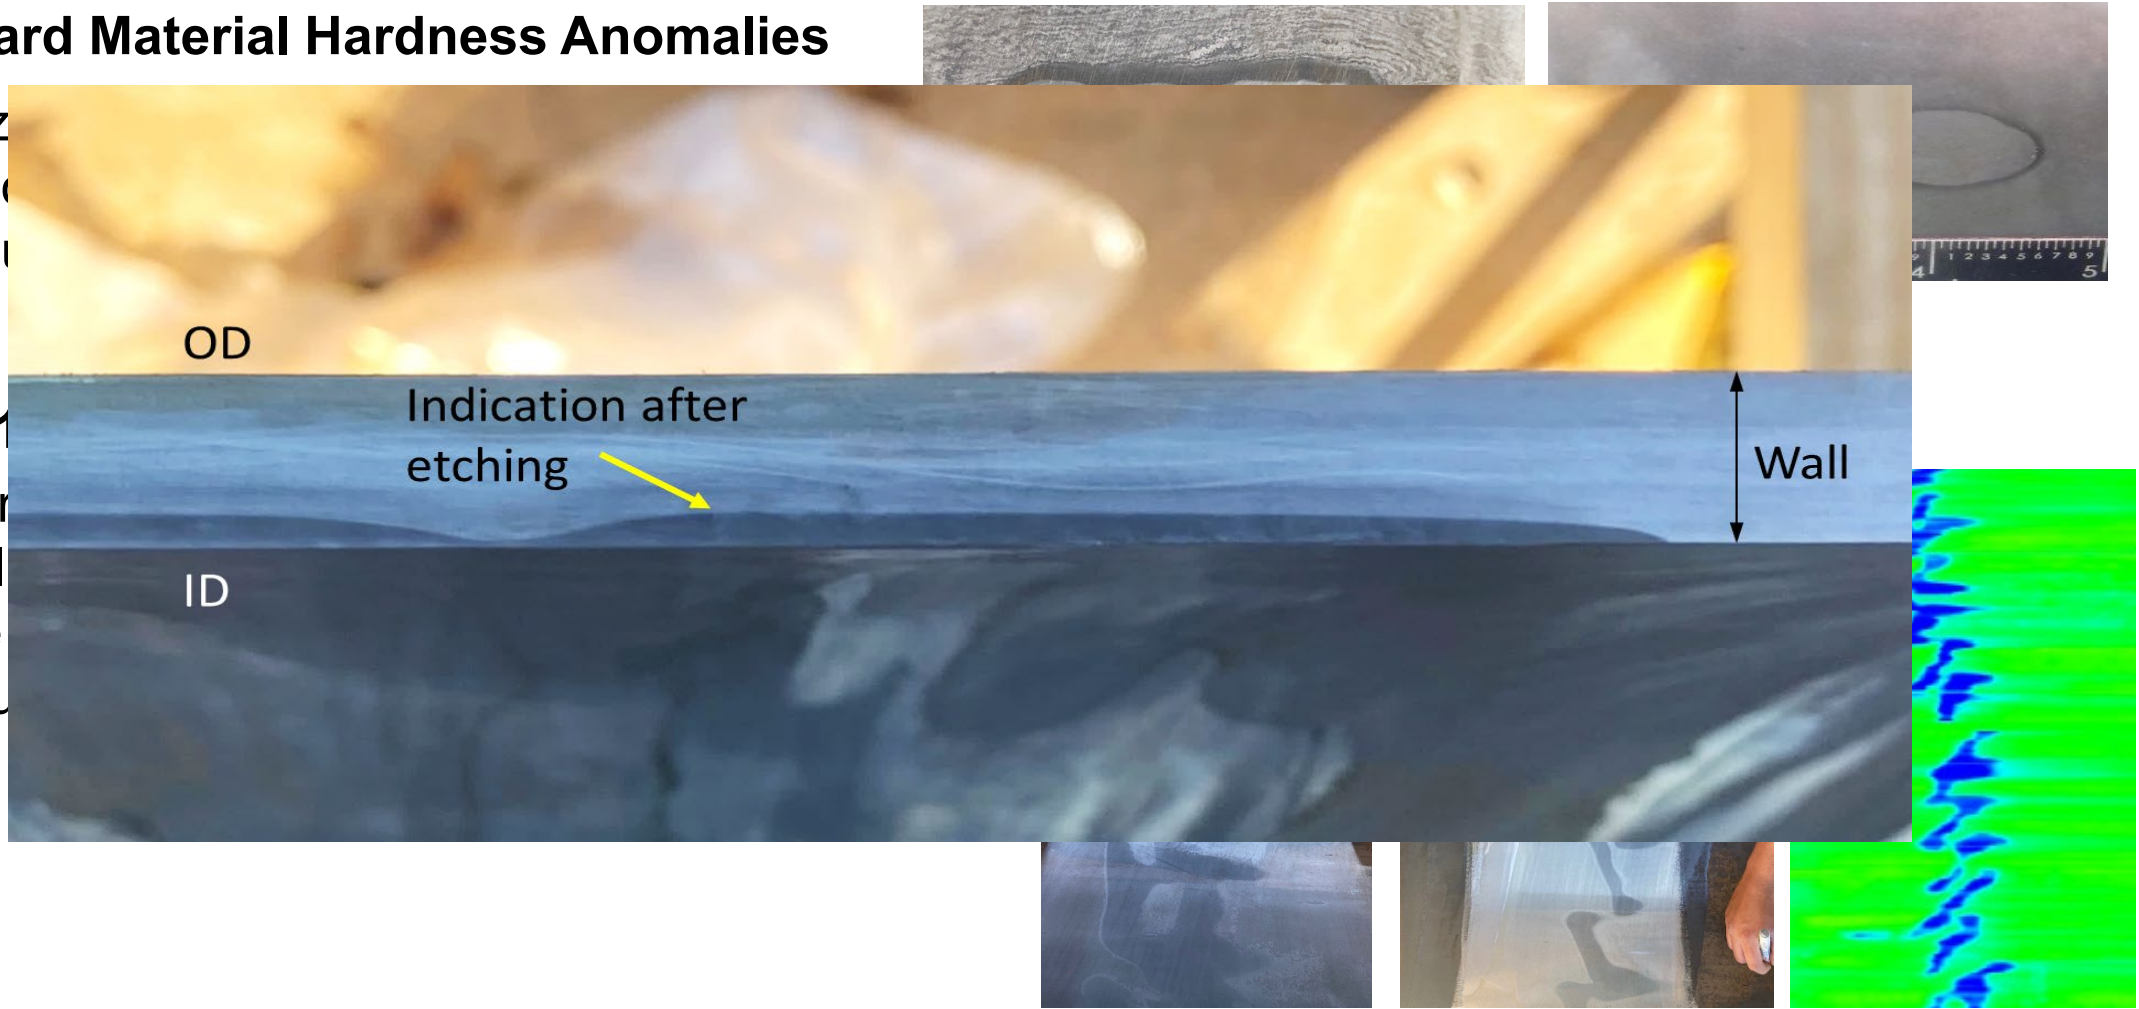
1. Standard Material Hardness Anomalies

- Localized
- Dark band
- Maximum

2. 'Type 1'

- Fully circumferential
- internal
- Can be
- Maximum

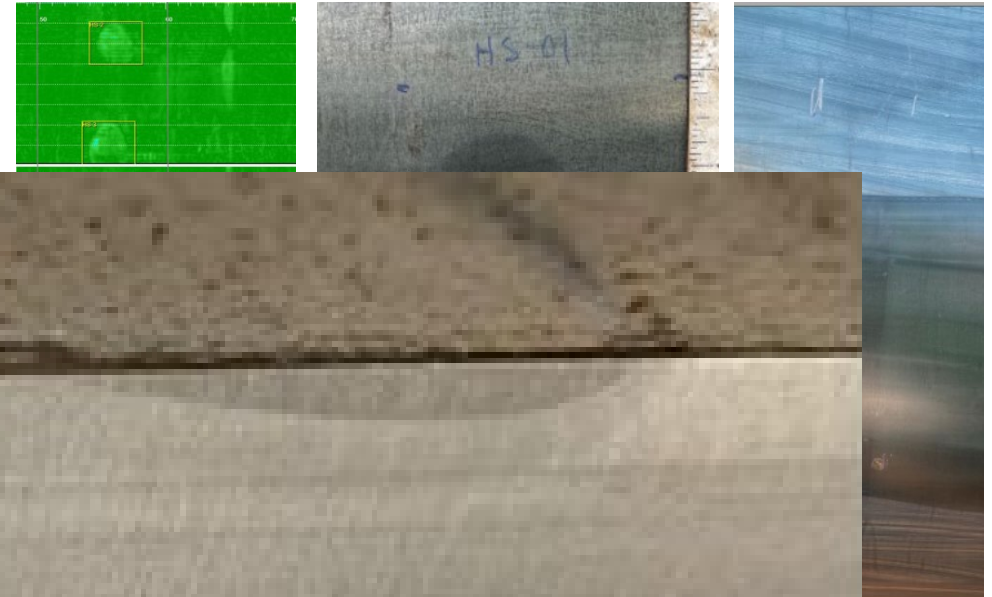
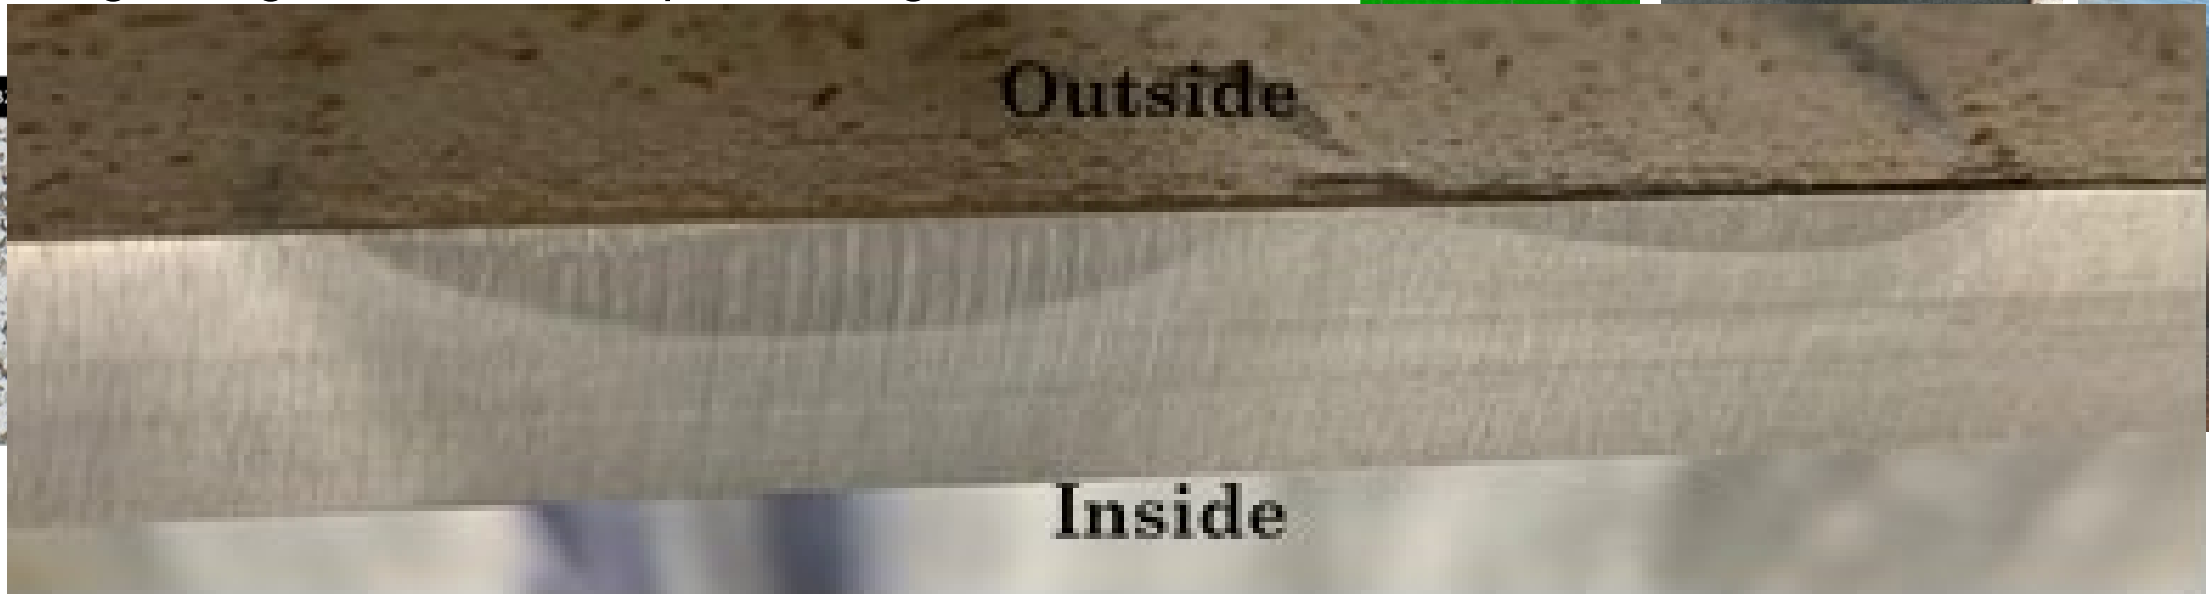
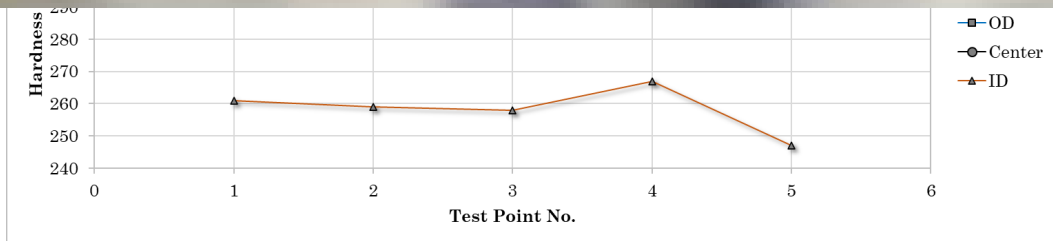
3. 'Type 2' Anomalies

- Existing in groups
- Originating on the OD and penetrating to the ID

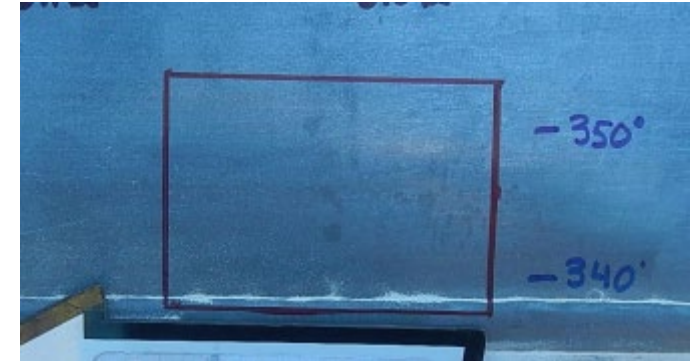
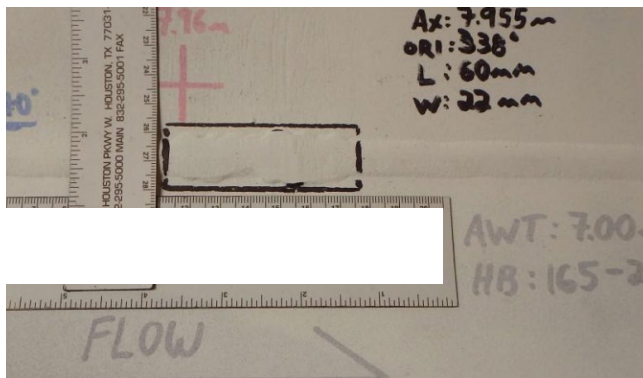
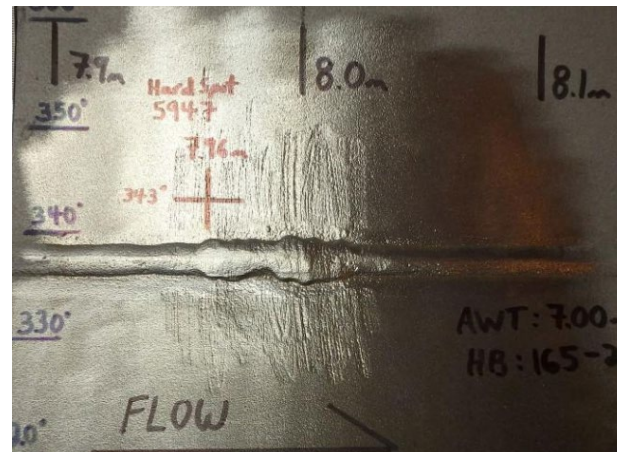
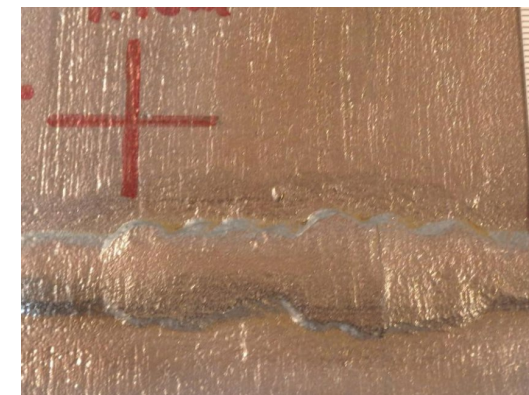
INTERNAL HARDNESS ANOMALY

- DSAW, 1957, Welland Tube, X-52
- ILI reported: length 3.70 in, width 2.36 in, hardness 278 HB

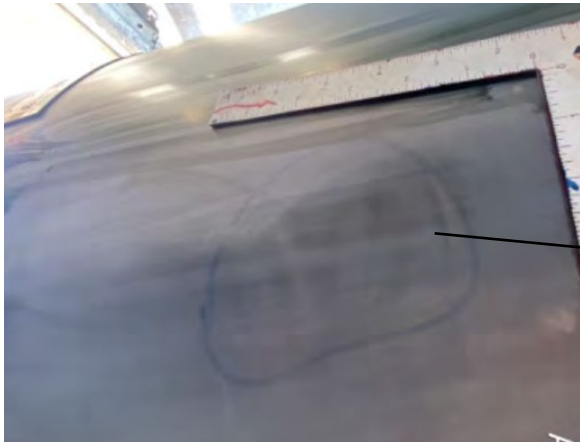
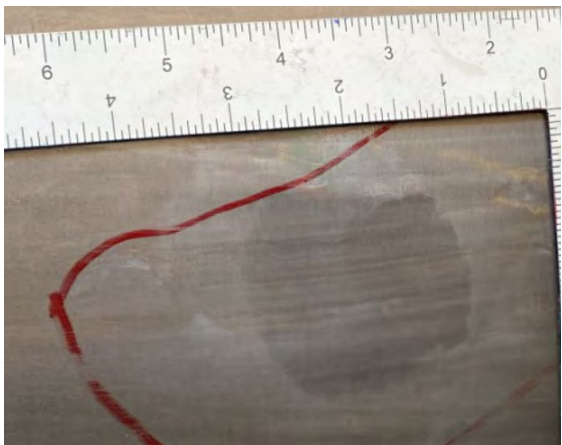
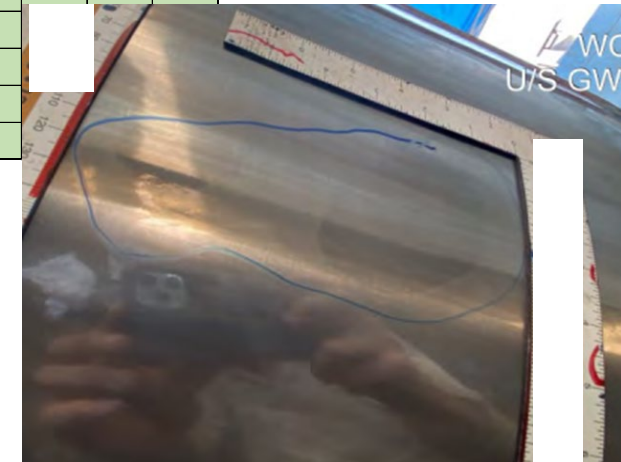
VALIDATED HARDNESS > 327 HB

- Multiple Type 2 Anomalies at one area; 1957 EFW A.O. Smith; X-52

1"	2"	3"	4"	5"	6"	7"	8"	9"	10"	11"	12"	13"	14"	15"	16"
1"						186	192	179	190	191	188					
2"						172	176	196	191	189	199					
3"						175	198	188	201	178	182					
4"						200	197	198	193	201	191					
5"						188	210	189	190	200	192					
6"	199	193	200	185	182	192	200	178	173	220	205	201	183	200	199	196
7"	186	201	179	216	188	210	201	212	220	202	220	216	218	212		
8"	205	202	198	194	219	221	232	262	279	264	262	299	247	225	221	221
9"	178	184	185	179	182	185	272	333	302	275	287	266	235	210	220	203
10"	185	181	178	171	174	175	310	315	303	251	261	236	247	207		
11"	178	175	174	169	176	162	220	220	225	228	201	219	206	206	186	182
12"						170	202	201	188	203	208	199	196	203	182	182
13"						173	217	203	213	201	199	216	204	201	180	180
14"						179	217	203	213	201	199	216	204	201	179	178
15"						170	195	190	184	181	178					
16"						170	190	178	171	175	169

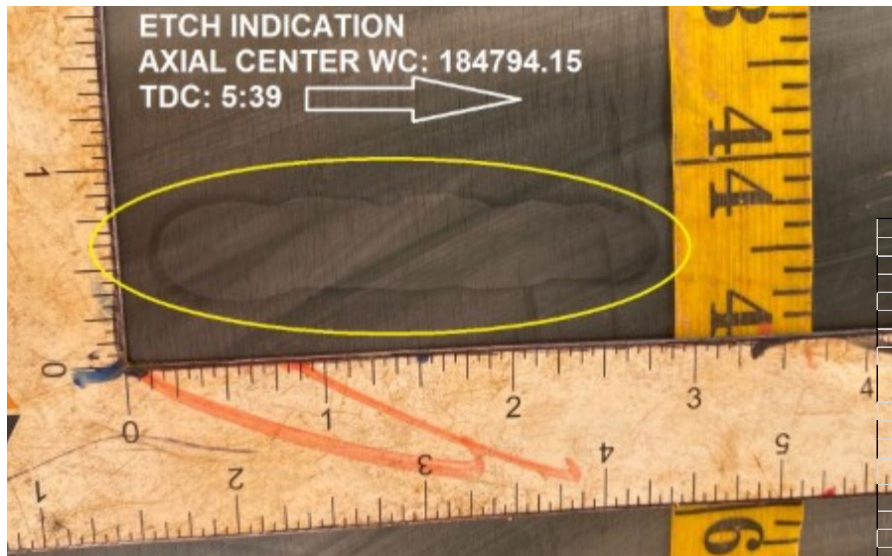
VALIDATED HARDNESS > 327 HB

- Standard Material Hardness Anomaly; 1957 DSAW Republic Pipe
- ILI Reported 315 HBW
- >> Max hardness measured: 353 HBW

0.5	1	1.5	2	2.5	3	3.5	4	4.5	5	5.5	6	6.5	7	7.5	8	8.5	9	9.5	10	10.5	11	11.5	12	12.5	13	13.5	14	14.5	15
0.5																														
1	162	142	149	149	150	148	141	140	140	142	152	150	154	154	148

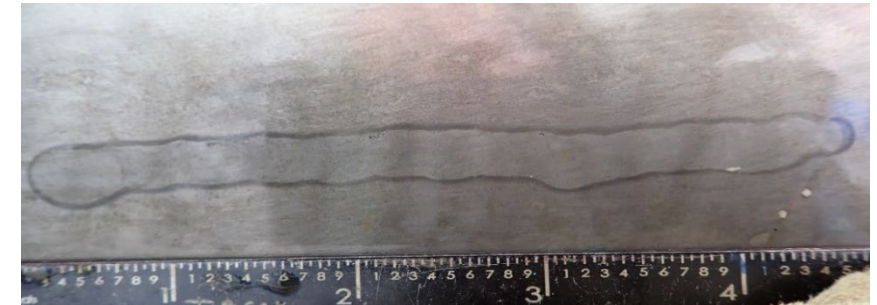
VALIDATED HARDNESS < 327 HB

- Standard Material Hardness Anomaly; 1954 Bethlehem DSAW; X-52
- ILI Reported 285 HBW

>> Max hardness measured: 295 HBW

>> Average of the max grid: 222 HBW

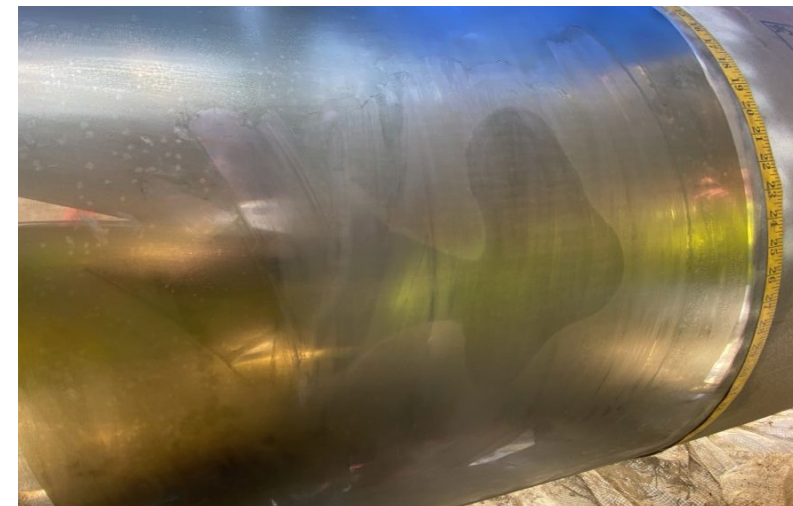
- Type 2 Anomaly; 1957 EFW A.O. Smith; X-52

>> Max hardness measured: 287 HBW

1"	2"	3"	4"	5"	6"	7"	8"	9"	10"	11"	12"	13"	14"	15"	16"	17"	18"	19"	20"	21"	22"	
1"							149	149	149	147	143	154	152	151	148	147							
2"							149	158	152	152	153	148	148	146	150	151							
3"							155	150	148	152	151	156	154	154	148	148							
4"							150	166	149	147	147	154	155	152	153	152							
5"							155	145	148	151	147	150	149	152	152	151							
6"							152	147	158	153	152	149	151	152	153	156							
7"	154	154	147	159	152	152	146	148	145	147	148	148	147	149	151	151	148	151	149	151	154	150	151
8"	152	144	148	148	142	146	143	143	143	144	144	151	150	149	148	148	157	153	156	182	173	158	153
9"	152	146	142	139	141	144	144	144	146	151	150	152	152	147	148	152	154	148	215	240	231	241	225
10"	165	146	150	144	145	143	145	146	147	144	150	148	147	153	152	149	248	263	271	270	273	263	241
11"	151	151	151	151	141	146	146	149	149	149	149	149	149	149	149	149	149	149	149	149	149	149	149
12"	147	153	150	146	147	147	147	147	147	147	147	147	147	147	147	147	147	147	147	147	147	147	147

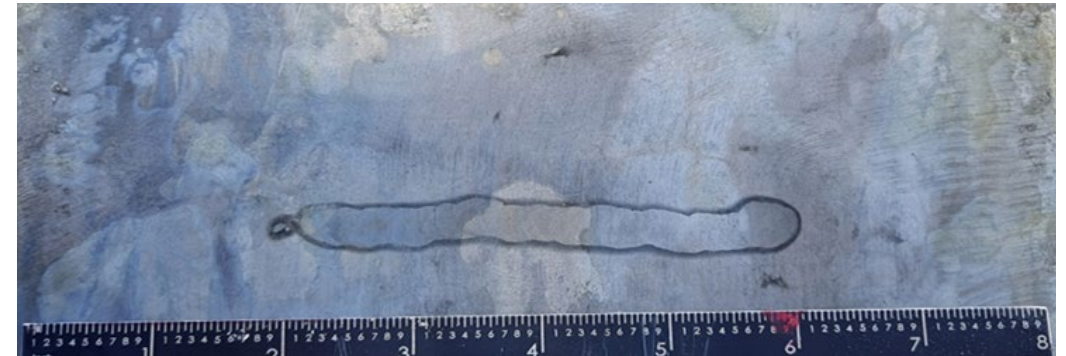
VALIDATED HARDNESS < 250 HB

- Standard Material Hardness Anomaly; 1954 DSAW Bethlehem Steel; X-52
 - ILI Reported 254 HBW
- >> Measured hardness value: 250 HBW

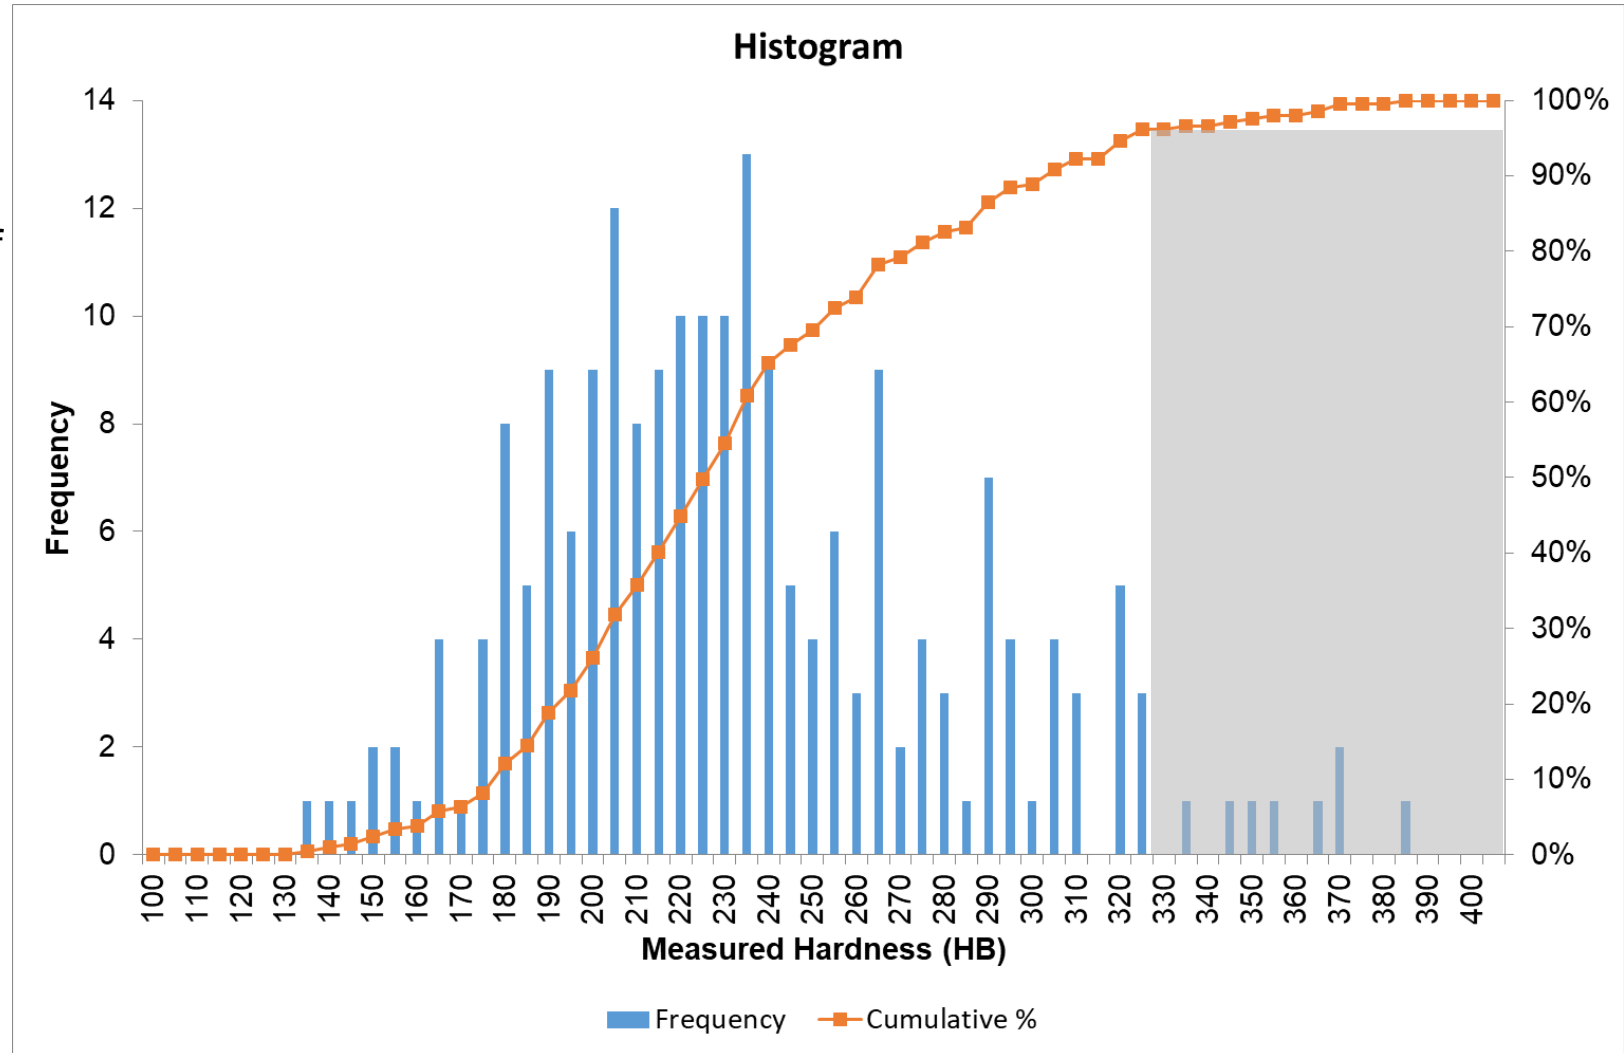
VALIDATED ILI REPORTED ANOMALIES

- 208 validated anomalies up to date
 - Validated anomalies with measured hardness < 327 HB make up of 96% of all validated anomalies.
- We are managing a portion of the threat.
