Assessment of Threats on Cast Iron Pipes

PHMSA R&D Forum Workgroup, 2021

Khalid Farrag, Ph.D., P.E., PMP
Senior Institute Engineer, R&D Manager
Gas Technology Institute

December 1st, 2021

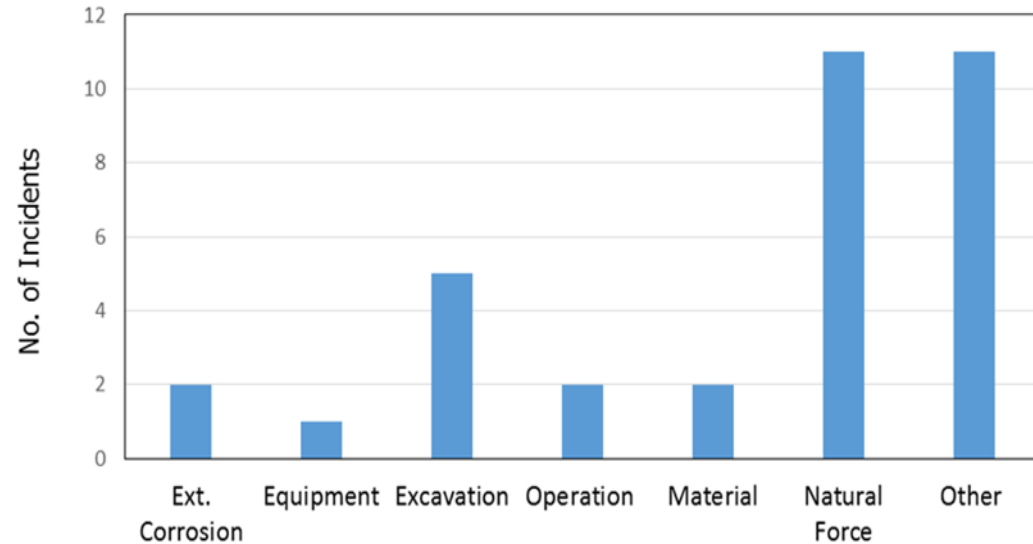
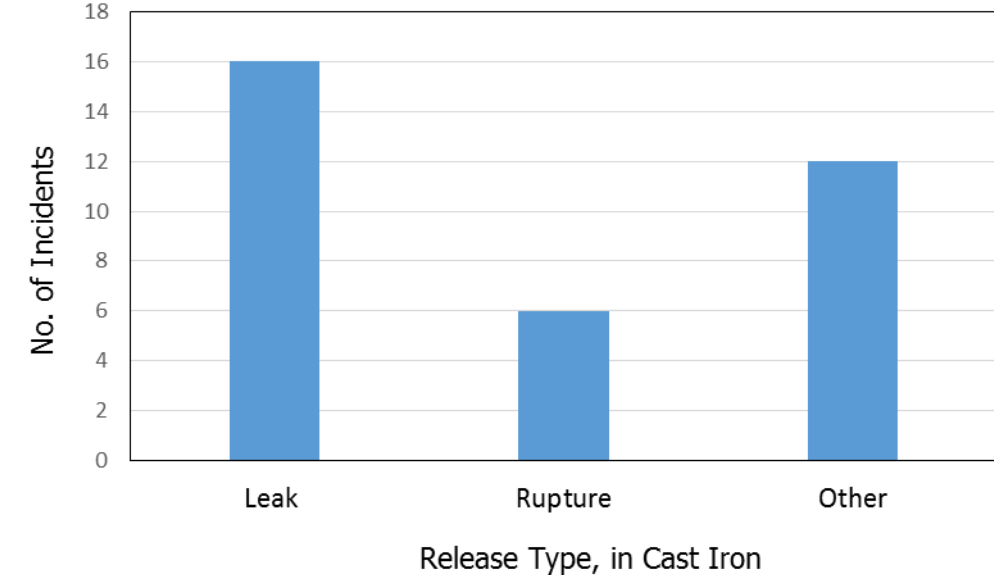
Causes of Incidents in CI Pipes [PHMSA Incident Reports 2010-2016]

- Stresses resulting from pipe internal pressure are negligible in cast iron pipes carrying pressures up to 30 psig.
- Pipe stresses are mainly caused by soil and traffic loads and other external forces.

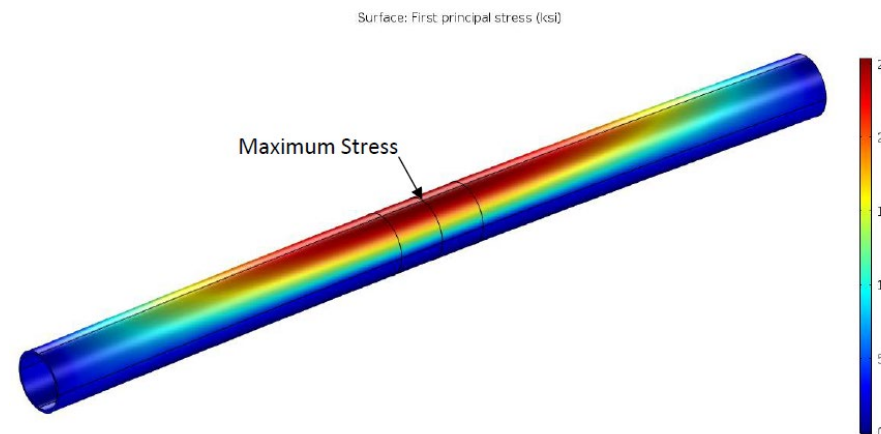
Example model output of the Finite Element (F.E.) program

- A nonlinear, 3D finite element (FE) model, simulating a single pipe span was utilized as the basis for the Fitness-For-Service (FFS) model.
- A Design of Experiment (DoE) method was used to produce response surfaces from the FE simulation results that can predict the maximum stresses in pipes with and without wall loss.

Inputs:

<i>Pipe Dimensions</i>					
Parameter	Units	Description	Value	Minimum	Maximum
class	ksi	Material class (tensile strength)	40	10	60
D	in	Pipe outer diameter	6	4.8	13.2
span	ft	Pipe span	12	12	18
t	in	Pipe wall thickness (if known)		<i><-- If a value is entered h</i>	
t.pred	in	Pipe wall thickness predicted by OD	0.413

<i>Corrosion Flaw Dimensions</i>					
Parameter	Units	Description	Value	Minimum	Maximum
flaw.d	in	Maximum corrosion flaw depth	0.33	0.021	0.330
flaw.l	in	Maximum corrosion flaw length (along pipe axis)	4	0.157	4.723
flaw.w	in	Maximum corrosion flaw width (around circumference)	4	0.942	9.236

<i>Operating Conditions</i>				
Parameter	Units	Description	Value	Minimum
P	psig	Pressure	5	0
T.max	°F	Maximum buried operating temperature	75	
T.min	°F	Minimum buried operating temperature	55

<i>Soil and Traffic Loads</i>				
Parameter	Units	Description	Value	
soil.type		Soil type	Gravel/Base	<i><-- If a value is entered h</i>
soil.weight	pcf	Soil wet weight per cubic foot	153	
soil.weight.user	pcf	Soil weight per cubic foot, user defined		
soil.depth	ft	Soil depth	4.5	
traffic.type		Traffic type (road,rail,none)	None

Outputs:

<i>Pipe stresses with corrosion defect</i>			
Parameter	Units	Description	Value
UTS	ksi	Material class (tensile strength)	40
P1.max	ksi	Maximum resolved tensile stress	56.9
SF.corroded	ratio	Tensile strength safety factor	0.70

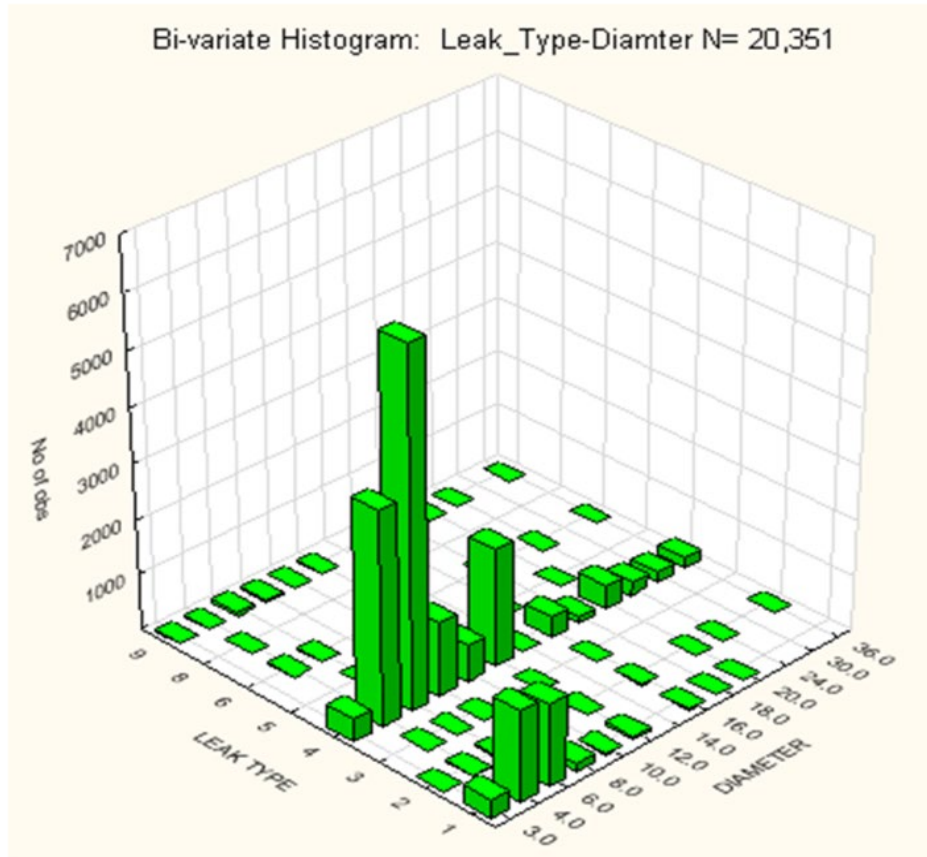
CI Leak and Breakage, Northeast Data from 2002 to 2012

LEAK TYPE

Code	Description
1	Broken Main
2	Leaking Pipe
3	Gate/Valve
4	Joint
5	Fitting
6	Drip
7	Regulator
8	Tap Connect
9	Other

- Earth movement damage to cast iron pipes includes landslide, flooding, thermal, and seismic loads.
- These forces can cause joint displacement, leakage, and pipe breakage.

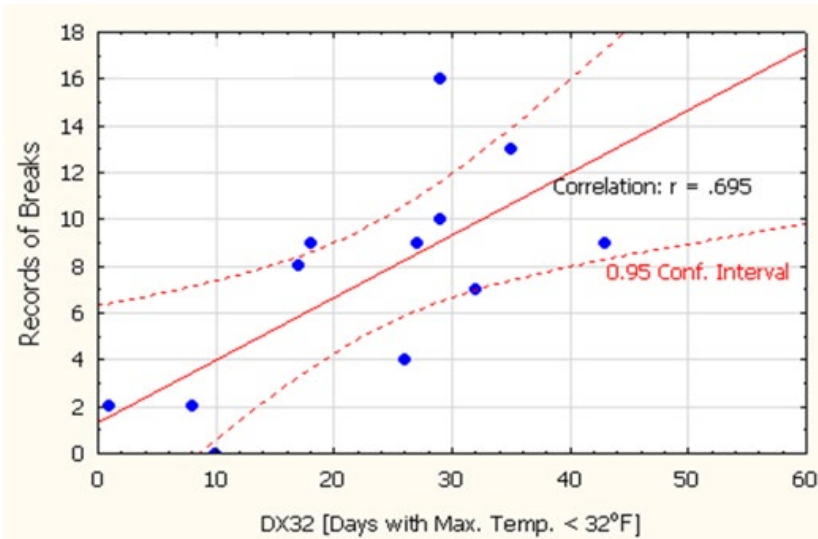
Increase in CI breaks with # of freeze days

- Analysis should be site specific to incorporate local soil, pipe, and site characteristics.
- Correlate the influencing parameters (weather, soil types, pipe size, etc.) with leakage and breakage records.
- Short number of freeze days is not as significant as long freeze periods (#days with max temp. < 32°F)

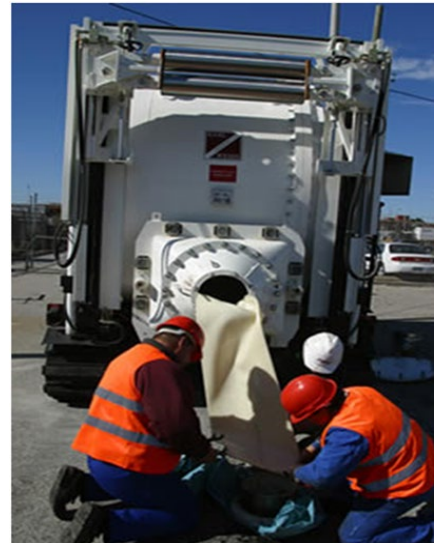
- Various types of composite pipes and Cured-in-Place liners exist in the market for CI rehabilitation.
- Several types of reinforcement fibers are used, including glass fiber, aramid, and carbon fibers.
- A following NGA presentation will discuss CI rehabilitation with Starline systems.

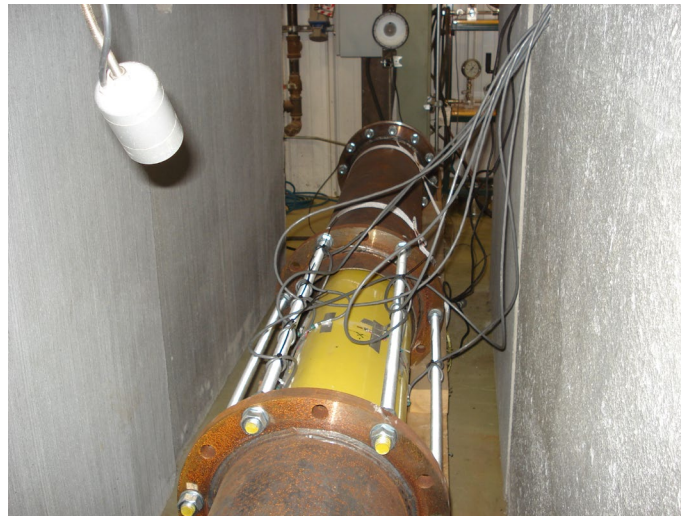
Bending, Pressure, and Permeability Testing of Liners

REPAIR – Technologies Evaluation:

- Define performance metrics (e.g., pressure capacity, deformations, bending strength) required to support implementation of REPAIR technologies.
- Establish a framework to evaluate & validate design life for Pipe-In-Pipe (PIP) solutions.
