Construction Issues

Pipeline and Hazardous Materials Safety
Administration

“Houston We Have A Problem”

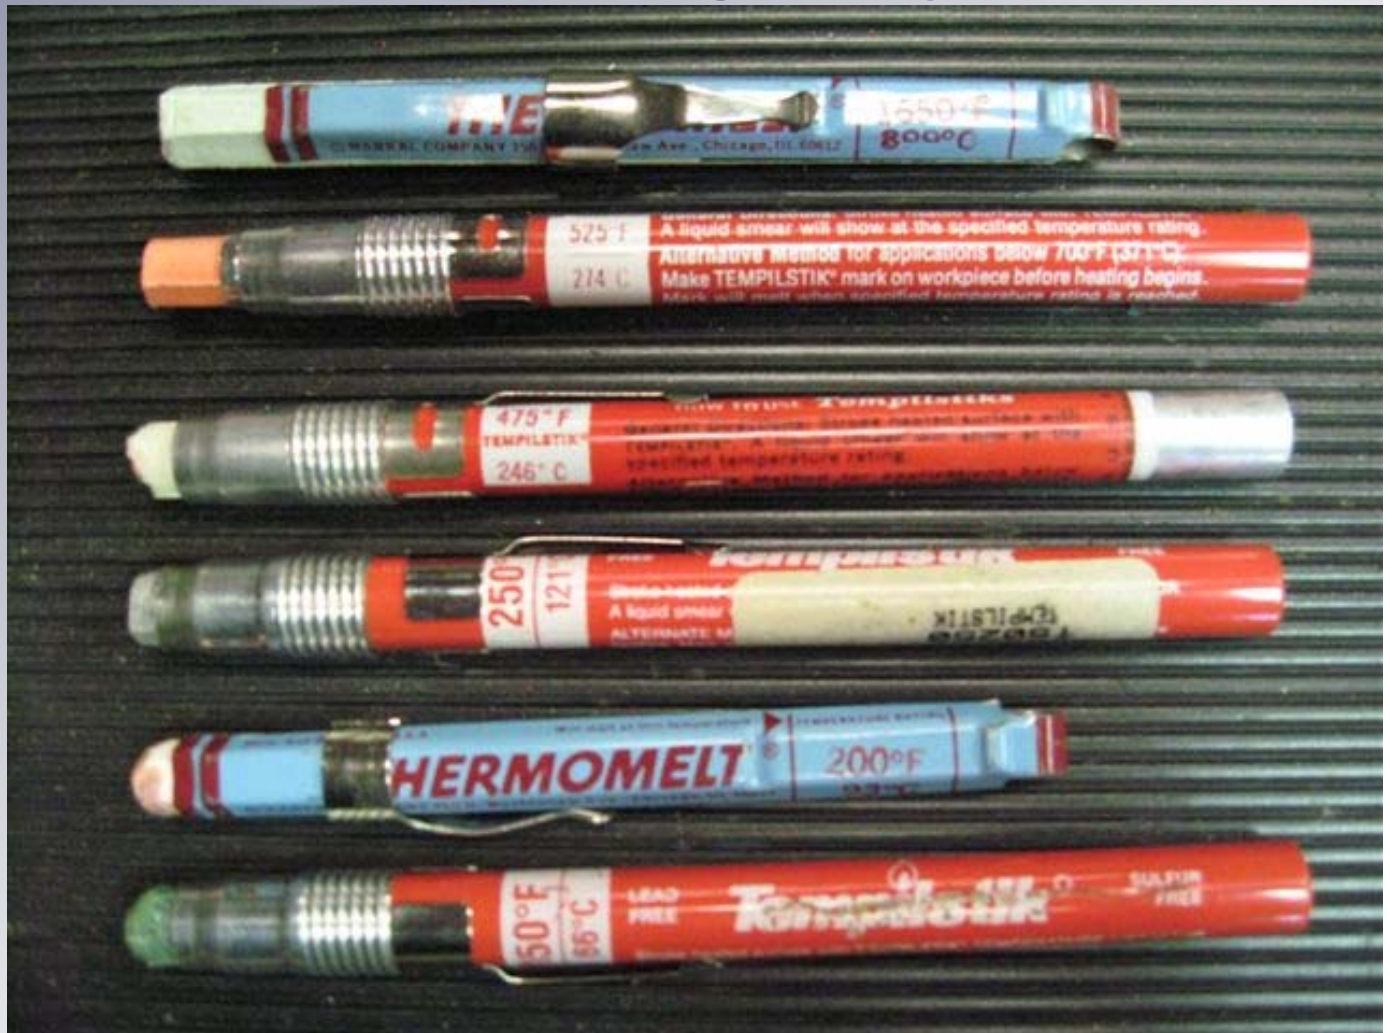
Temperature Indicating Crayons

The crayon holder specifies the melt temperature

- Temperature indicating crayons (Tempilstik) are specially formulated to change color and melt at a specific temperature.
- On a cold pipe surface upon heating, the mark changes color and melts at the specific temperature
- Used on a hot surface, the crayon only indicates the temperature is greater than the specified temperature on the crayon if the crayon melts
- Applying the crayon on an area adjacent to a weld joint and then heating with a propane torch directed on the mark will give a false temperature indication. In this case, the flame heats the crayon mark faster than the pipe. The pipe will not be up to the required temperature.
- On a hot surface, the crayon should be used after heating and two different temperature crayons may be necessary to determine the preheat is within the welding procedure.

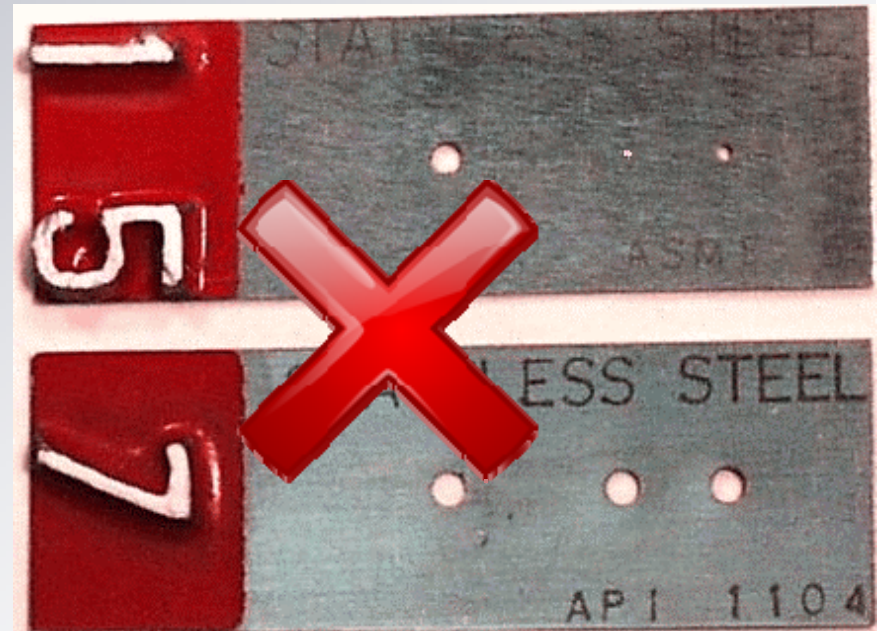
Image Quality Indicators (Penetrameters)

- PHMSA recognizes the 20th edition of API 1104. The 20th edition **only** allows the use of Wire Type Image Quality Indicators.

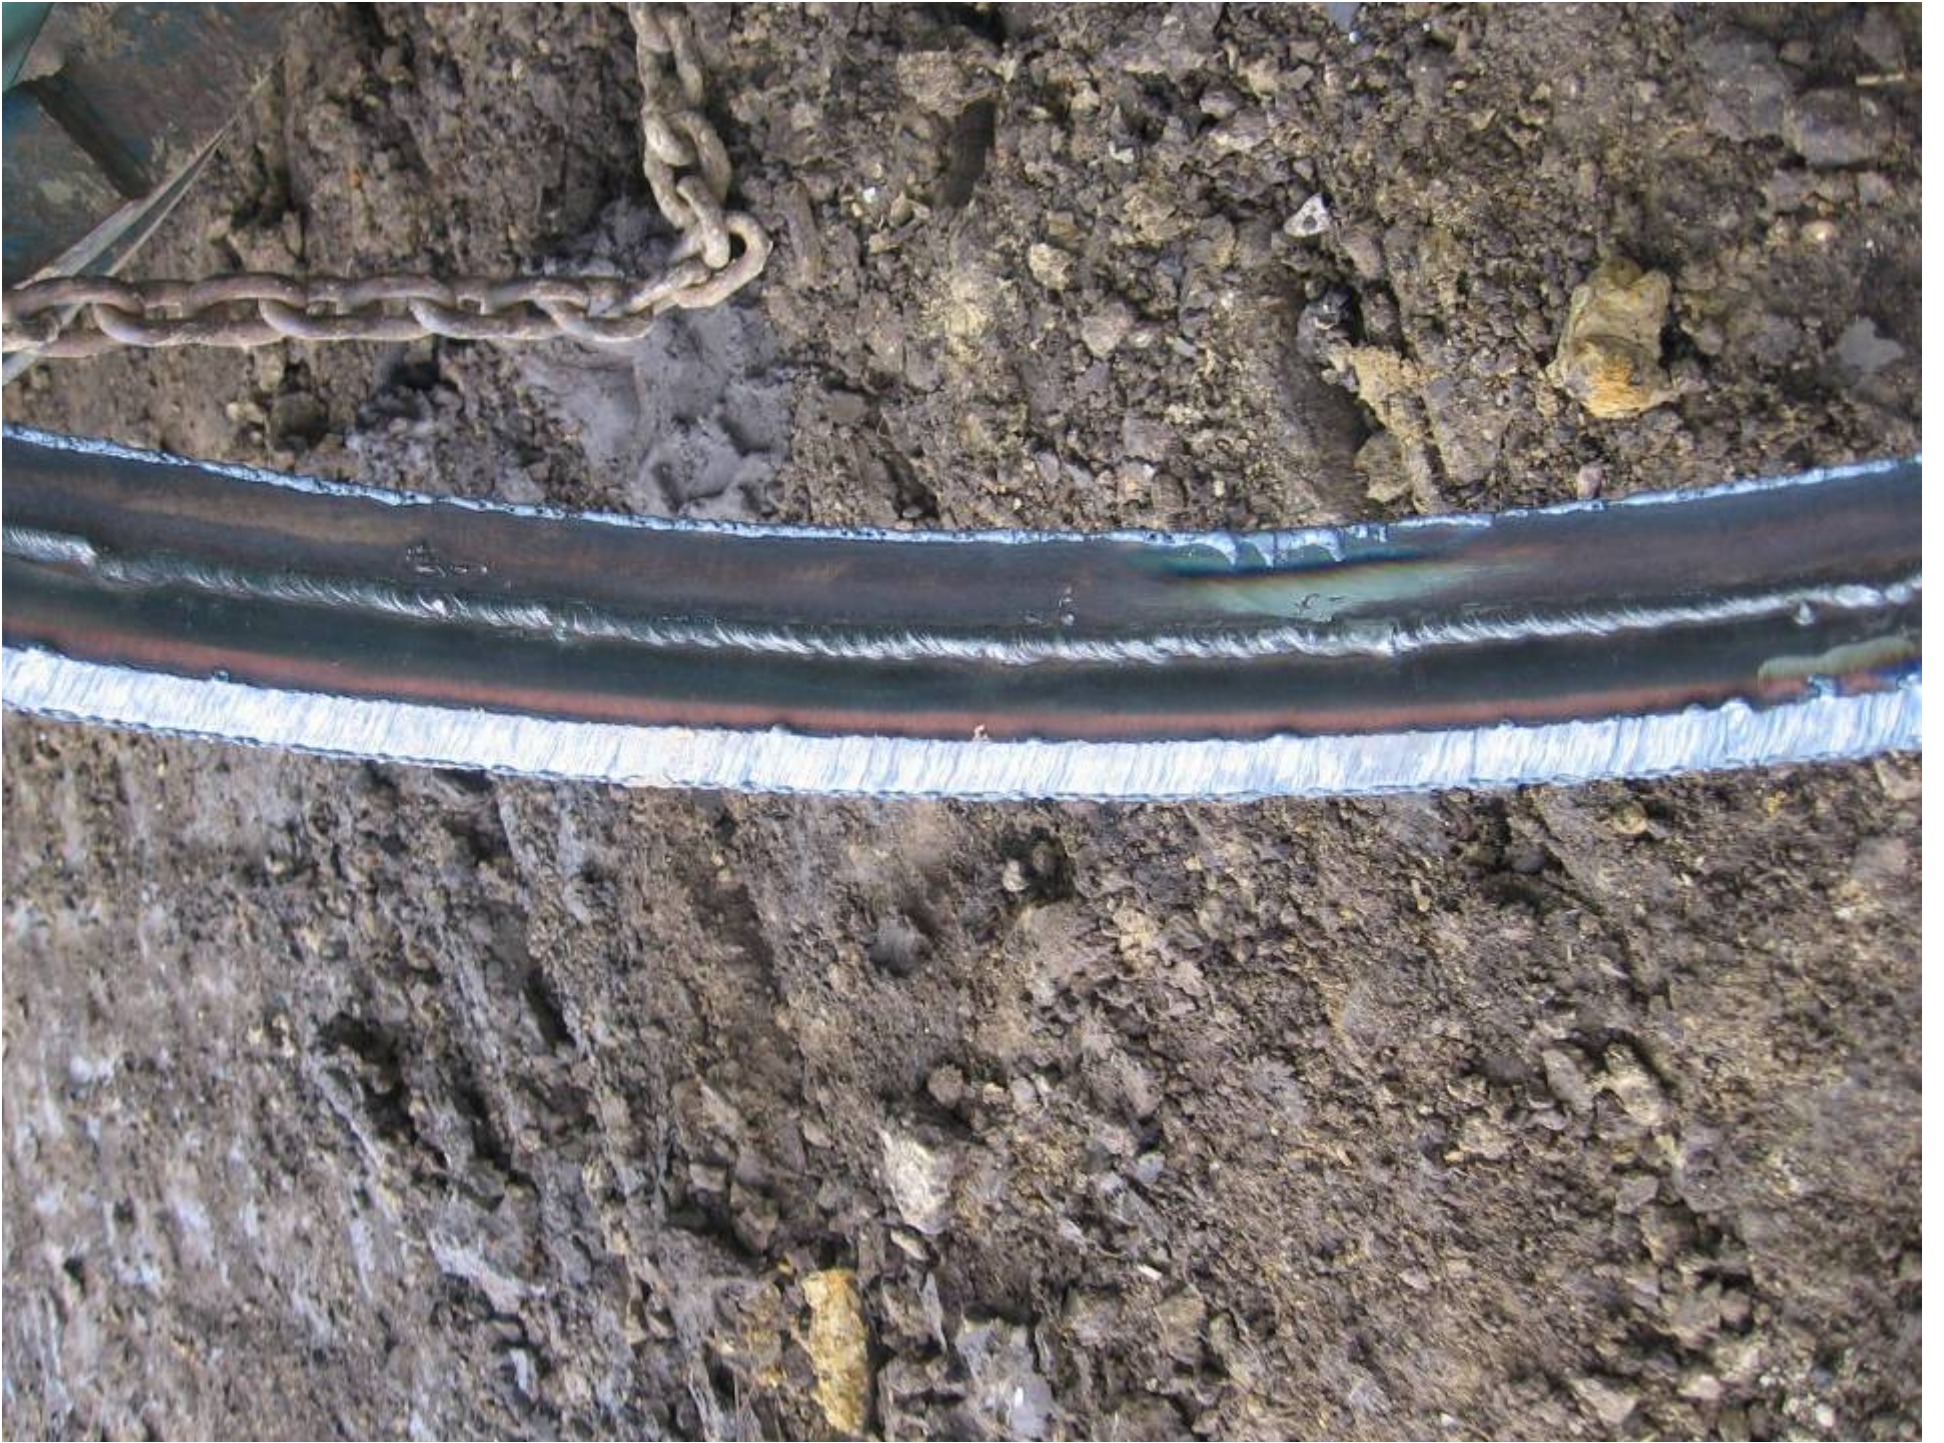
Arc burns and welder competency

- Arc burns are not acceptable on high pressure gas pipelines and liquid pipelines.
- The following slides show that arc burns can happen during internal back welding.
