# PHMSA Cased Pipeline Integrity Assessment Workshop

Chicago, IL  
July 15-16, 2008

Scott Meierotto

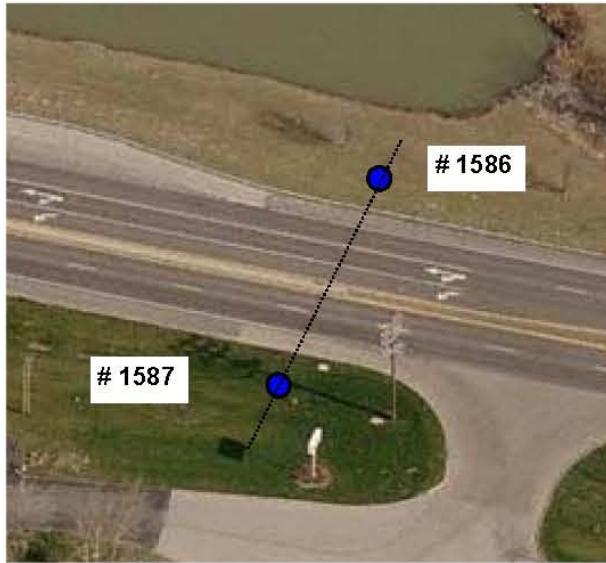
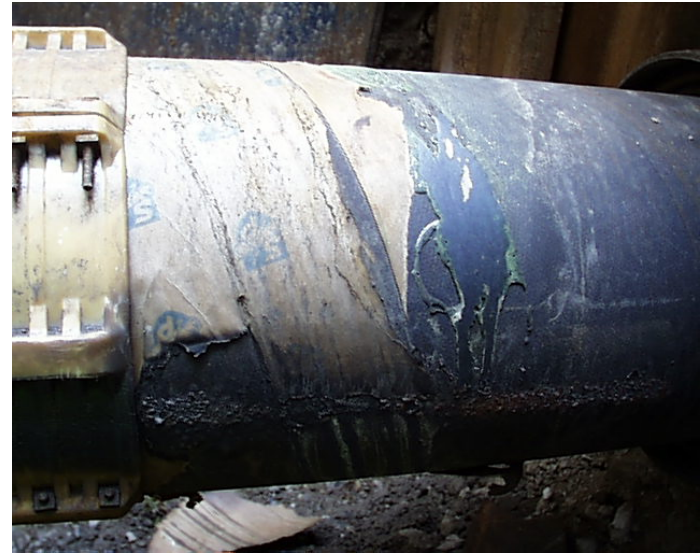
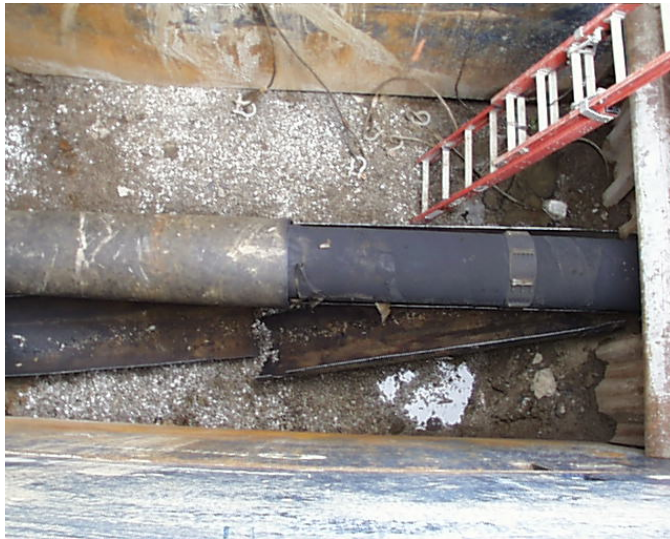
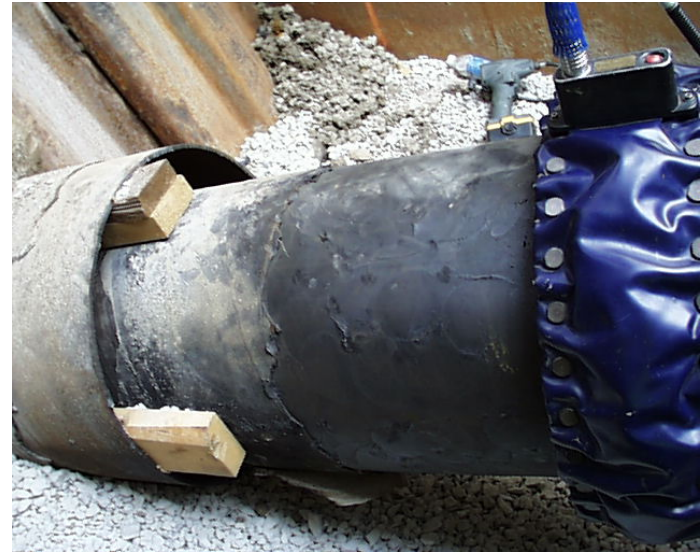
- Almost all partially filled with water
- Old style “Lug” insulators have failed and caused coating damage
- Minimal remaining CTE seems to provide adequate protection for atmospheric corrosion
- For all cased crossings inspected, only two measurable defects have been found

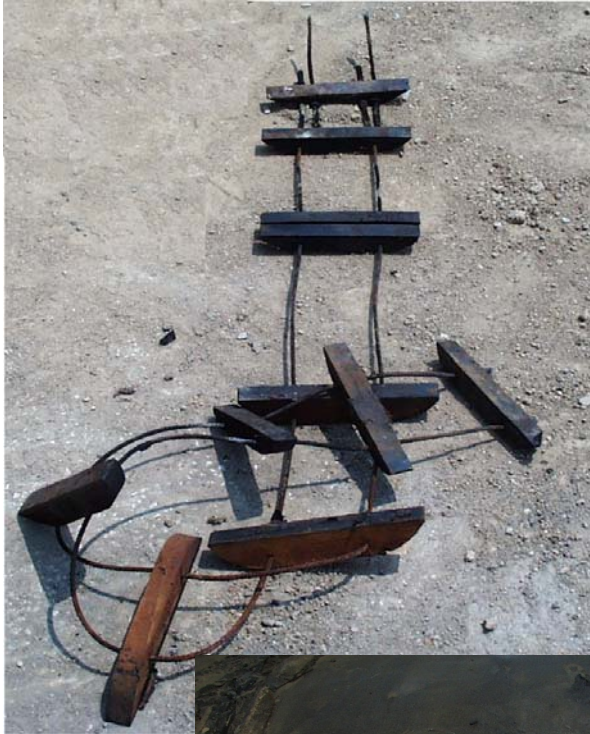
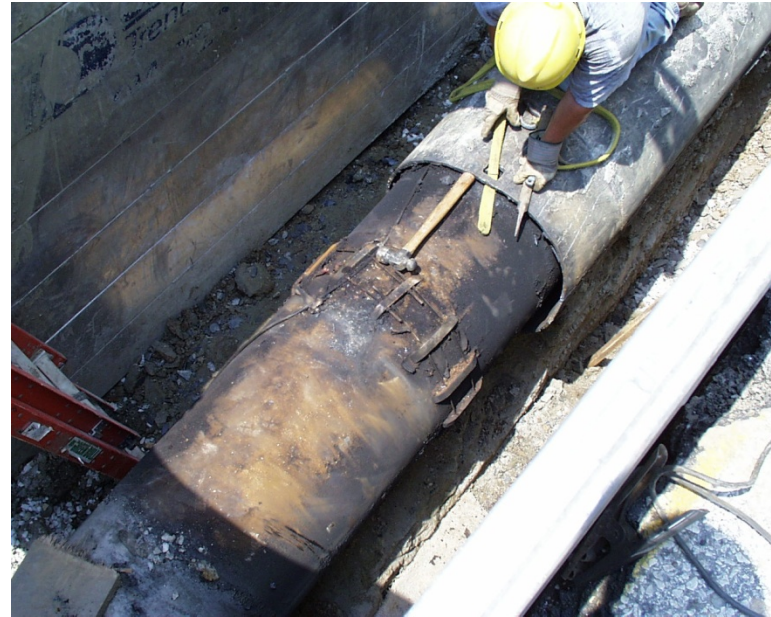
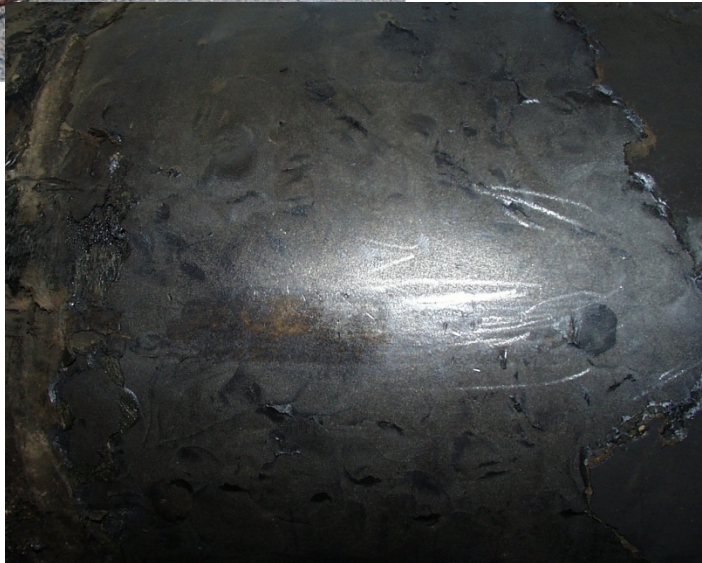
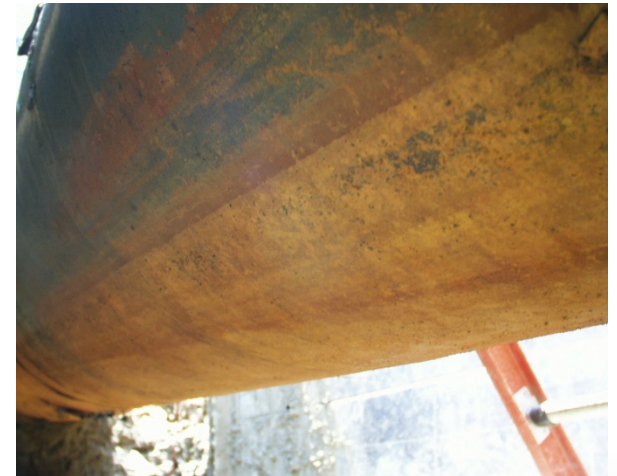
24" Carrier 0.312" wall – 26" Casing 115' Long  
Installed 1950

Looking North
