# PLYMOUTH PLANT INCIDENT INVESTIGATION

# Overview

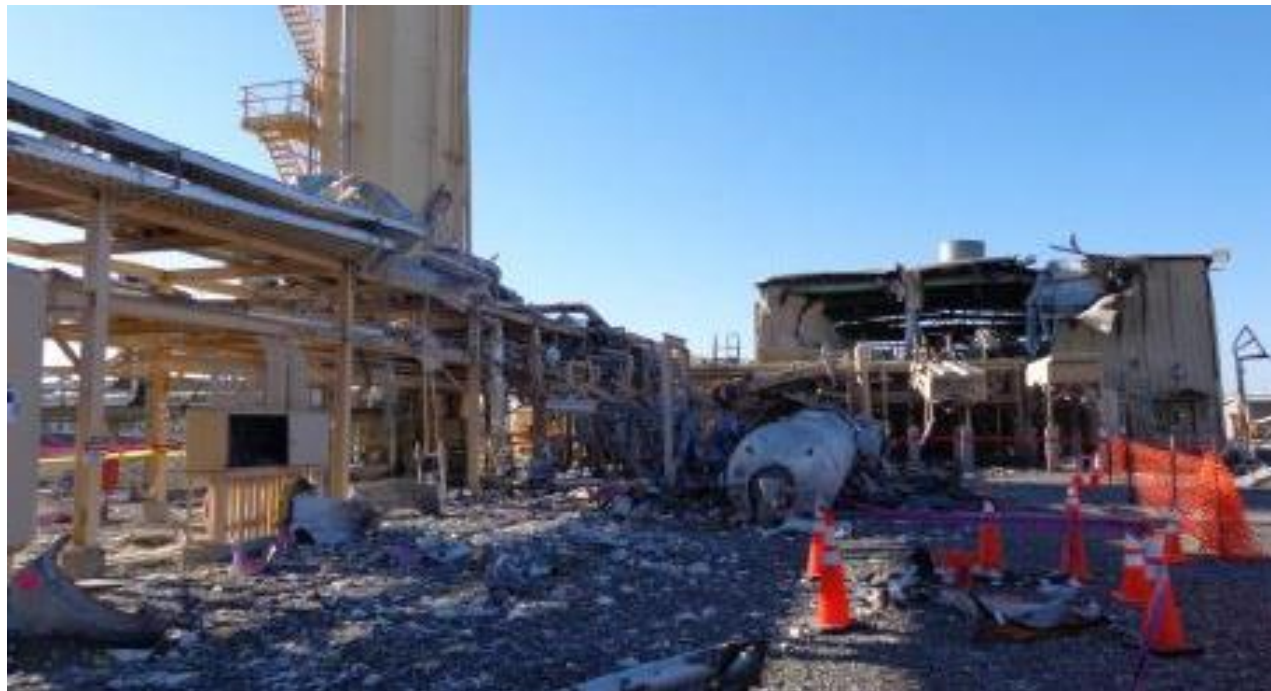
- A 3-D scan was completed prior to initiation of any disassembly or clean up of debris in the incident area
- Evidence preservation was methodically slow, but necessary in an investigation of this magnitude

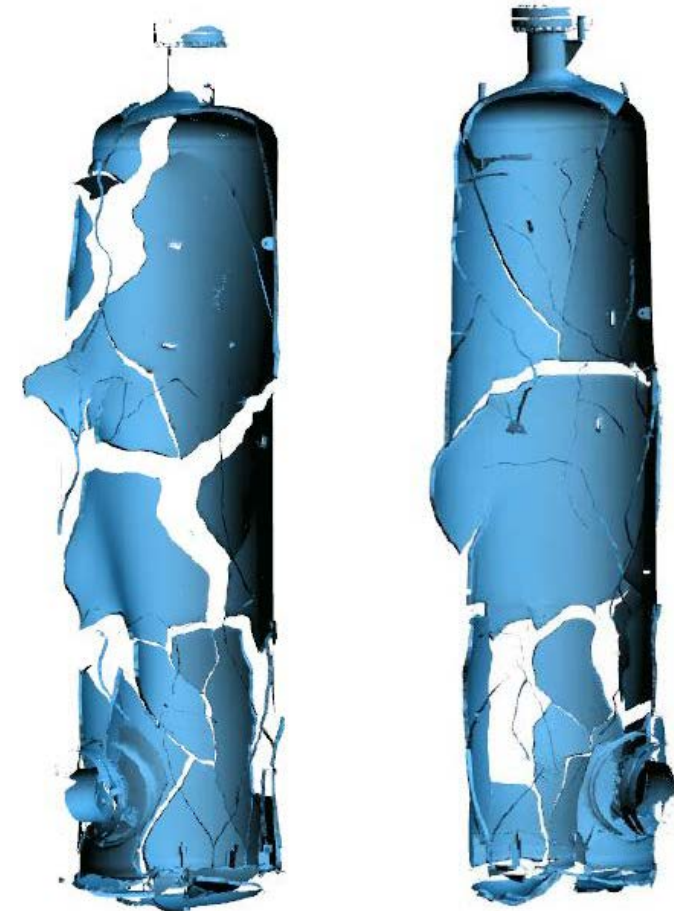
- Adsorber D-20A weighing ~50,000 lbs
- Debris generated from the failed adsorber caused significant collateral damage
- Mechanical failure of the adsorber was the initial focus of the investigation
- Stress Engineering Services (SES) was contracted and mobilized to the site to evaluate vessel fragments
- SES performed high resolution scans of all available vessel fragments
- Scanned fragments were weighed and re-assembled in a 3-D model to ensure all pieces were accounted for

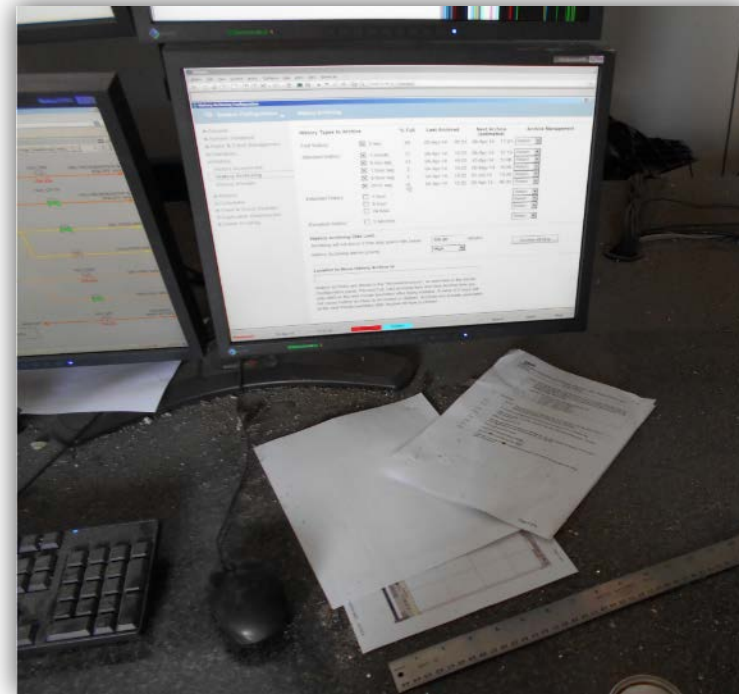
- The investigation team reviewed current and past revisions of Plymouth operating procedures
- Paired with operator interviews this provided the best understanding of how the Plymouth facility is operated
- Determined that current procedure was used and followed

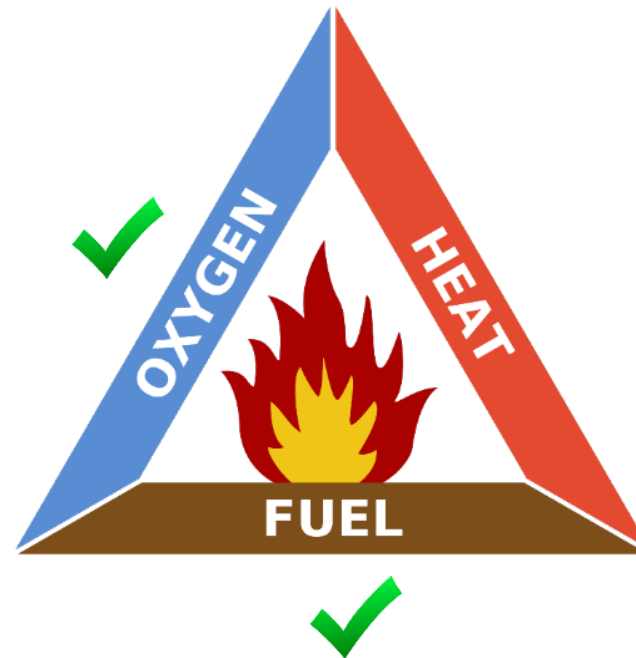
- “Pack and Purge to 100 PSIG 3 times”
  - Valve Alignment allowed for “spring effect” if not blown down to 0 psig
  - AGA: Purging Principles and Practice provides purging guidelines, however it doesn’t prescribe methodology for purging molecular sieve adsorbers.

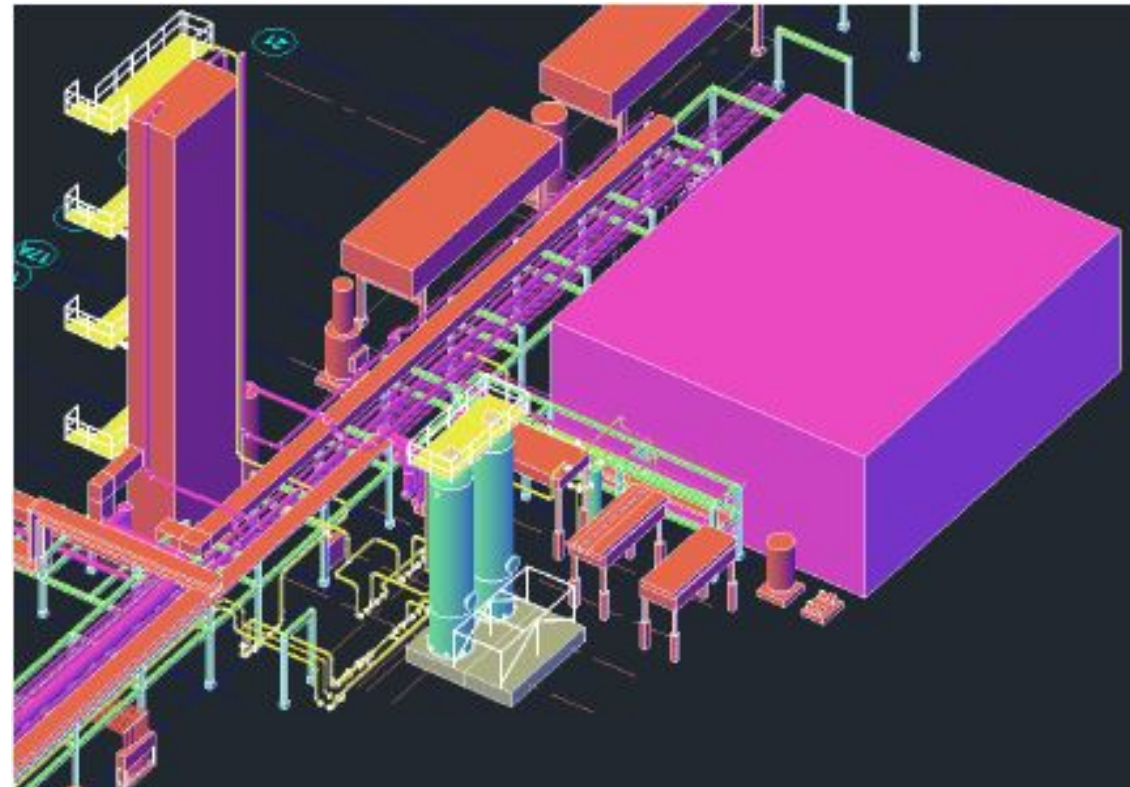
- With evidence that combustion was not internal to Adsorber D-20A the investigation team hired ABS to perform blast modeling in order to determine potential ignition locations

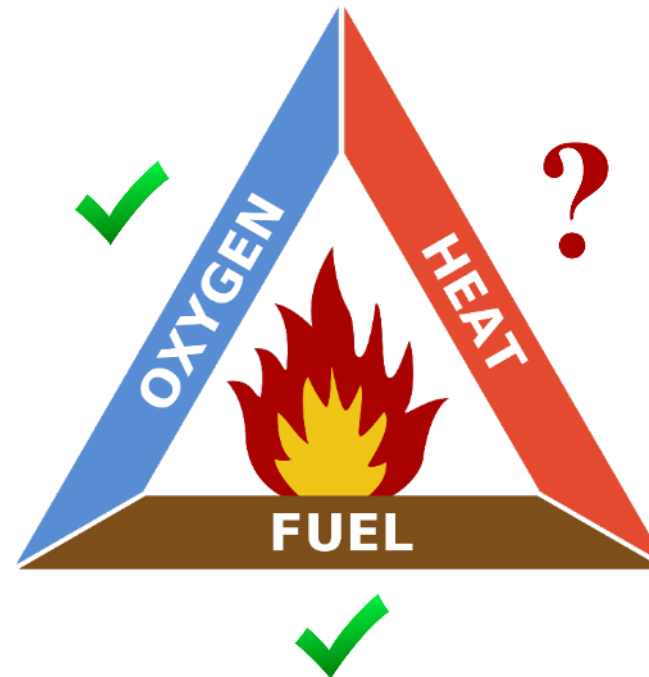
- Published values of the auto-ignition temperature of Methane is currently documented as ~1000-1100 deg F
- Salt Bath Heater set-point = 550 deg F

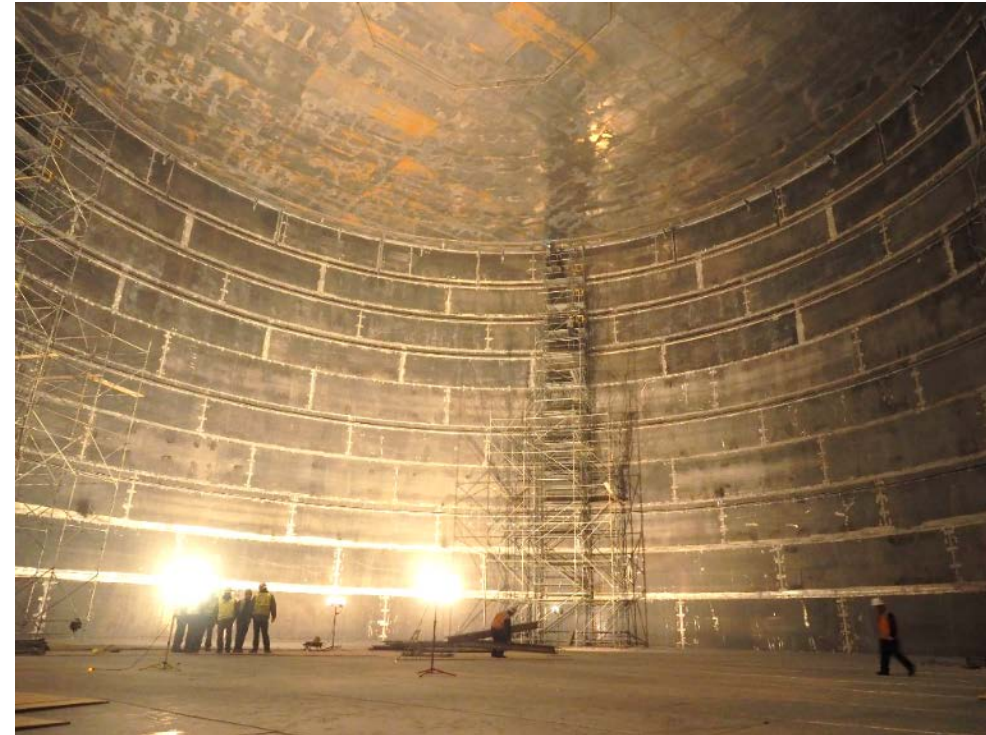
- API 653 inspections of the inner and outer tanks
- 4 full height quadrant inspections using penetrant (PT) and visual methods
- 100% shell to floor weld vacuum box inspection and sample penetrant and vacuum box inspections on the floor plates
