s & Advisory Bulletin

U.S. Department of Transportation
Pipeline and Hazardous Materials
Safety Administration

Case Study 1: Denbury Satartia, Mississippi

Case Study 2 – Hillsboro, Kentucky

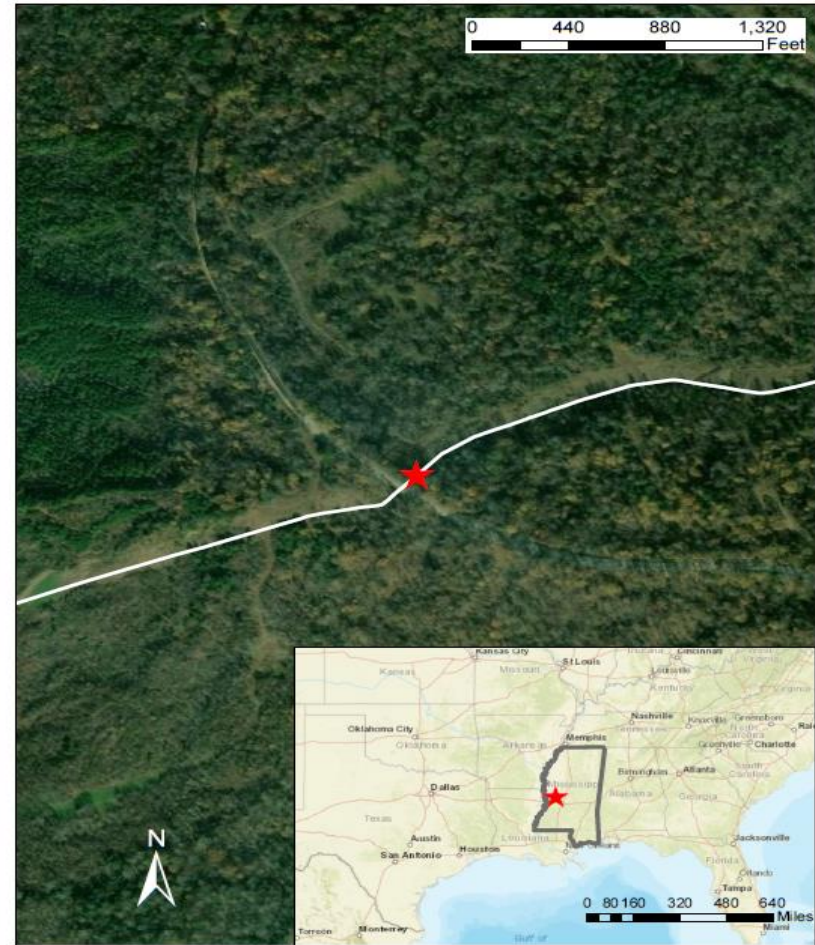
OPID 32545 - Denbury Gulf Coast Pipelines, LLC - Satartia, MS. 2/22/2020

- Occurred 1 mile southeast of Satartia, Mississippi
- 200 people were evacuated
- 45 individuals sought medical attention
- Over 30,000-barrels released

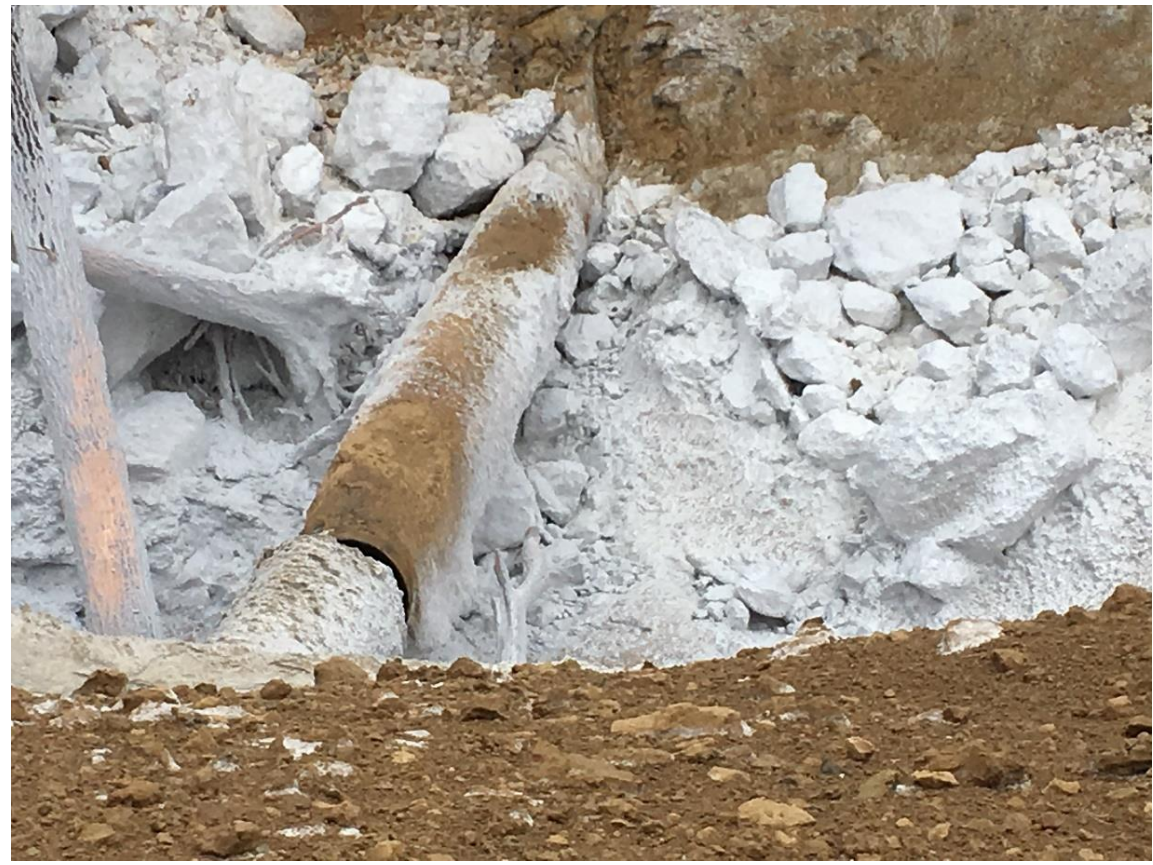
Earth Movement: Two Key Factors

- Loess Soil
- Precipitation

The failure of the Delhi Pipeline was a result of **soil movement**, which caused excessive axial loading leading to failure at the girth weld.

Area topography, soil type and large amounts of rain over the preceding months saturated and vertically eroded the loess soil on the side of the hill above the pipeline.
