Identifying/Managing the Manufacturing Threat

PHMSA Workshop
Chris Whitney
El Paso Pipeline Group
July 20, 2011

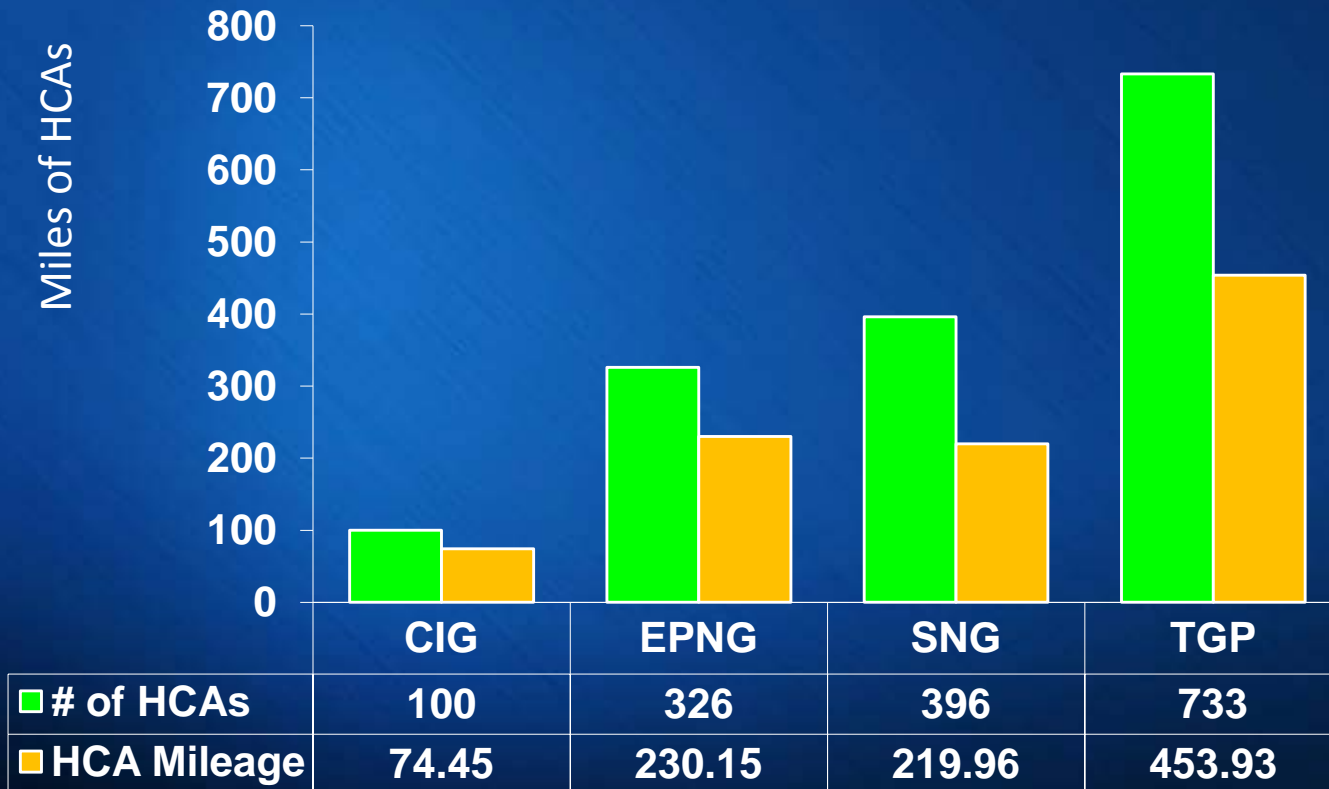
El Paso Pipeline Group HCAs

Total for EPPG – 978.5 miles of pipe / 1,555 HCAs (5/16/11)
